**THE NINTH MEETING OF THE SOUTHEAST ASIA AND BAY OF BENGAL  
SUB-REGIONAL ADS-B IMPLEMENTATION WORKING GROUP  
(SEA/BOB ADS-B WG/9)**

**UPDATE ON TPR901 PROBLEM**

(Presented by Airservices Australia)

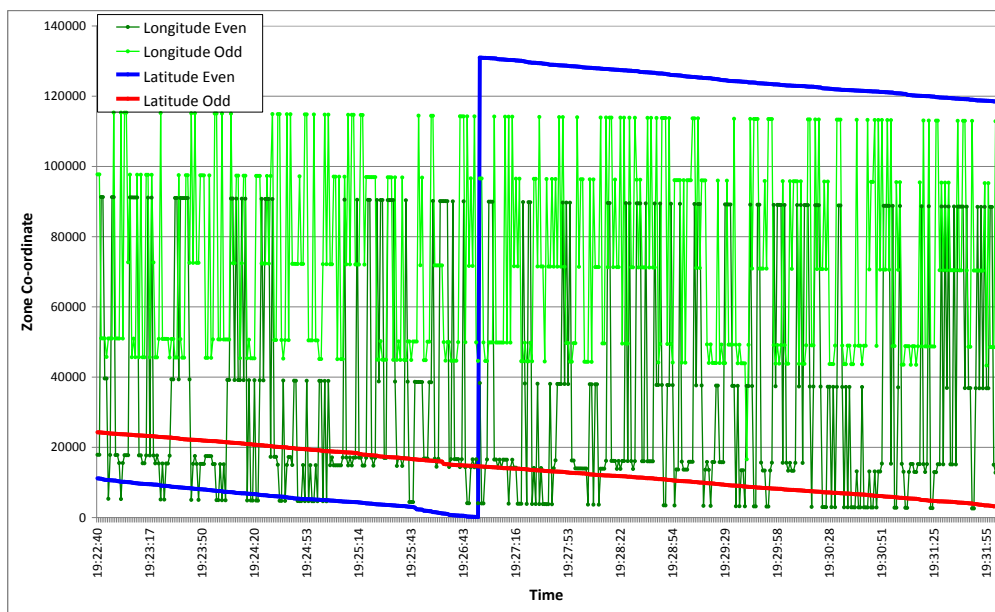
2.1 During the last months this issue has been investigated further by Rockwell Collins and Airservices Australia. In one case, the ADS-B transmissions from an aircraft were examined prior to CPR decoding. Encoded latitude and longitude bin values were plotted for both odd and even messages.

2.2 The data shows that even prior to decoding the aircraft position the encoded values for longitude exhibited multiple jumps. Normally these values should follow a saw tooth pattern with jumps corresponding to when the aircraft position crosses a zone boundary as shown below :

2.3 The continuous jumping pattern on the longitude values suggested that the problem was occurring prior to the decoding process.
