**EIGHTEENTH MEETING OF THE COMMUNICATIONS/NAVIGATION
AND SURVEILLANCE SUB-GROUP (CNS SG/18) OF APANPIRG**

PBCS IN NZZO – POST IMPLEMENTATION MONITORING

(Presented by New Zealand)

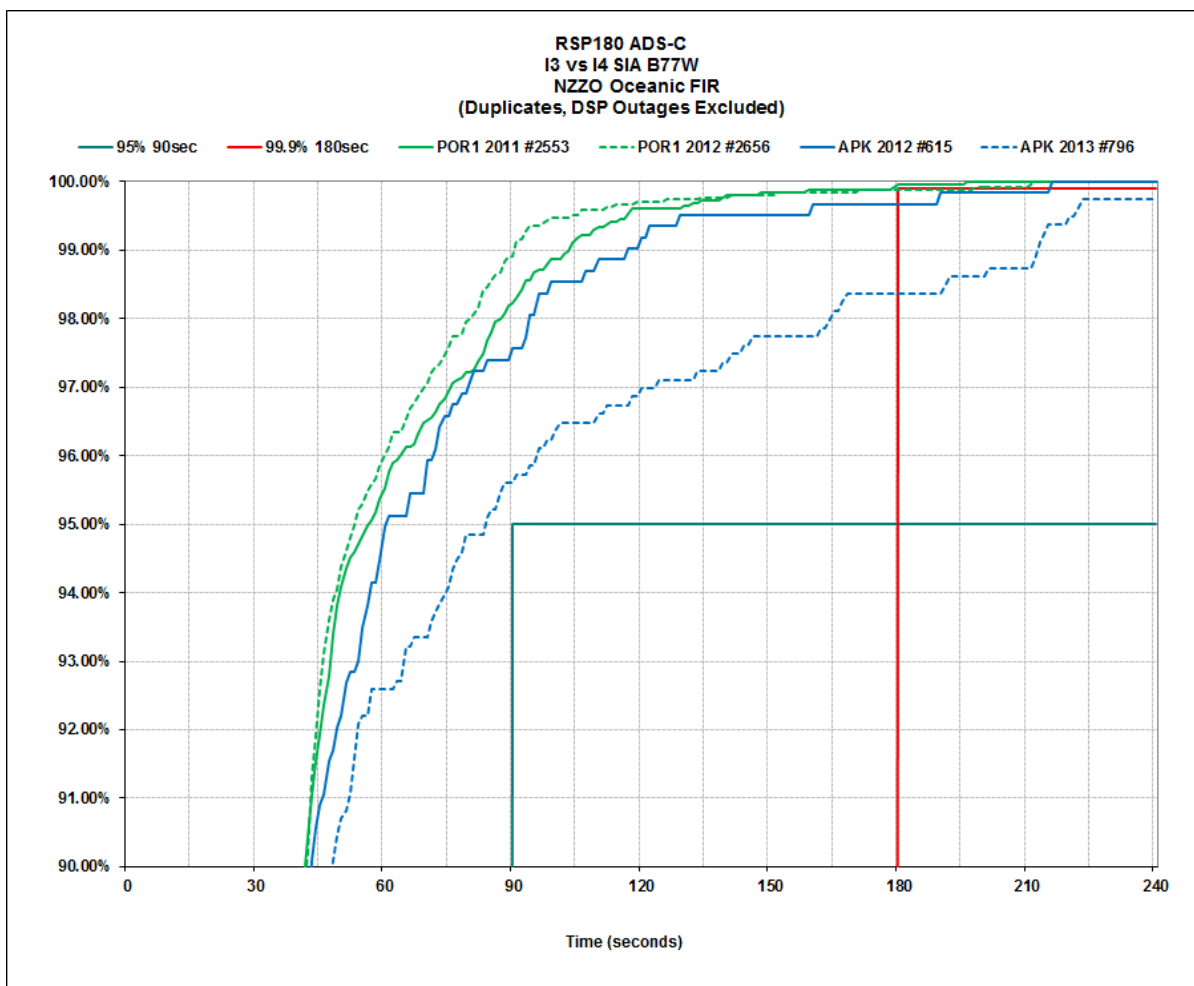
to the Inmarsat I4. Analysis of the September and October data for these aircraft showed a significant deterioration below that expected and further investigation showed that all I4 traffic was being affected. Analysis of all fleets operating on the I4 showed consistent performance deterioration as indicated in the table below.

2.2 An analysis of data from the SIA B77W fleet 2011-2013 (refer Figure 1 below) clearly showed deterioration in performance in 2013. SIA had been one of the first fleets to transition to the I4 in NZZO airspace in 2012.

Figure 1: ANZ B77W I4 - September October 2013

2.3 A FANS problem report was raised on the ISPACG Central Reporting Agency (CRA) website on 25 November. Feedback to the PR was swift and Inmarsat advised that the observed deterioration had been caused by a software fault in a software package released into operation on 12th August that was causing all AES operating on the Pacific I4 to be allocated to a low speed 1200bps channel. Inmarsat also advised that the fault had been rectified on 20 November which was confirmed by subsequent analysis.

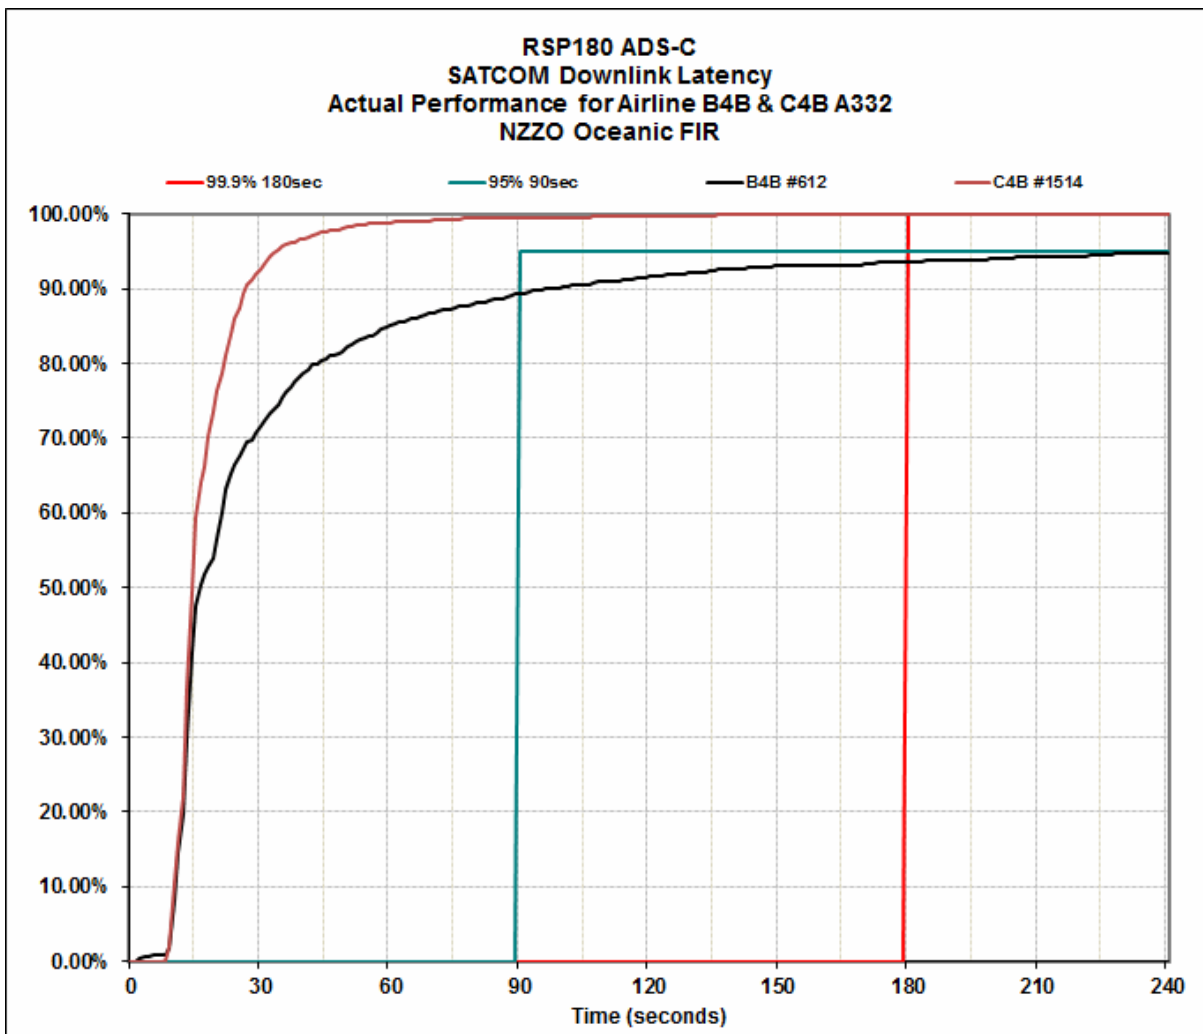
2.4 In early 2013 a new A332 fleet was introduced into the SOPAC. Monitoring of RSP180 and RSP240 performance from this fleet which had been incentivized by numerous controller complaints of sub-standard performance confirmed controller assessments. The observed performance is depicted in Figure 2 which illustrates typical performance from another A332 fleet (C4B) and the below par performance from the new fleet (B4B). The degraded performance falls below the normal operating 95% 90 second performance level. We have observed in the past that controller complaints of poor performance will be heard when performance falls below the 95% 90 second level and this occurred in this example.

Figure 2: New fleet operating below RSP180 standard

2.5 Airbus investigation determined that the aircraft had been set-up to use HFDL in the Airbus next-on-busy mode. Unfortunately, the airline was not an ARINC customer and any messages downlinked by HFDL were promptly discarded. Additionally, the airline had not registered to use the Inmarsat I4 service so the aircraft AES was being rejected from the I4 back to the I3. We had seen similar I4 registration problems on an A388 implementation and the performance impact is quite significant.

2.6 This issue generated three CRA problem reports. Two from Air Services and one from ourselves. The performance issues are now resolved with HFDL de-activated and the aircraft operating on the Inmarsat I3.
