**AUTOMATIC DEPENDENT
SURVEILLANCE – BROADCAST SEMINAR
AND FOURTEENTH MEETING OF
AUTOMATIC DEPENDENT
SURVEILLANCE – BROADCAST (ADS-B)
STUDY AND IMPLEMENTATION TASK
FORCE (ADS-B SITF/14)**

Christchurch, New Zealand, 14 – 17 April 2015

CATALOGUE OF KNOWN ADS-B AVIONICS ISSUES

(Presented by Australia)

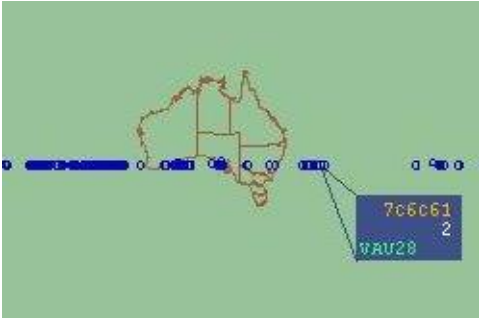
Reference	"Problem"	Cause	Presentation to ATC if allowed to display	Comments
4.	<p>Track Jumping problem with TPR901</p>

<p>Software issue with TPR901 transponder only affecting Airbus aircraft after they cross 180 degrees longitude.</p>	<p>Will present as a few wild/large positional jumps. Nearly all reports are tagged as low quality (NUC=0) and are discarded, however, some occasional non zero reports get through.</p> <p>Problem is very "obvious". Could result in incorrect longitudinal position of Flight Data Record track. Can trigger RAM alerts.</p>	<p>Problem identified and fix has been rolled out in fleets known to have been affected.</p> <p>Rockwell Collins released Service Bulletin TPR-901-34-503 on March 1, 2011 to correct this anomaly for Boeing aircraft (but not for Airbus aircraft). This component service bulletin changes the part number to 822-1338-005.</p> <p>The fix has been proven to work for Boeing aircraft. Airlines operating to Australia have been corrected.</p> <p>Airbus has developed a reset procedure to remove the problem after each crossing of 180 degrees longitude.</p> <p>The problem will be corrected when a DO260B transponder replaces the TPR901.</p>

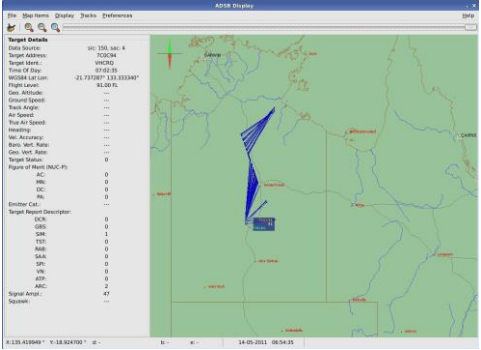
Reference	"Problem"	Cause	Presentation to ATC if allowed to display	Comments
5.	<p>Rockwell Collins TDR94 Old version.</p> <p>The pattern of erroneous positional data is very distinctive of the problem.</p>

<p>Old software typically before version - 108. The design was completed before the ADS-B standards were established and the message definitions are different to the current DO260.</p> <p>Rockwell has recommended that ADS-B be disabled on these models.</p>	<p>Will present as a few wild positional jumps. Nearly all reports are tagged as low quality (NUC=0) and are discarded, however, some occasional non zero reports get through. Also causes incorrect altitude reports.</p> <p>Problem is very "obvious".</p>	<p>Problem well known. Previously affected Gulfstream aircraft which unfortunately left the factory with ADS-B enabled from this transponder model. This now corrected</p> <p>Rockwell has issued a service bulletin recommending that ADS-B be disabled for aircraft with this transponder software. See Service Information Letter 1-05 July 19, 2005. It is easy to disable the transmission.</p> <p>If a new case is discovered, an entry needs to be made to the black list until rectification has been effected.</p>

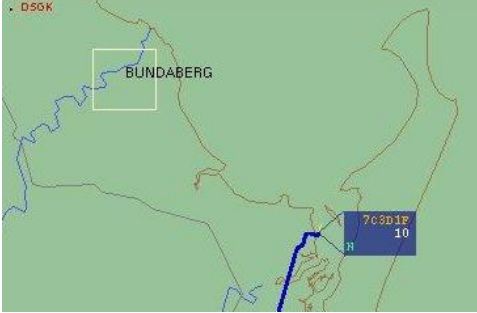
Reference	"Problem"	Cause	Presentation to ATC if allowed to display	Comments
8.	<p>Garmin "N" Flight ID problem</p> <div data-bbox="300 421 775 624" style="border: 1px solid gray; padding: 5px;"> <p>Target Details</p> <p>Data Source: sic: 111, sac: 4</p> <p>Target Address: 7C3D1F</p> <p>Target Ident.: N</p> <p>Time Of Day: 01:52:43</p> <p>WGS84 Lat Lon: -25.357132° 152.921855°</p> <p>Flight Level: 9.50 FL</p> <p>Geo. Altitude: 1200.00 ft</p> </div>

<p>Installers of Garmin transponder incorrectly set "Callsign"/Flight ID. This is caused by poor human factors and design that assumes that GA aircraft are US registered.</p>	<p>Flight ID appears as "N". Inhibits proper coupling.</p>	<p>Can be corrected by installer manipulation of front panel. Does not warrant "black list" activity.</p>

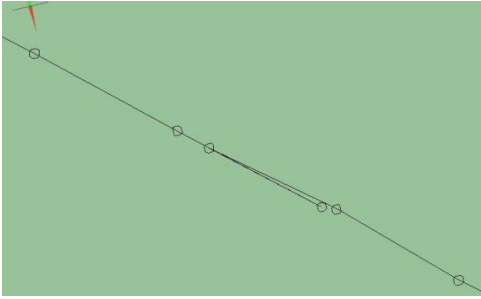
13.	Occasional small position jump backwards

For some older Airbus aircraft, an occasional report may exhibit a small "jump back" of less than 0.1 nm Root cause not known	Not detectable in ATC due to extrapolation, use of latest data and screen ranges used.	ATC ground system processing can eliminate these.
