BCA Aviation Safety

National Airlines 747BCF
NAL 102 - Accident
Bagram, Afghanistan
April 29, 2013

Rick Mayfield
Air Safety Investigation
Boeing Commercial Airplanes

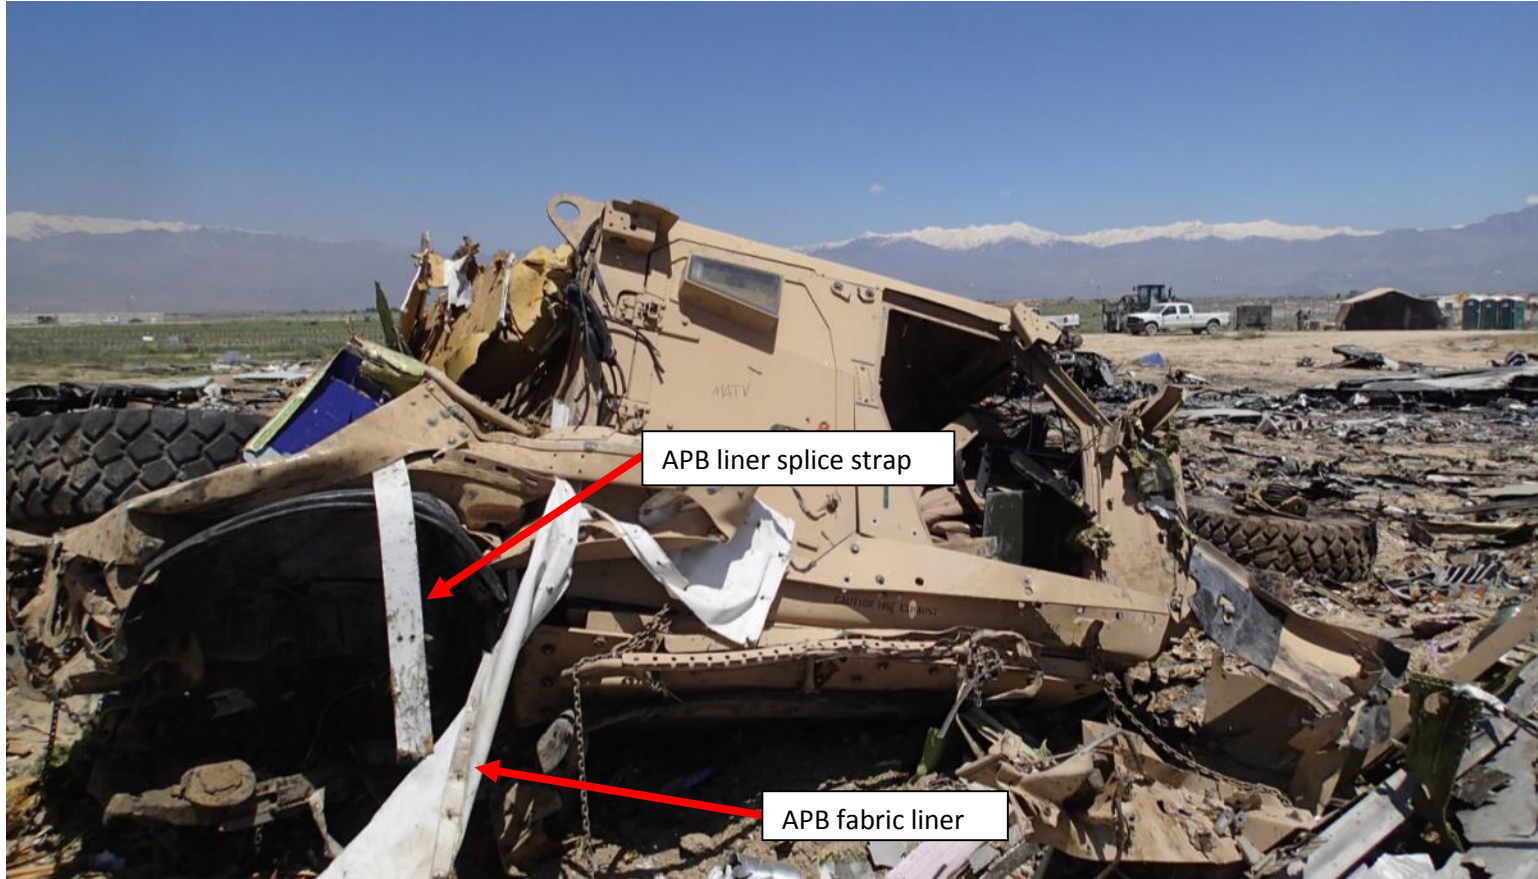
Loose M-ATV

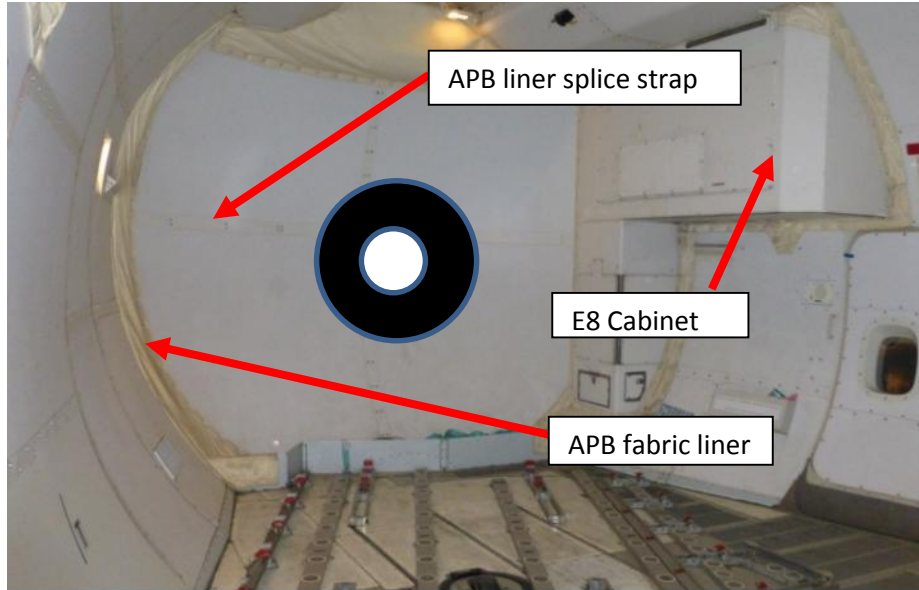
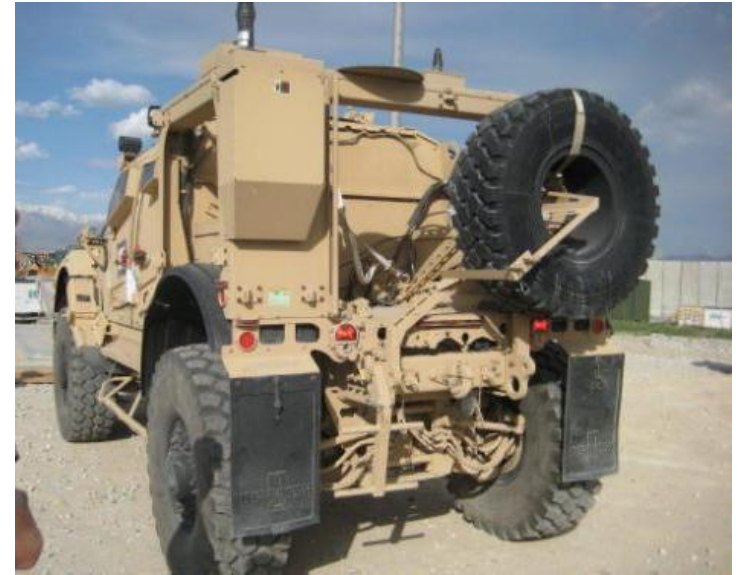
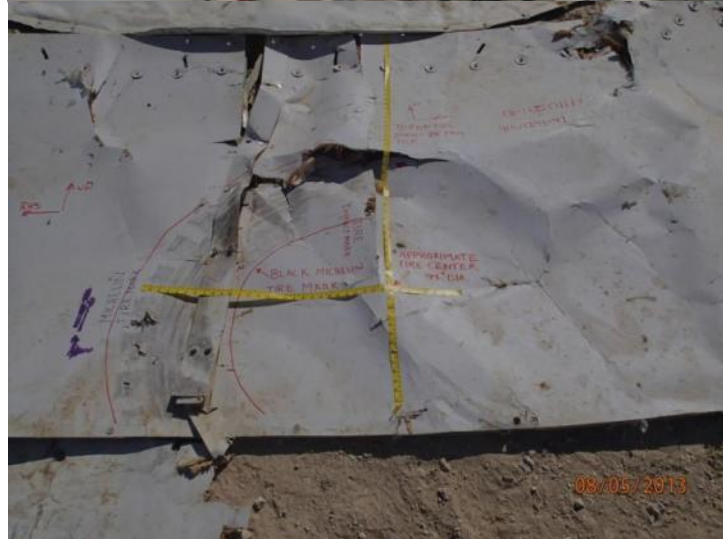
Spare Tire Imprint On APB Liner

- Tire print found on APB liner match tire on aft M-ATV
- APB liner splice strap and fabric liner found trapped in aft M-ATV

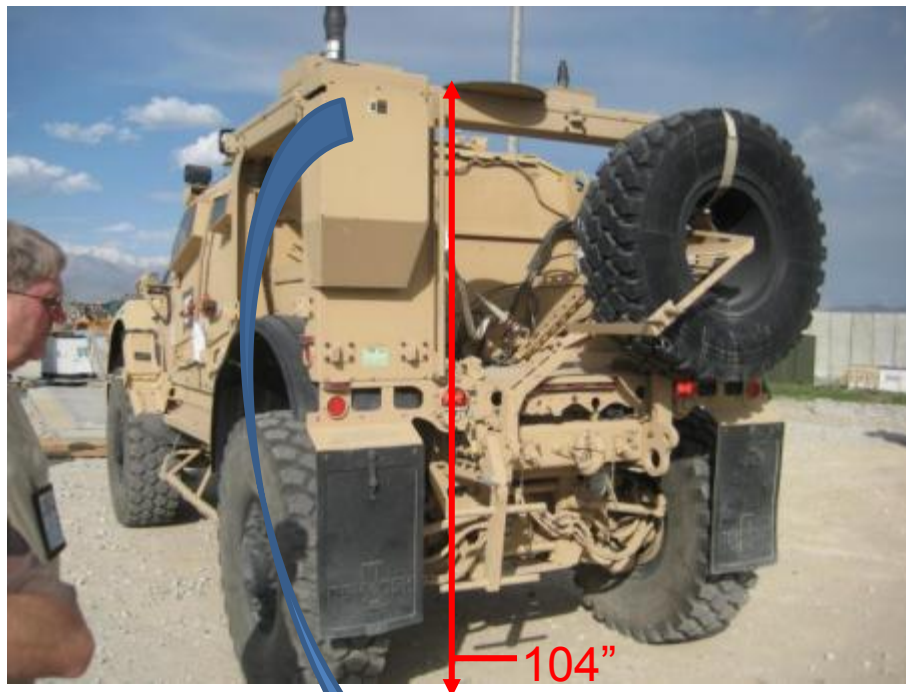
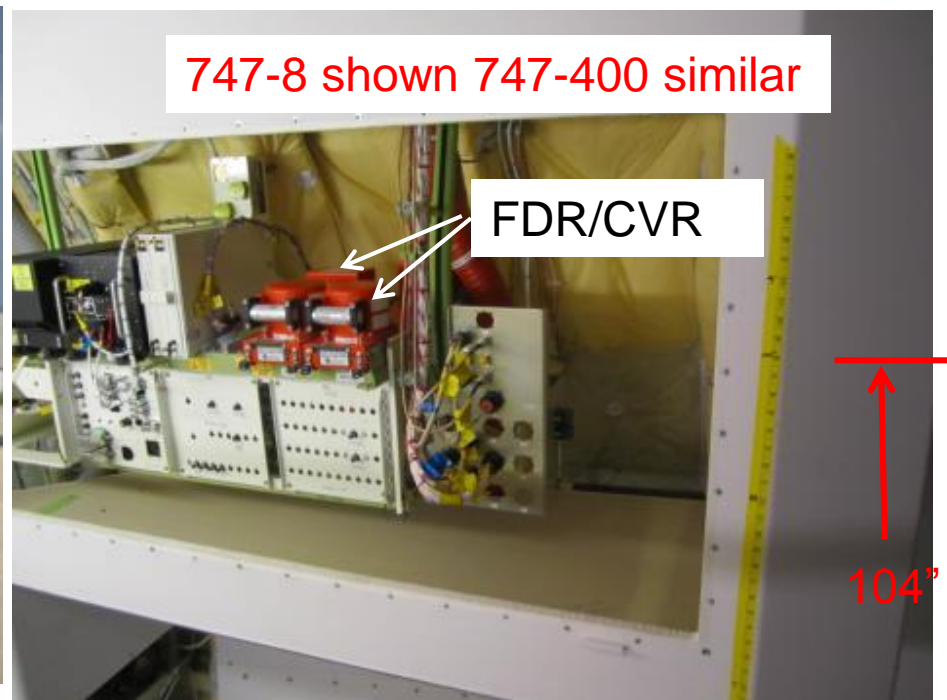
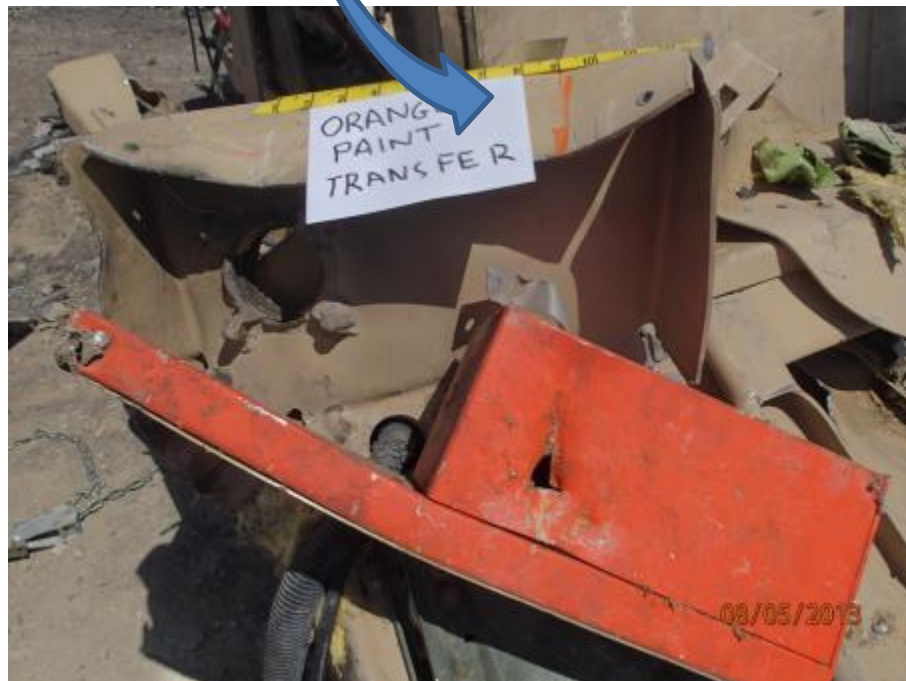
- Orange paint similar in color matches paint transfer on aft M-ATV
- Height of transfer matches height of FDR and CVR in the E8 cabinet.

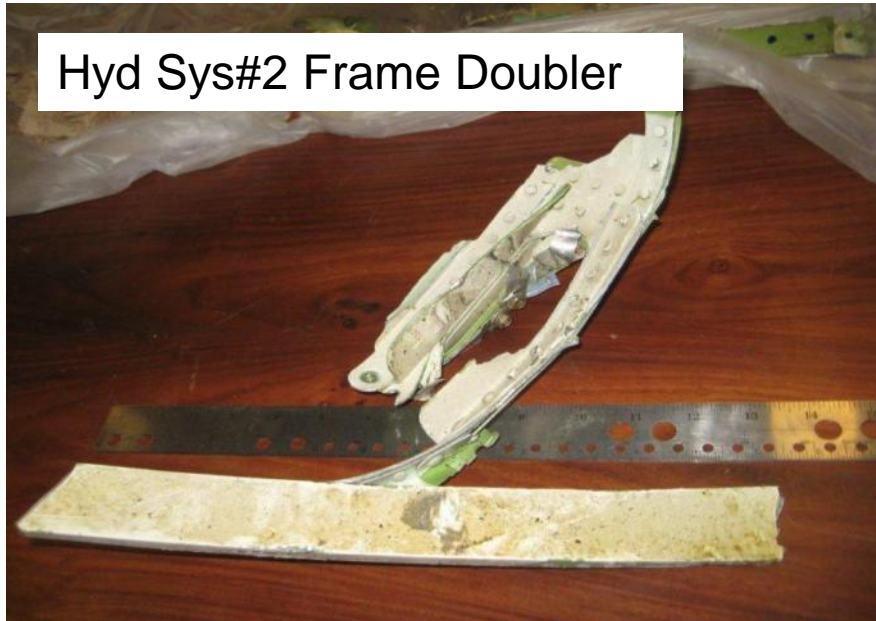
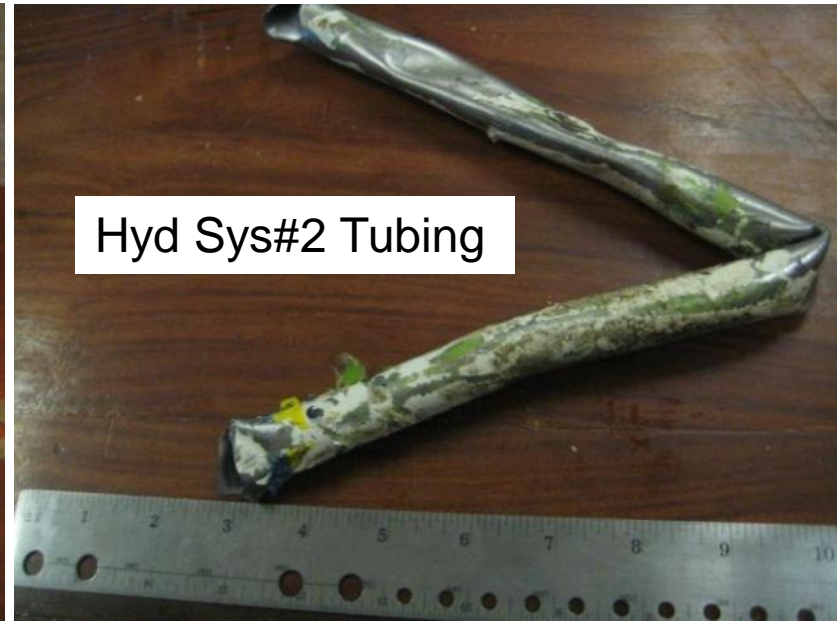
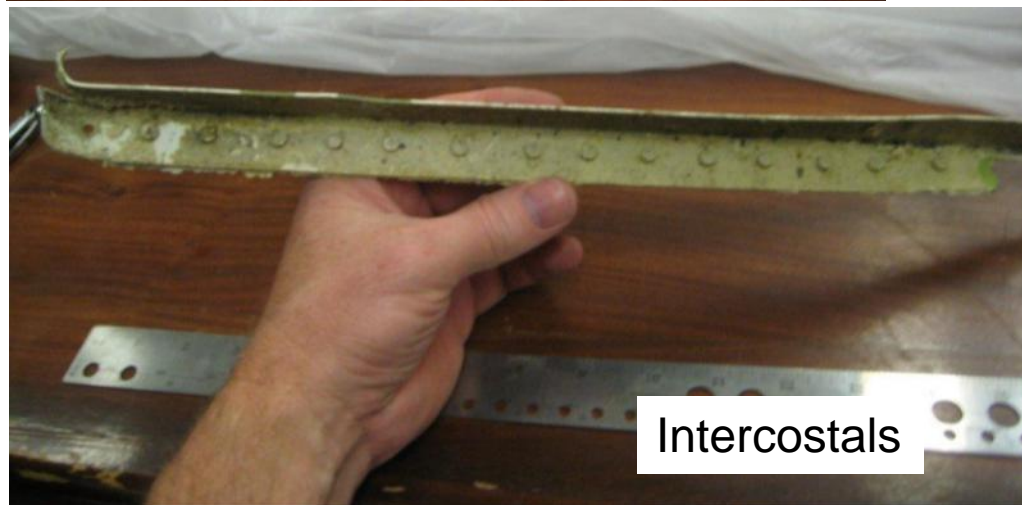
Parts Found Near Runway

- Tubing found from Hydraulic Sys #2
- Structure from same area found

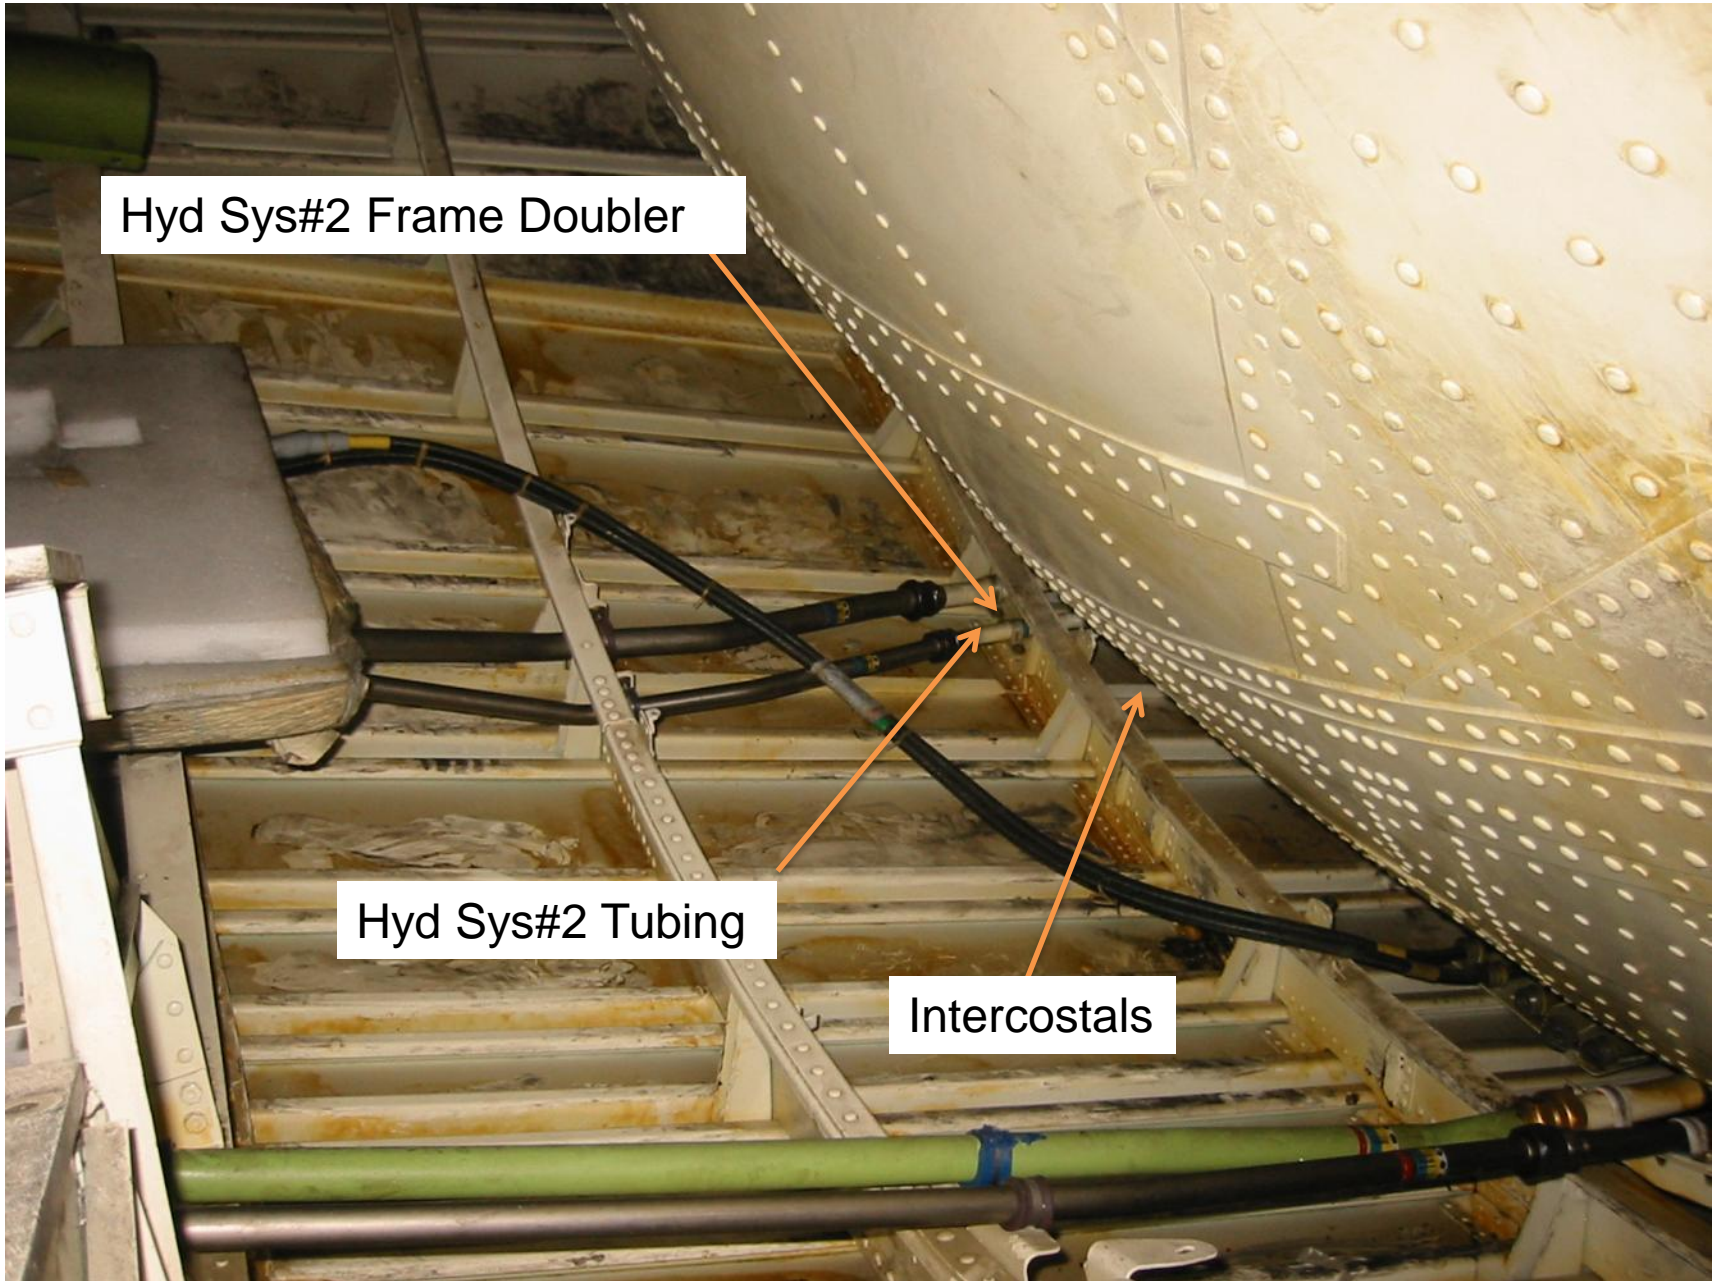
Hyd Sys#2 Frame Doubler

Hyd Sys#2 Tubing

Intercostals

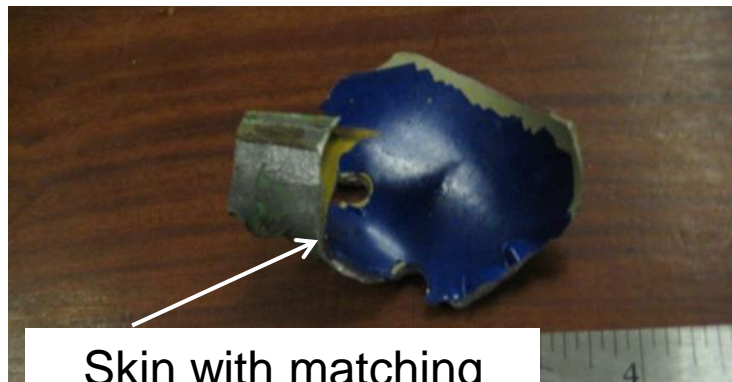
Skin with matching blue paint

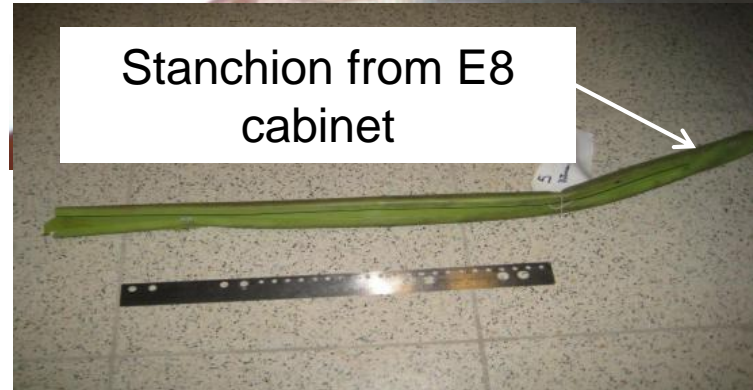
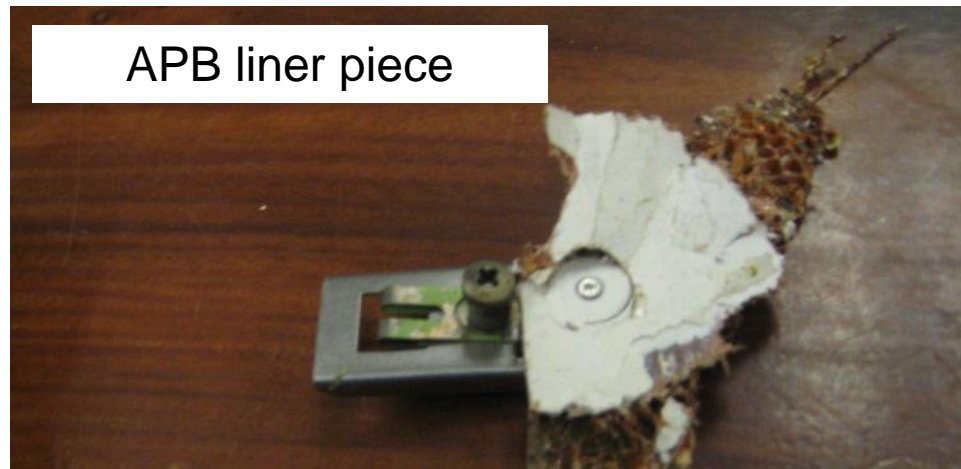
APB liner piece

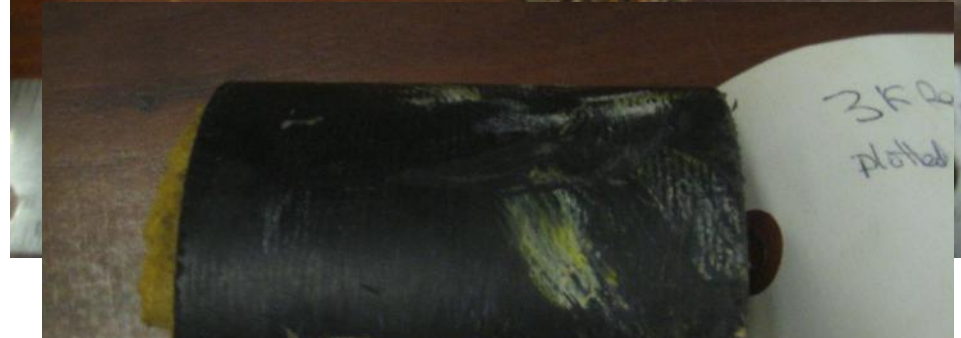
Antennae part – missing on aft M-ATV

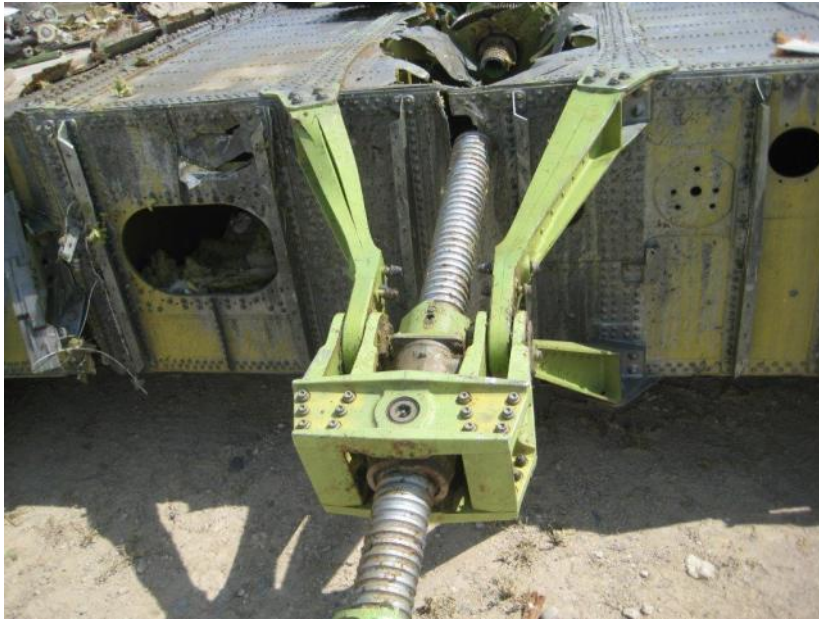
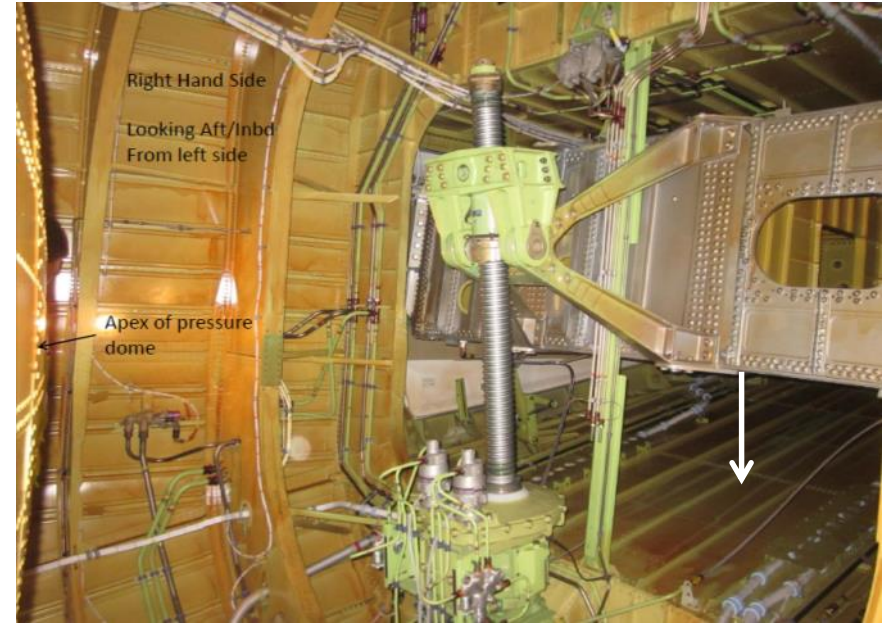
Horizontal Stabilizer Jackscrew

- Jackscrew severed sometime during event
- For loss of pitch control, the Horizontal Stabilizer would need to be displaced downward (with Hyd Sys #1 and #2 failed)
 - 16 inches with one MRAP shifted aft
 - 10 inches with two MRAP's shifted aft

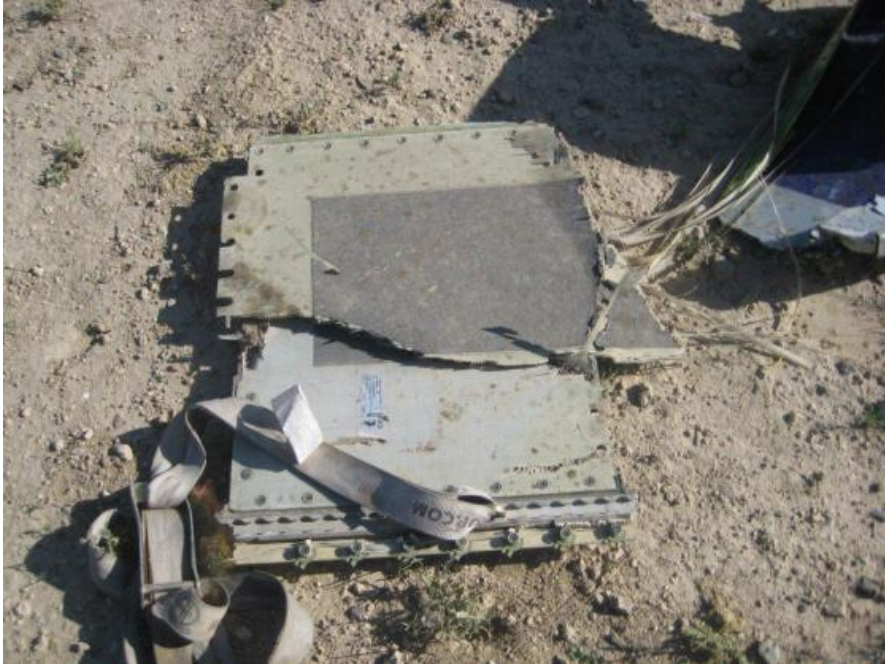
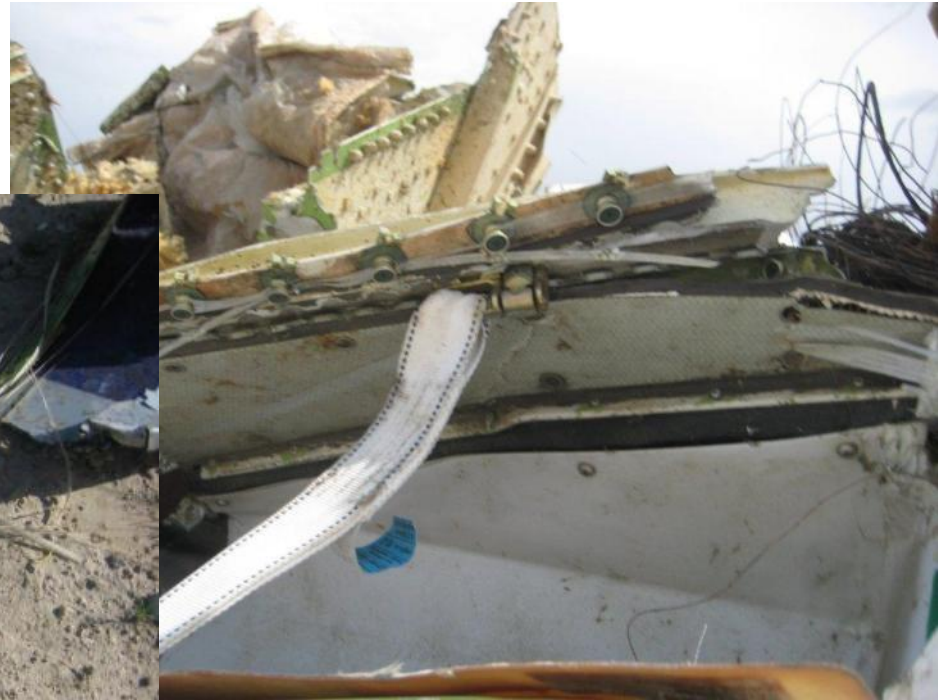
Seat Tracks

- Does not recognize load restrictions at airplane seat tracks attach points taking strap angles into account
- Assumes that the straps are limiting factor
- Does not recognize which airplane seat tracks cannot be used
- The running load limit for the center position is incorrectly represented
