# AIRCRAFT ACCIDENT INVESTIGATION

AVIATION AND RAILWAY ACCIDENT<sub>1</sub>

INVESTIGATION BOARD

- Operator: Asiana Airlines
- Type: A321-200
- Registration Mark: HL7730
- Manufacturer: Airbus
- Date & Time: 16 April 2013, 17:37 (Local)
- Location: Incheon International Airport

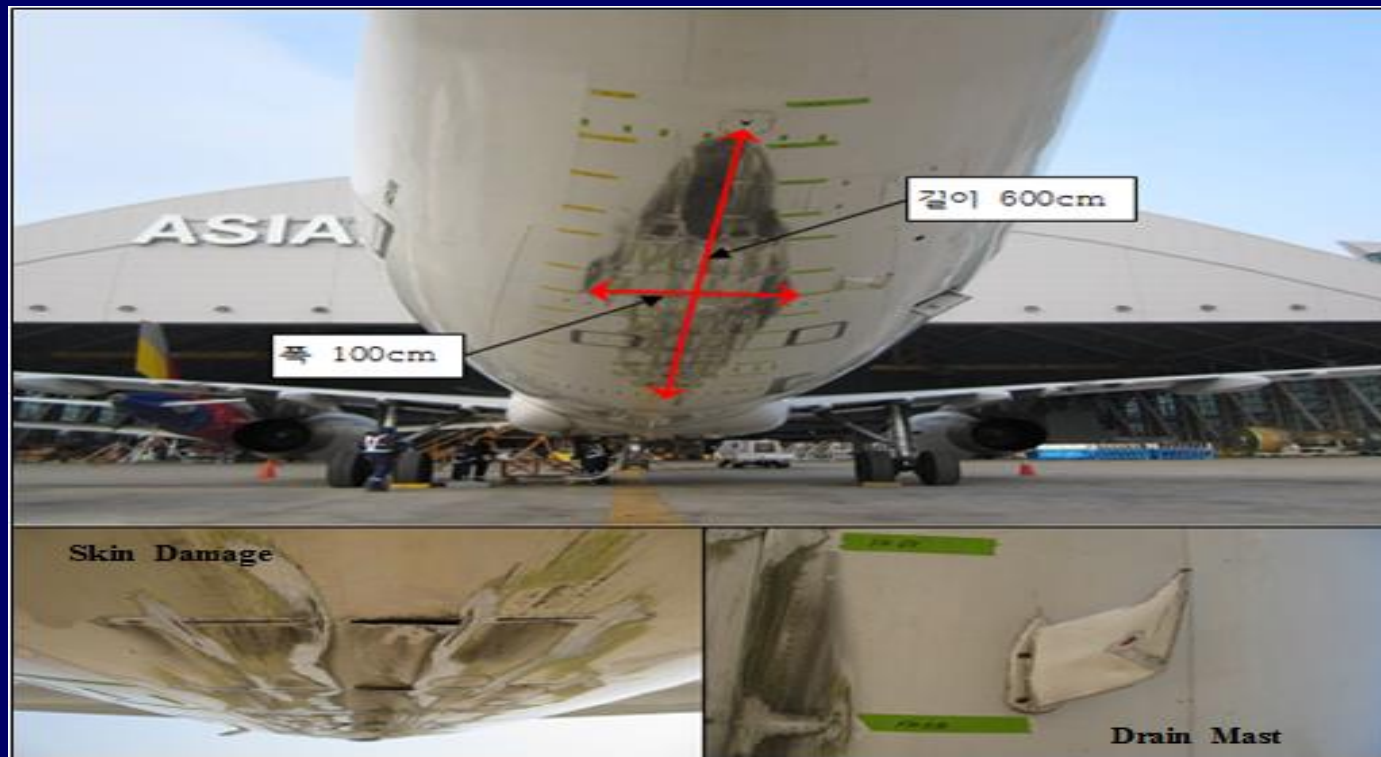
- Exterior Fuselage

- ❖ Rear fuselage damage 100 cm wide and 600 cm long

- ❖ During landing, right cross wind at 10kt with no wind shear, and base ceiling 200ft
- ❖ When A/C made an initial touchdown and bounced, thrust was not kept at idle, then when it made a second touchdown with pitch attitude exceeding A321 airplanes' limitation, it sustained a tail strike.

- ❖ A/C bounced due to PF's failure to maintain proper approach speed until flare just before touchdown, and due to increased thrust and speed just before touchdown
- ❖ A/C made a second touchdown at the pitch attitude exceeding an A321 airplane's limitation and sustained a tail strike due to PF's failure to keep thrust at idle and proper pitch attitude during the bounce

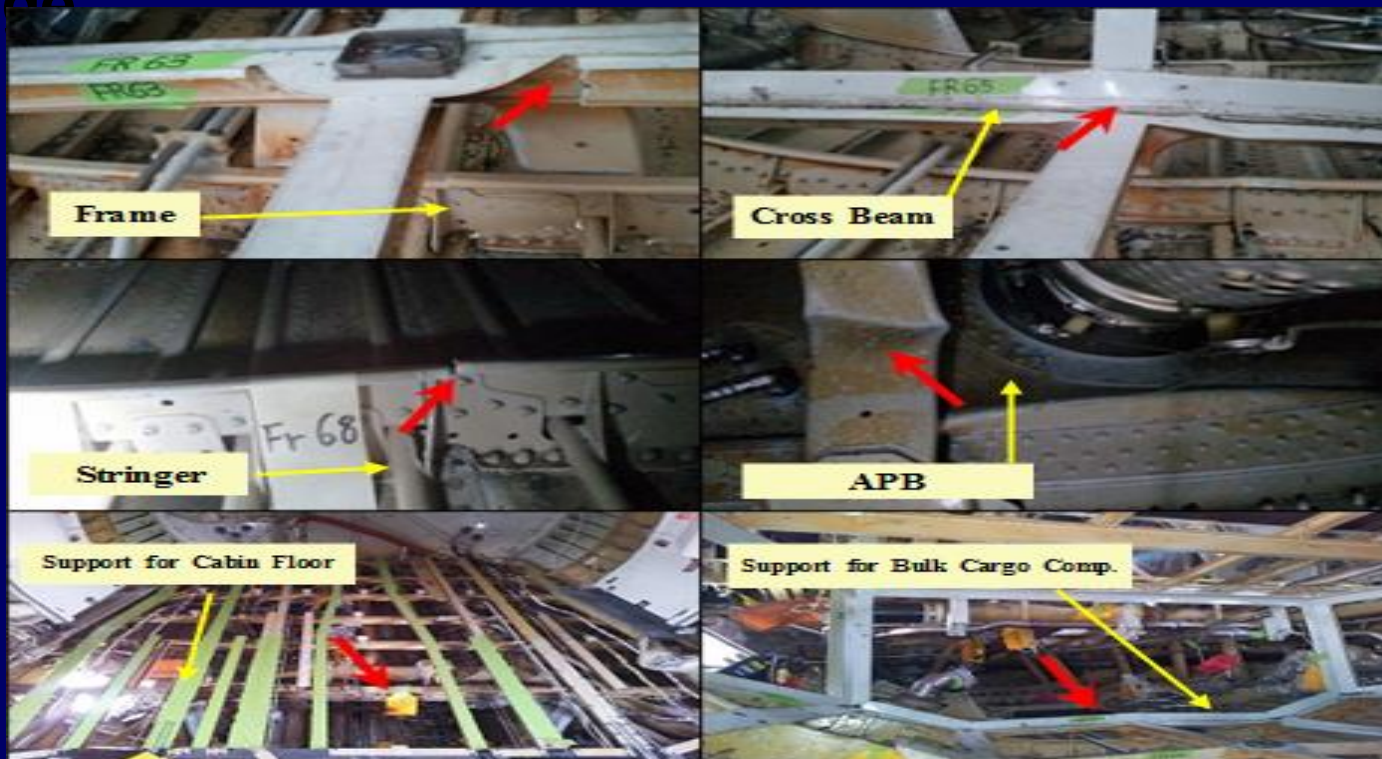
### Fuselage

- ❖ Frames damage (major structure of the fuselage)

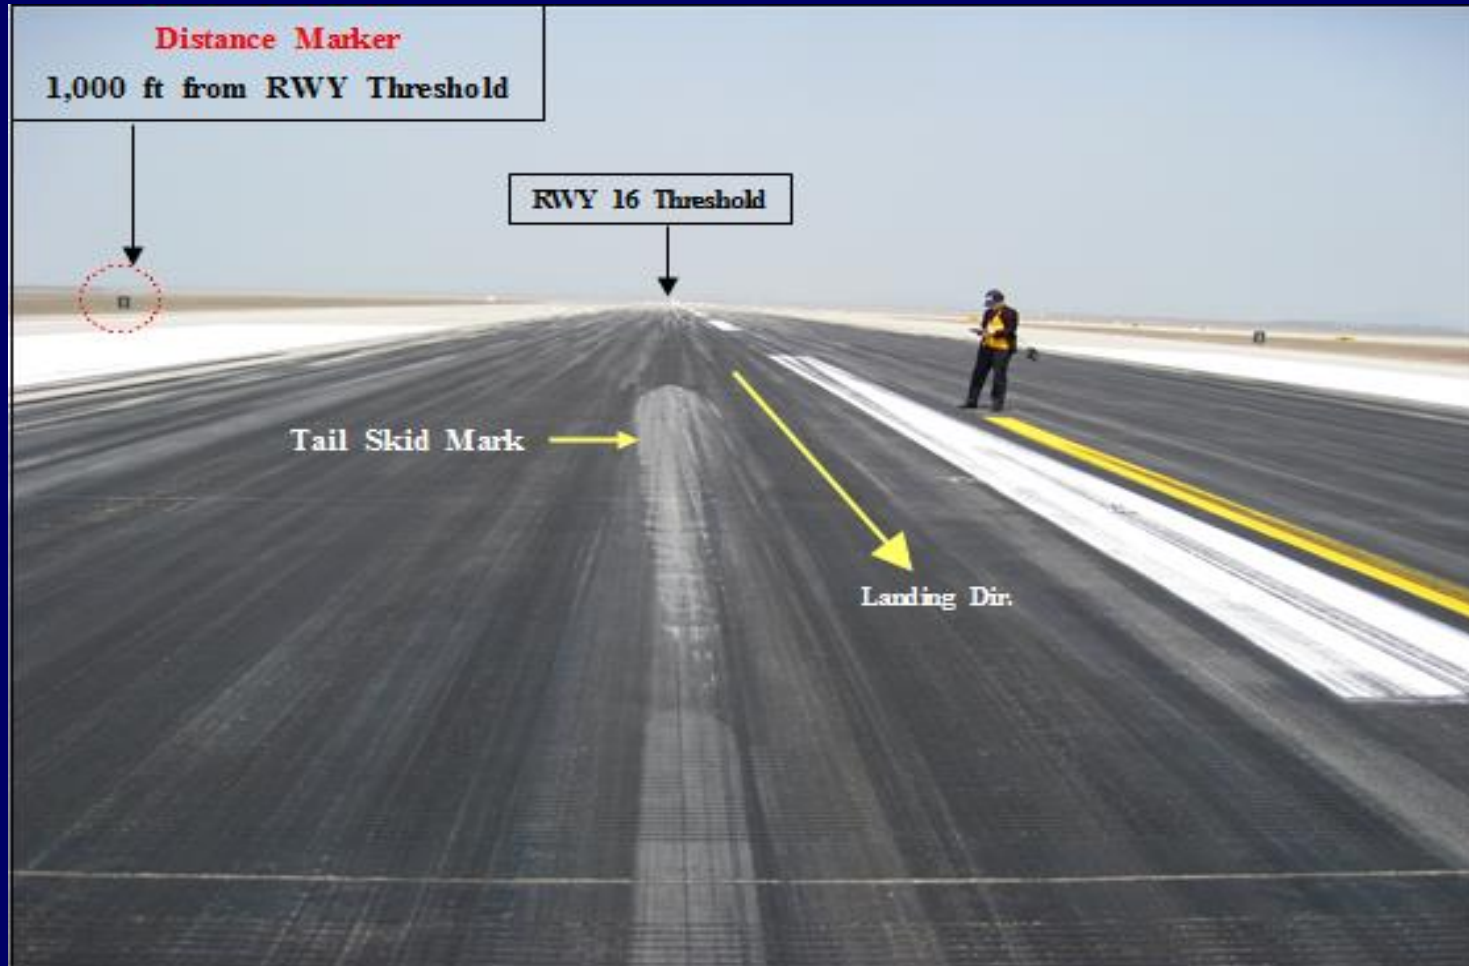
## 2. Factual Information ( Tail Skid Mark )

- According to A321 FCOM, if pitch attitude during landing is more than  $9.7^\circ$ , with main gear position fully compressed (by the weight of the fuselage), a tail strike will occur

- ❖ Failed to control A/C speed due to A/T disconnection during approach
- ❖ Failed to make an immediate go-around at 29 ft
- ❖ Failed to maintain pitch and keep thrust at idle after bouncing
- ❖ Increased pitch to  $10.9^\circ$  (more than  $9.7^\circ \rightarrow$  tail strike)
