For Prevention of Accidents
due to
Turbulence

FASTEN SEAT BELT

2015 JUNE

Case Study(1) The shaking of the aircraft by CAT(APR 2001)

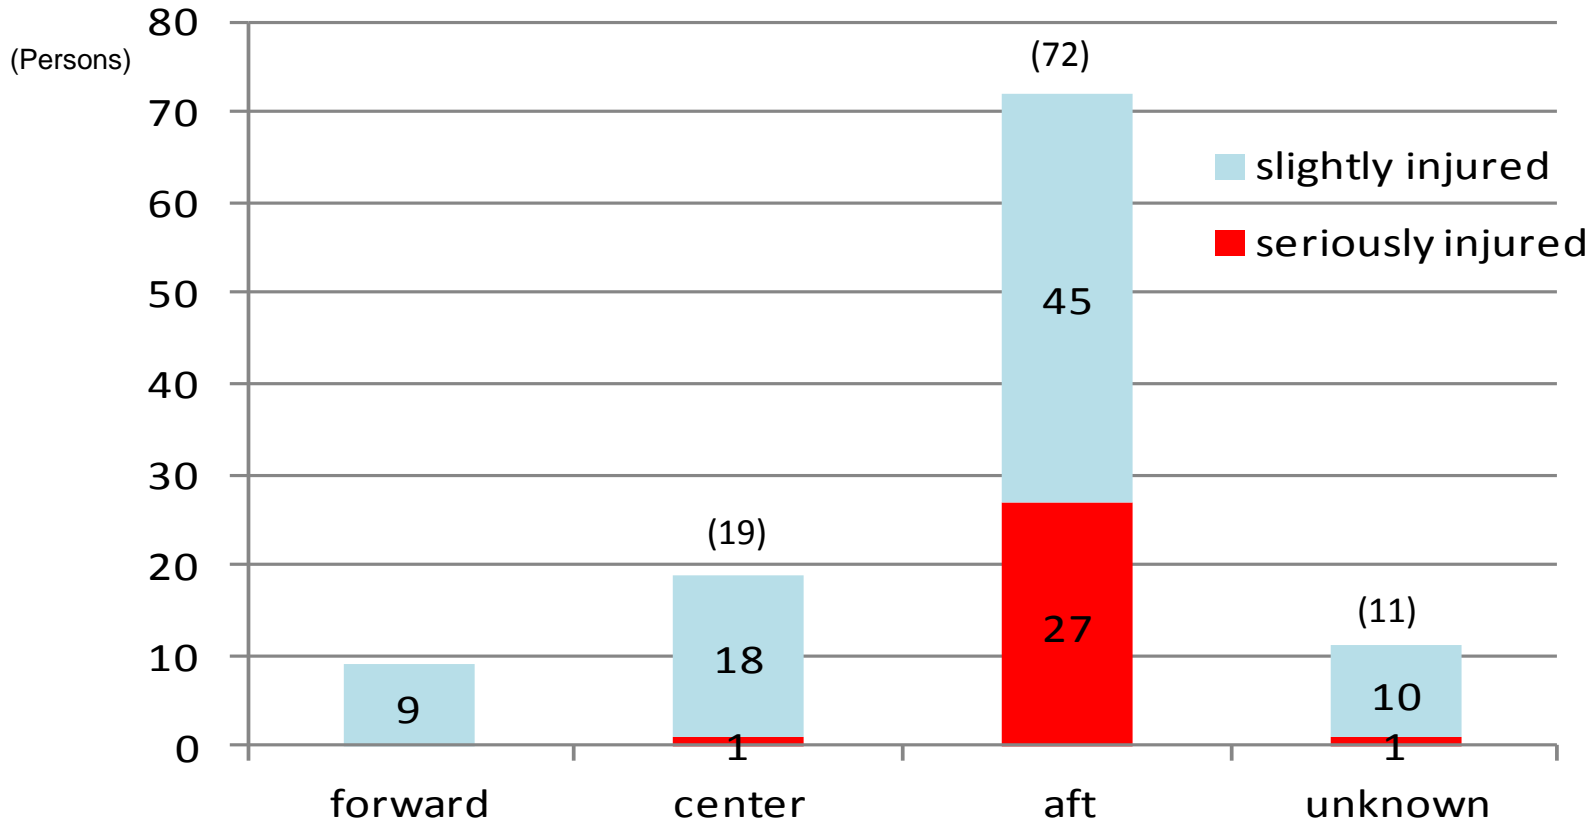
Fig.9 : Positions

AFT > CENTER > FORWARD (Excluding 11 unknown cases)

JTSB Analysis: Negative vertical acceleration affected more on the aft than the foreside when the pitch angle(*1) of the aircraft changed rapidly.

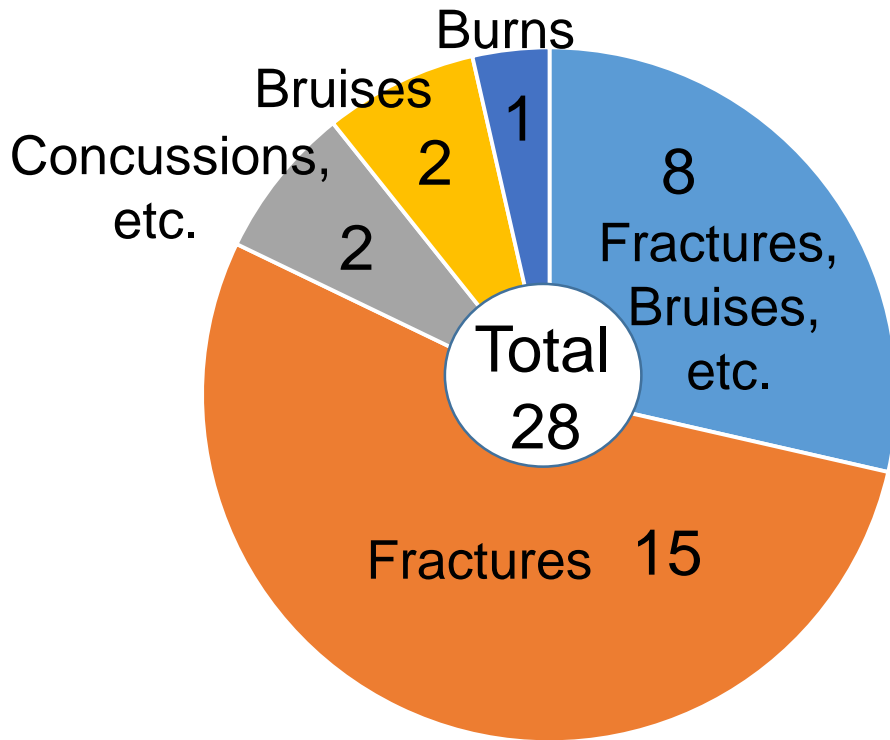
Fig.10 Type of serious injuries
(Details revealed regarding 28.)

> Fractures:23
(Cervical, Collarbone, Ribs, Thoracic vertebrae)

> Concussions:2
(Brain, Cervical vertebra)

> Bruise:2
(Face, abdomen)

> Burns (Infant):1
(Right upper extremity, abdomen, etc.)

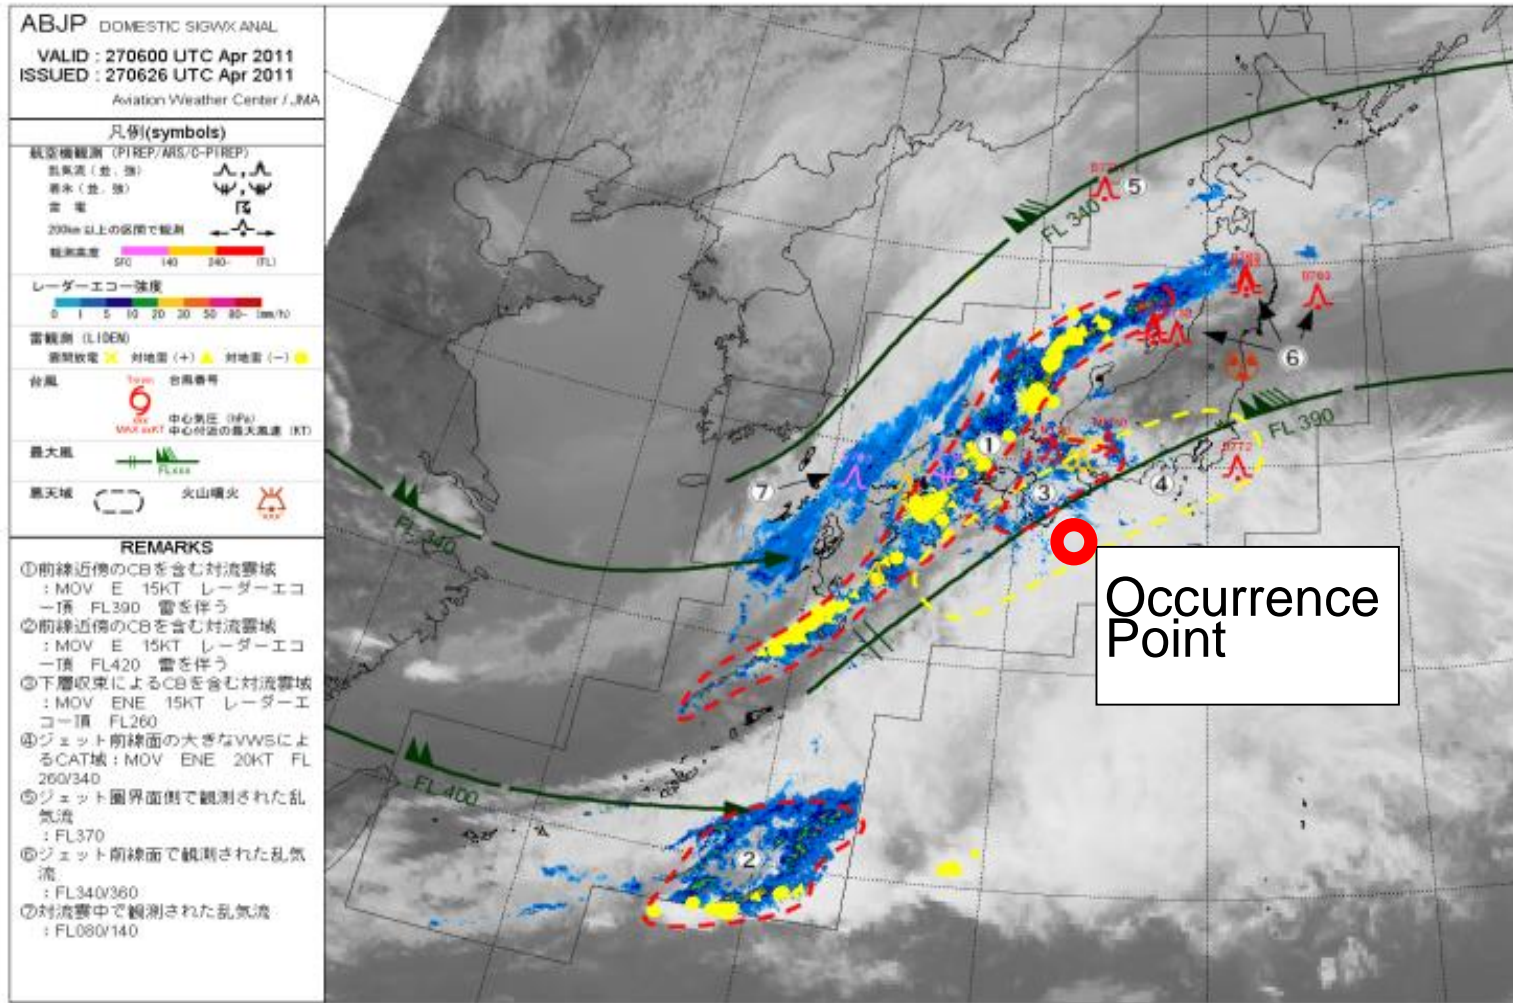
Fig .2

Domestic Significant Weather Analysis Chart(1500JST)

Temperature and atmospheric pressure values different, accompanied by wind velocity difference(wind shear), generated the unsteady air conditions where turbulence was likely to occur near the layer boundary.

The aircraft gradually approached the frontal zone under the jet stream.

Nothing more than a weak vertical shear with 0 to 6kt was analyzed at the occurrence point.

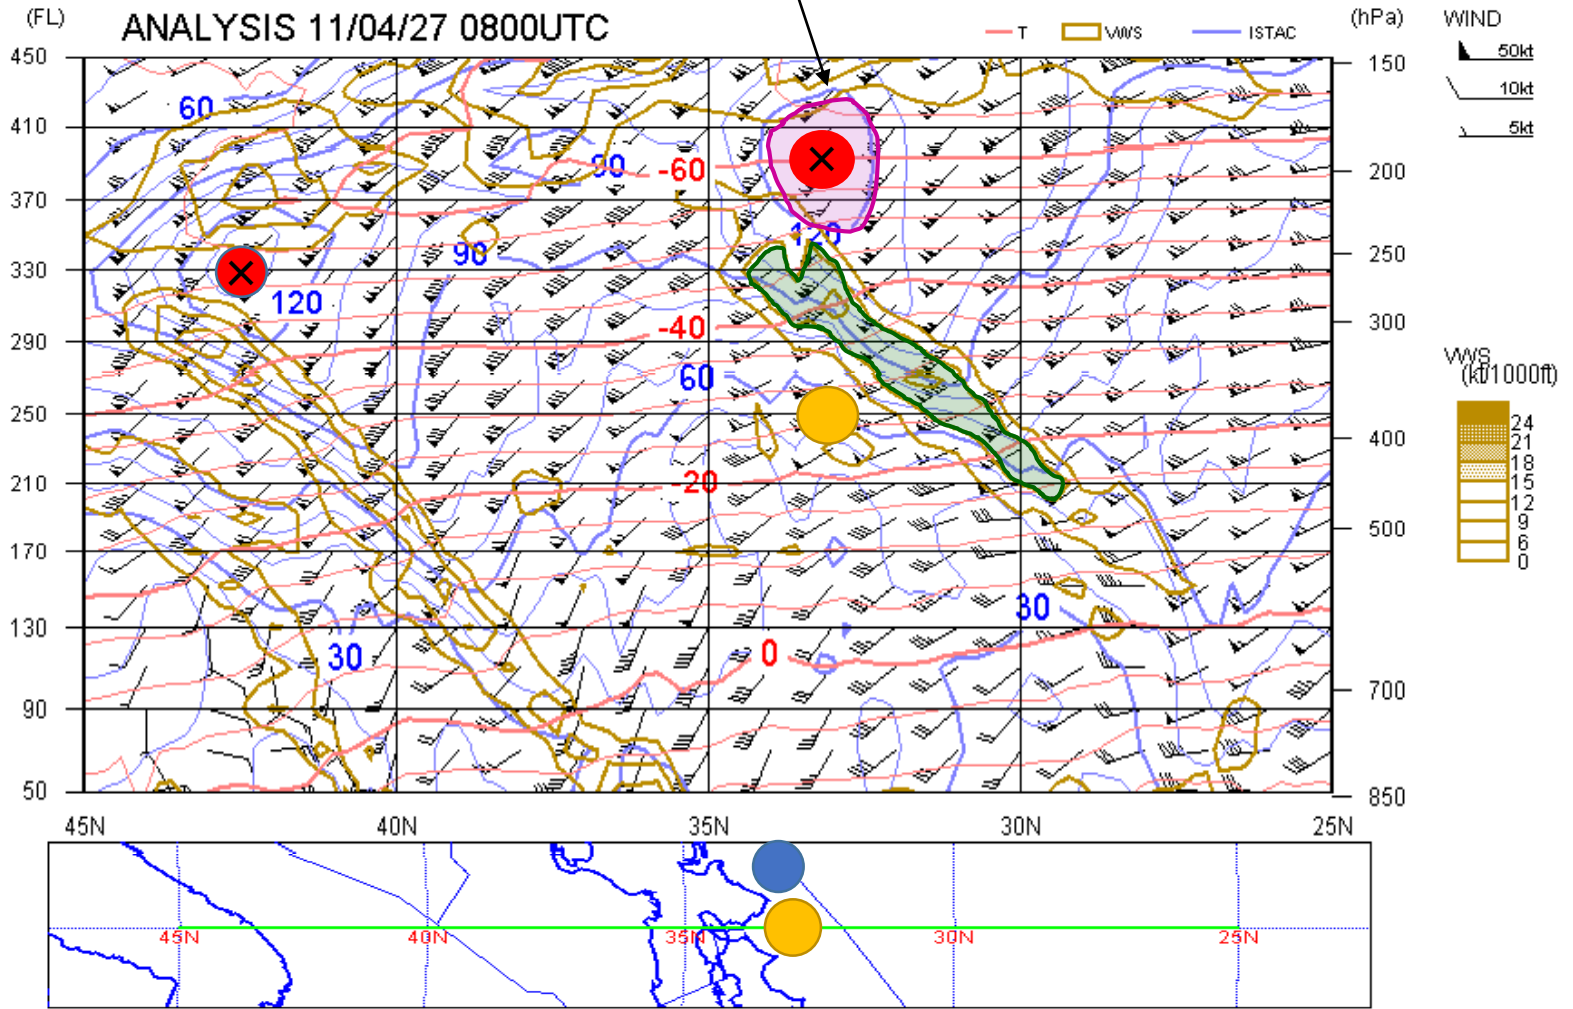
Fig.3

Hourly Analysis Chart (Vertical Cross Section)

Wind velocity
120kt

- ✕ Jet stream axis
- Estimated Flight Track
- Estimated position of the accident

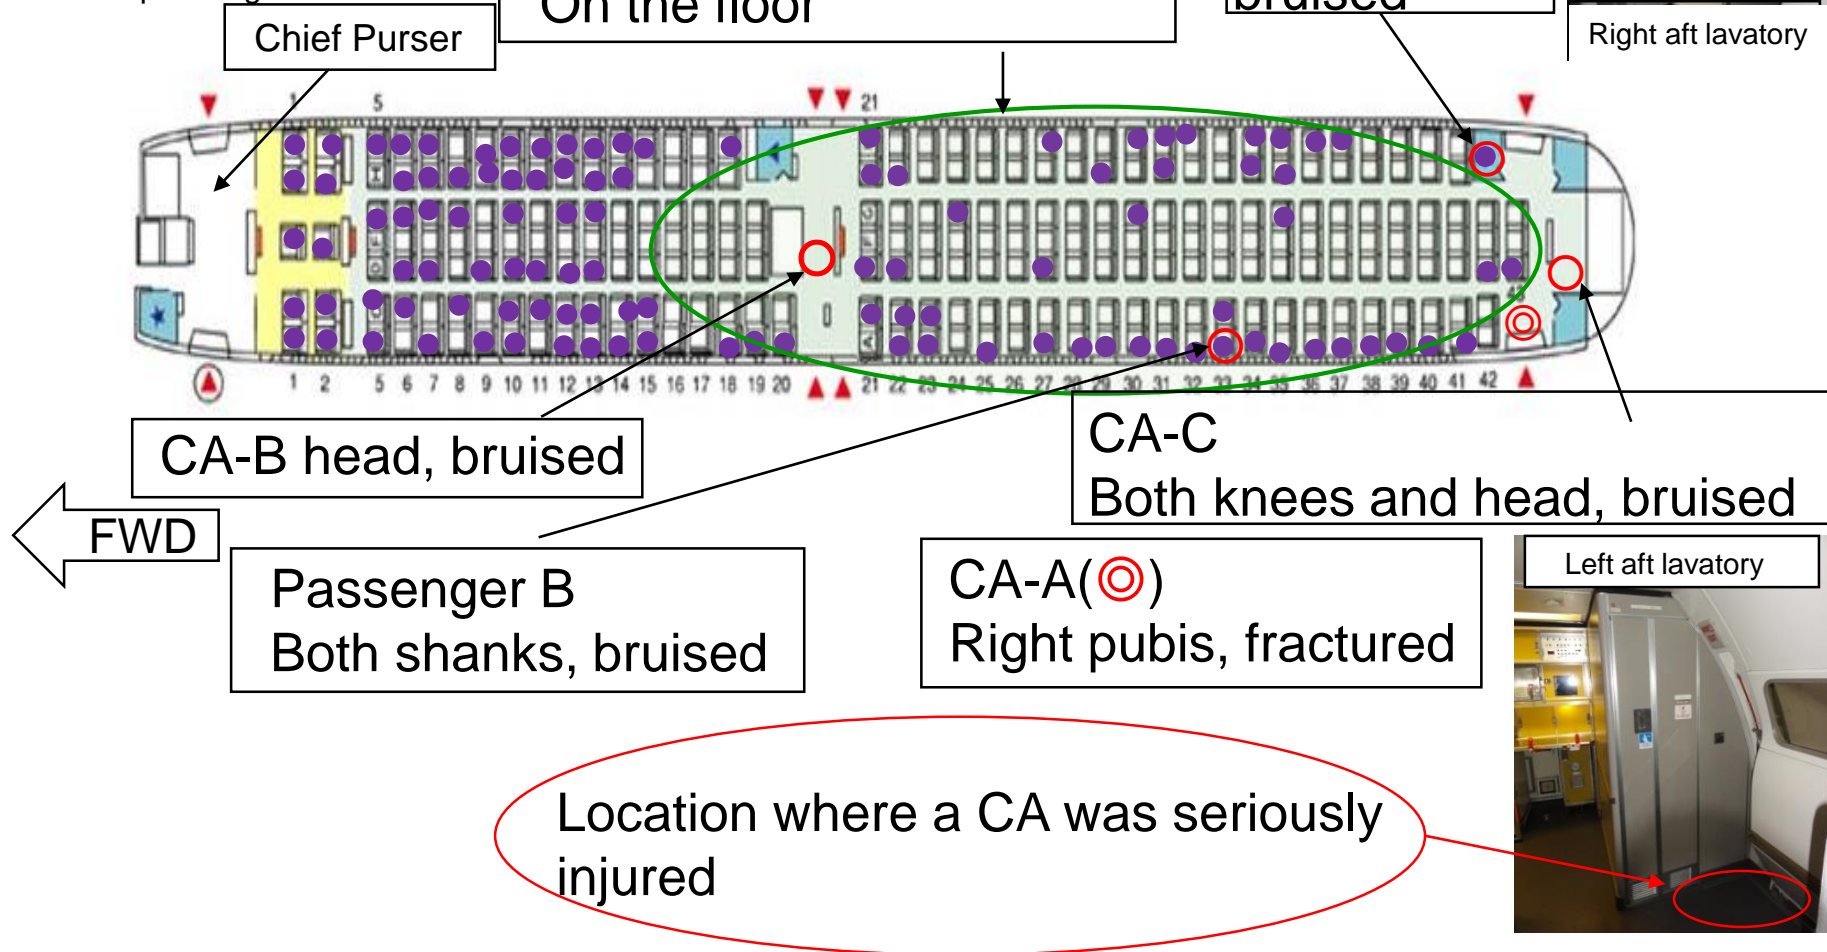
Fig.4

Locations of the Injured when the Accident Occurred

- ⊙ location of the CA seriously injured
- location of the CA slightly injured
- Seat occupied by passengers

The combination of the aircraft motion around the center of gravity caused by the increase in the pitch angle and the sharp descent of the aircraft by 80 ft gave the aft section of the aircraft a sudden lowering.

It is highly possible that the CA near the left aft lavatory flew up into the air and suffered a serious injury upon the fall to the floor.

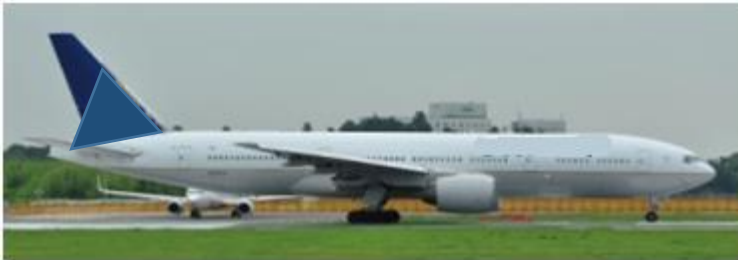
- > Handhold designed specifically for the shaking aircraft were not equipped.
- > Fixed objects such as the counters and the cart handles stored in the lower part of the galley on four sides were available to hang on as substitute for handholds.
(All carts had been stored when the accident occurred.)
- > Making the FAs and the fixed objects, when used as substitute for handholds, were slightly far apart.

It is probable that the four FAs working in the rear galley were thrown into the air because they had not been informed by the PIC of the turbulence in advance and were unable to hang onto fixed objects around them when the rear of the airframe sank suddenly.

➤ After the occurrence of this accident, Company A strengthened the contents of Flight Attendant Operations Manual (UNEXPECTED TURBULENCE).

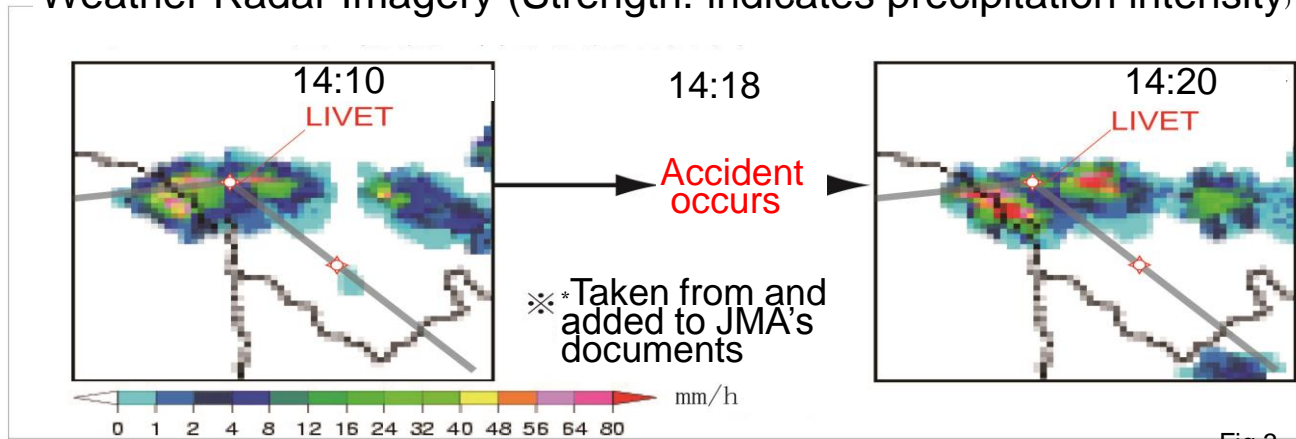
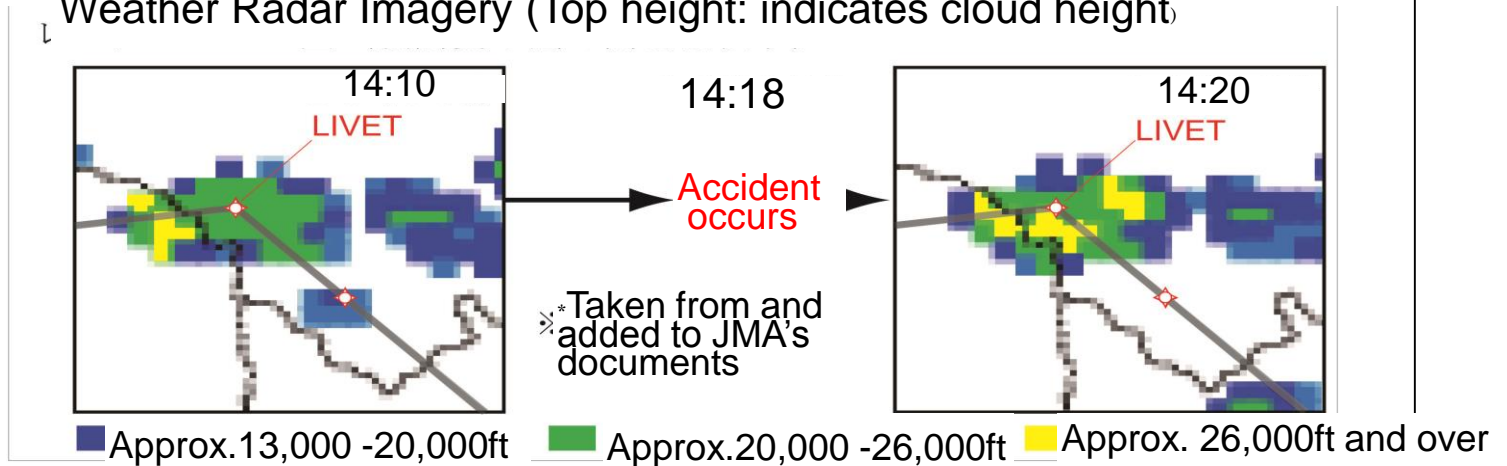
Fig.3

Weather Radar Imagery (Strength: indicates precipitation intensity)

Weather Radar Imagery (Top height: indicates cloud height)

It is highly probable that the cumulonimbus the aircraft avoided had developed quickly immediately before the time of the accident.

It is probable that the aircraft took detour the cumulonimbus to avoid it, but was forced into a part of the cloud which had developed rapidly, and then encountered its disturbance.

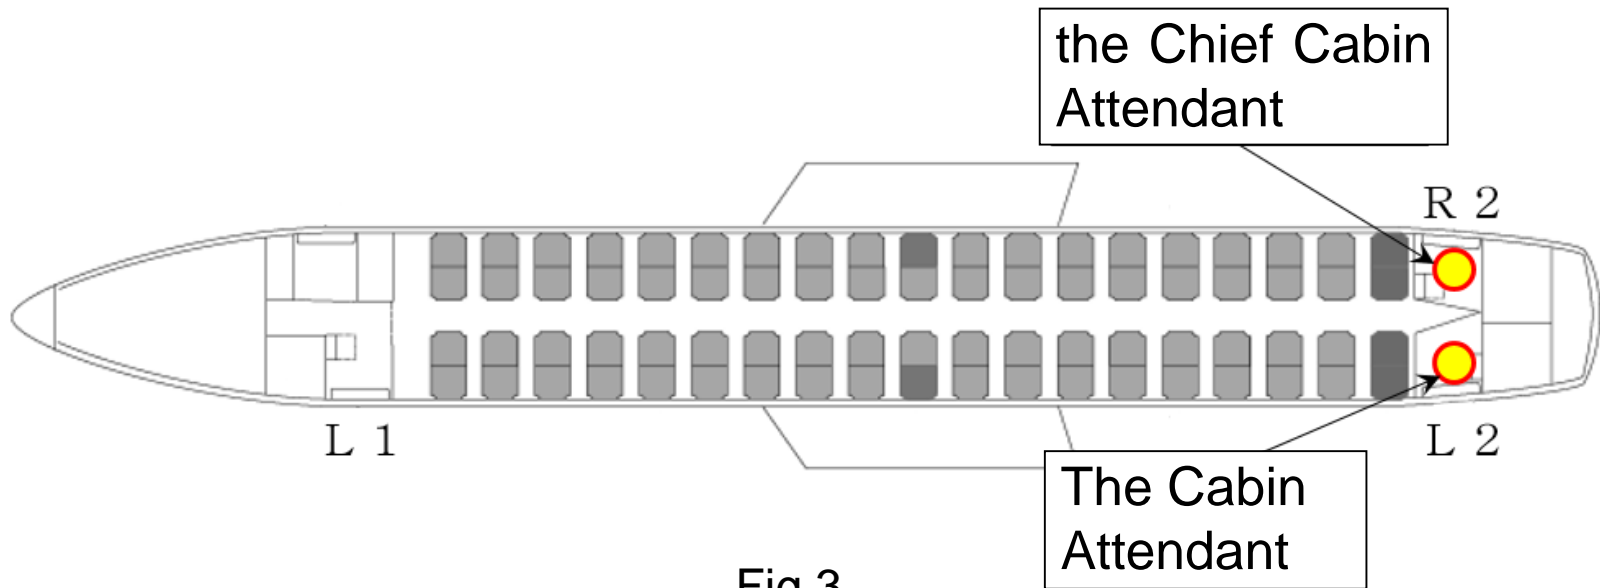
Fig.3

※The Chief Cabin Attendant fell down with her head toward the L2 side on the aft galley floor with the Cabin Attendant (L2), laying on top of each other, and confirmed that the passengers were sitting from there.

- It is probable that this accident occurred by the shaking of the Aircraft which encountered the strong wake turbulence from the Preceding Aircraft while the aircraft was descending; accordingly, two cabin attendants in the aft galley fell down and one of them was seriously injured..
