WORKING TOGETHER TO ENHANCE
AIRPORT OPERATIONAL SAFETY

Most common Infrastructural gaps identified

APEX in Safety Reviews 2011-2019

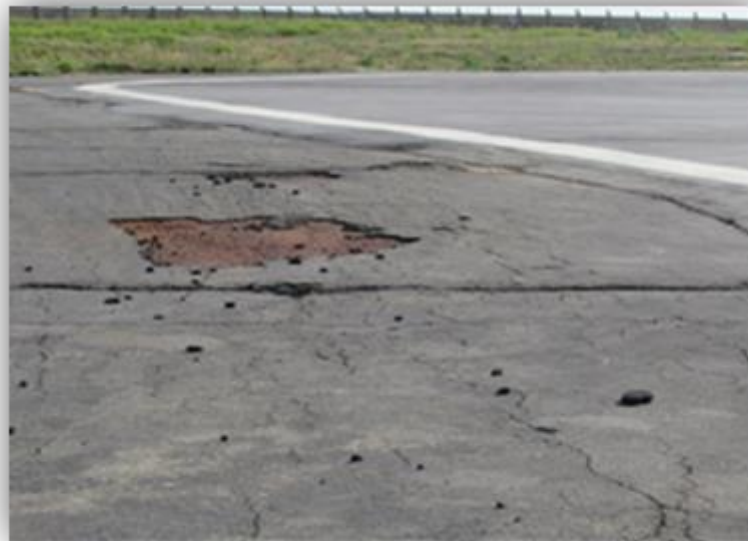
- In many cases, pavement is in advanced state of deterioration
- Runway strip and graded areas are non-existent or out of compliance in many cases

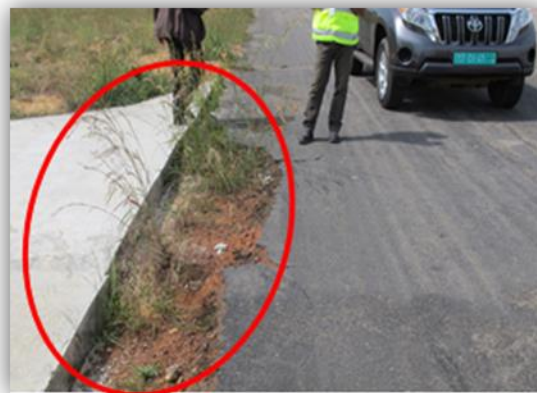
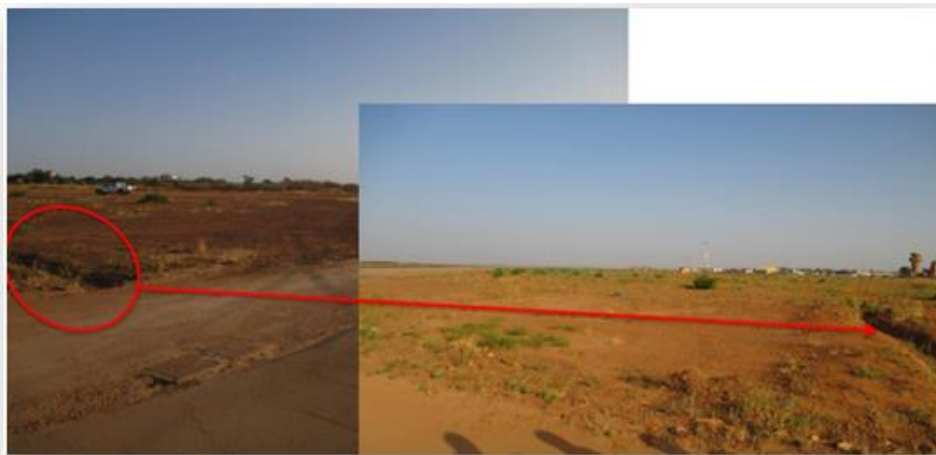
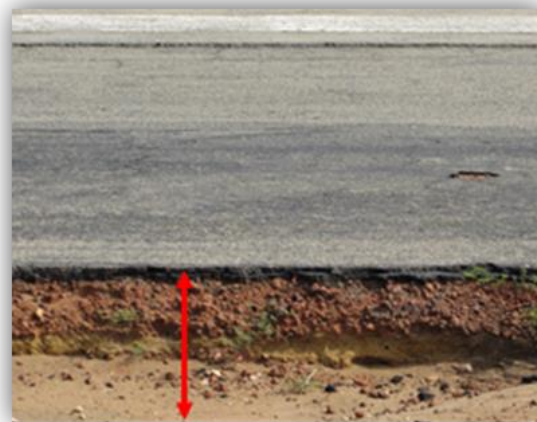
- Lack of accurate declared distances
- African Airports are rarely equipped with compliant Runway Safety End Area (RESA)
- No documents to support the published data, but true bearing strength is often insufficient

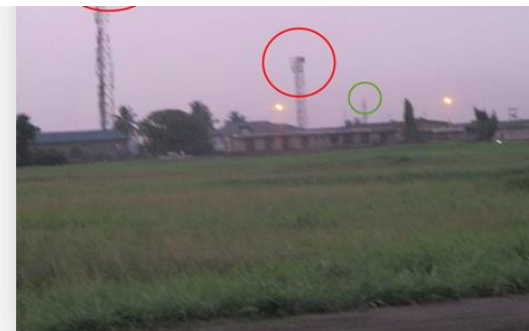
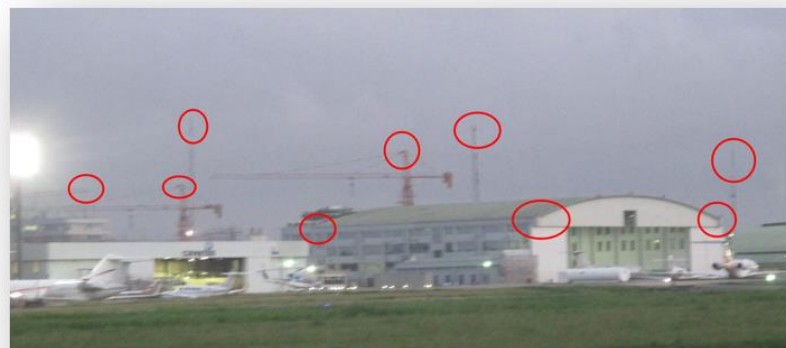
- Obstruction lighting is often missing or not maintained on and off the airport.
- Lighting system is often old and obsolete which causes for high maintenance repair or need for full rehabilitation

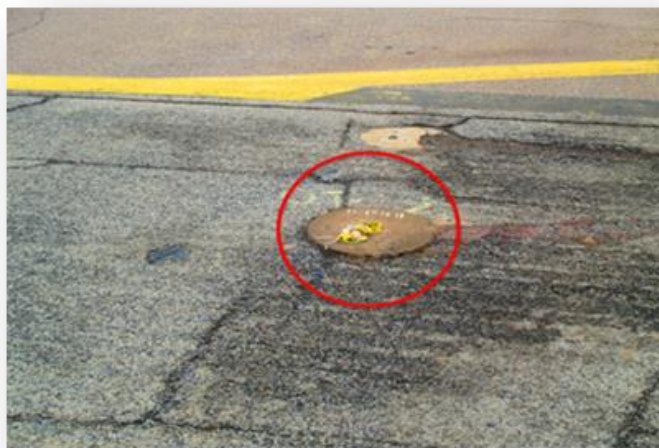
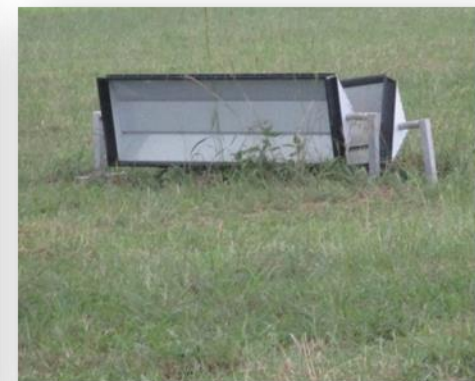
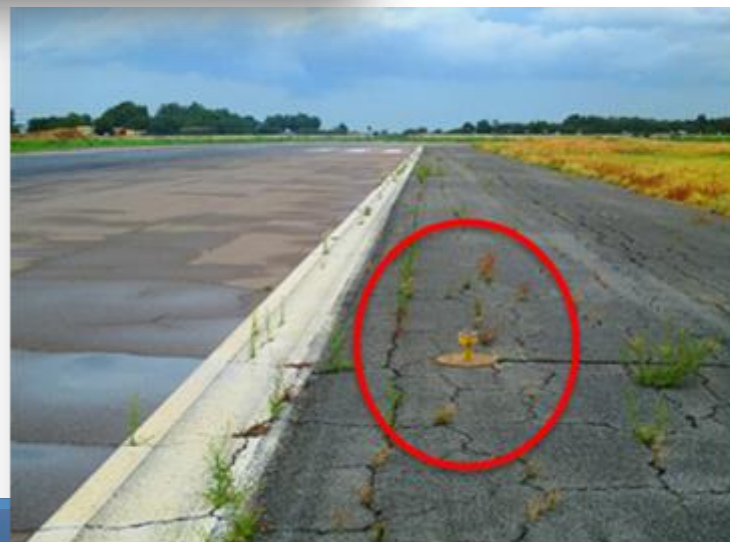
- Signs are often missing or not to standard
- Missing lights and old wiring
- Electrical systems are obsolete and over 40-45 years old.

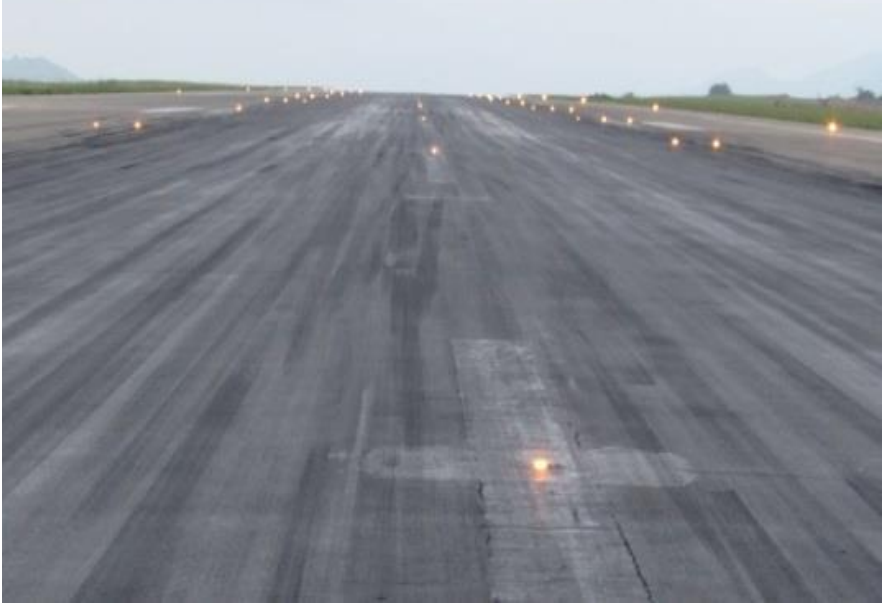
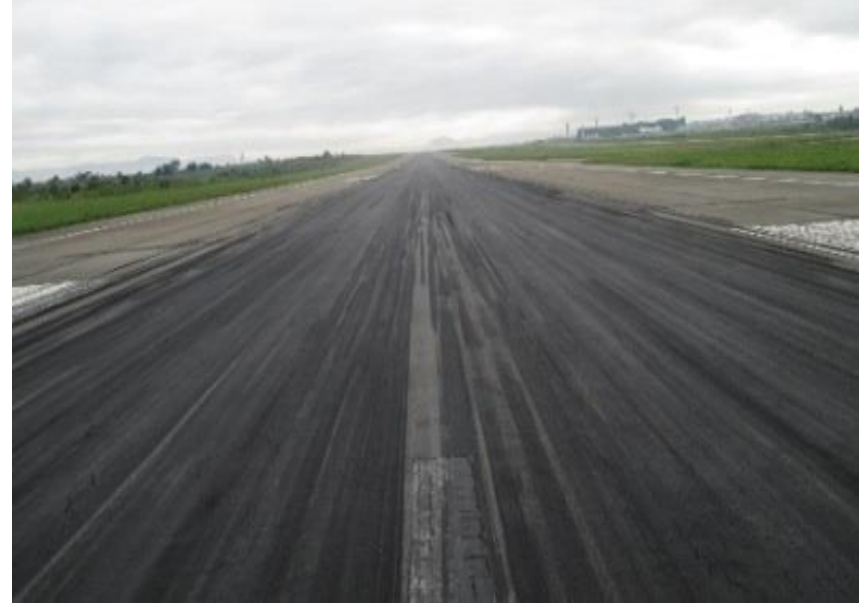
b) The APEX team was informed that the last friction test was conducted over two years ago. The runway requires immediate attention because it shows a considerable accumulation of rubber and appears to be slippery when wet.

c) A self-wetting, continuous friction measuring device is not available for conducting friction tests.

Perform a friction test and the necessary rubber removal as a matter of high priority.

Issue a Notice to Airmen (NOTAM) which points out the portion of the runway that has friction values below the minimum friction levels indicated by the national regulation.

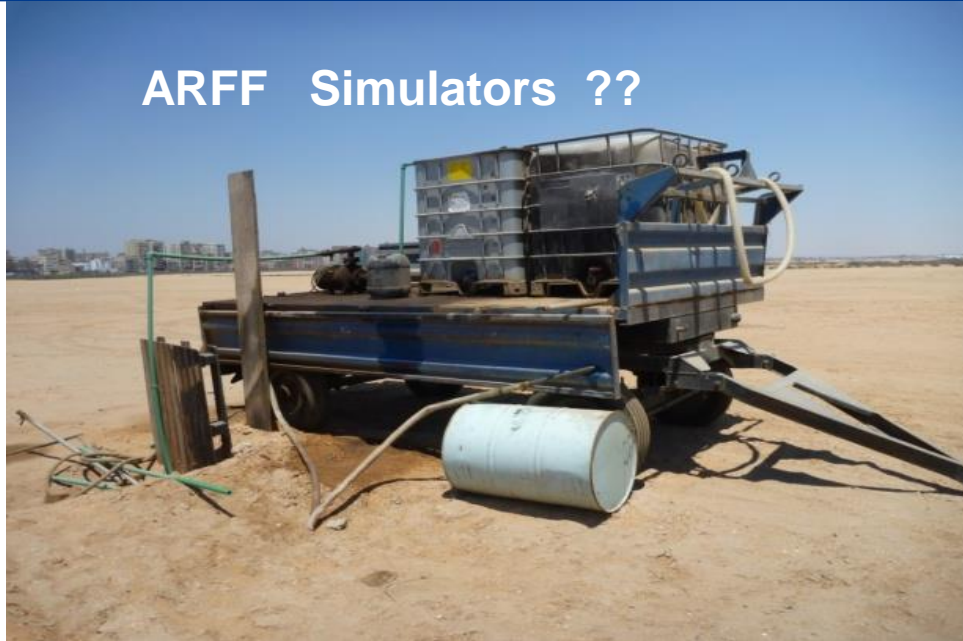
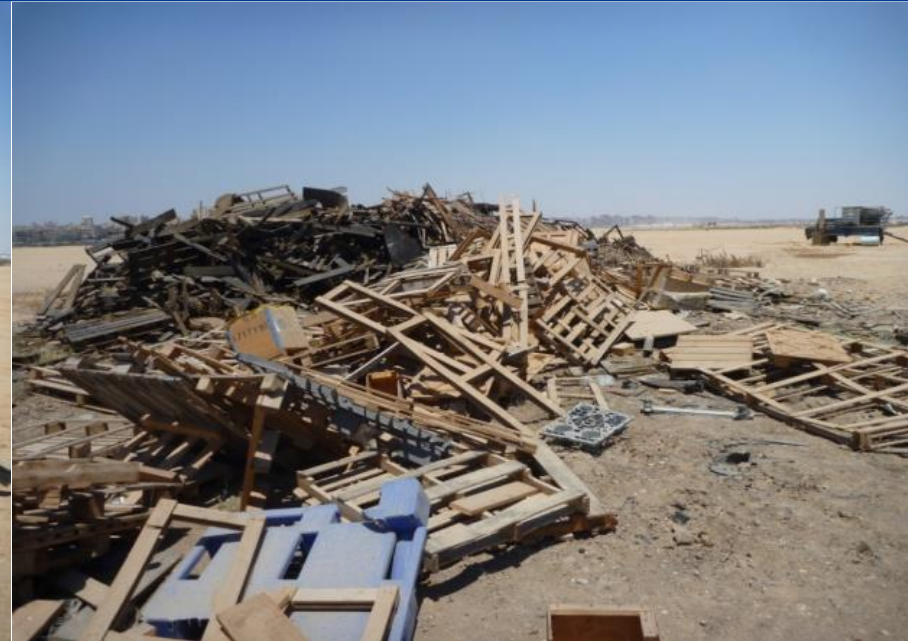
ICAO Annex 14 states: “All rescue and fire-fighting personnel shall be properly trained to perform their duties in an efficient manner and shall participate in live fire drills commensurate with the types of aircraft and type of rescue and fire-fighting equipment in use at the aerodrome, including pressure-fed fuel fires”. There are no appropriate hot fire training facilities at the airport. The fire training ground has only wooden pallets with a small pressure-fed fire which does not comply with the ICAO standard

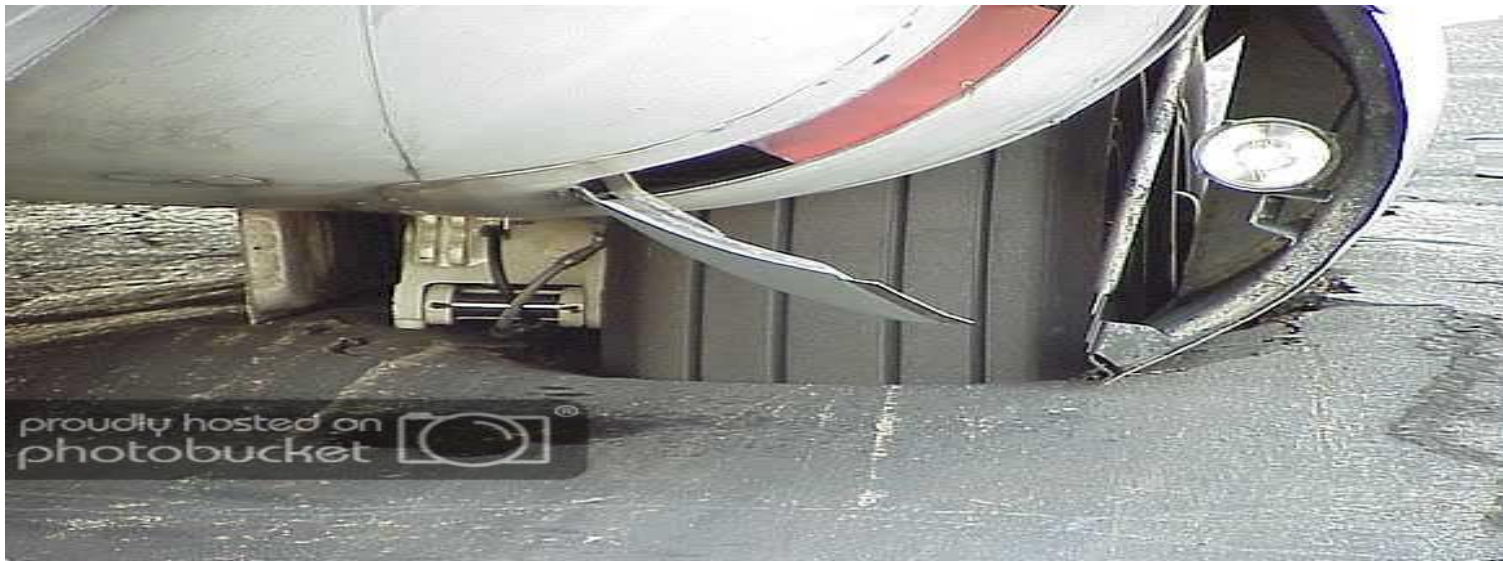
- **Pavement Management**
- **The AIP shows a pavement strength load classification number (LCN) of 100; LCN is not used to classify the pavement strength, rather the pavement classification number (PCN) should be used as per ICAO Annex 14, Section 2.6. If the AIP is referring to the pavement classification number (PCN) with a value of 100 (which is the maximum value for the strongest pavement), it does not reflect the reality of the pavement conditions. The AIP shows also a concrete pavement while the pavement is in asphalt. 1.3. RUNWAYS**
- **a) Runway pavement is in very poor condition and needs immediate attention. There are many high severity cracks and holes in different areas of the runway. Many of the cracks are very deep and allow the water to penetrate the base of the pavement, accelerating the deterioration of the runway.**
