International Civil Aviation Organization

Fifteenth Meeting (MIDRMA Board/15)
(Muscat, Oman, 29 – 31 January 2018)

WAKE TURBULENCE SEPARATION IN RVSM AIRSPACE

Interim Report

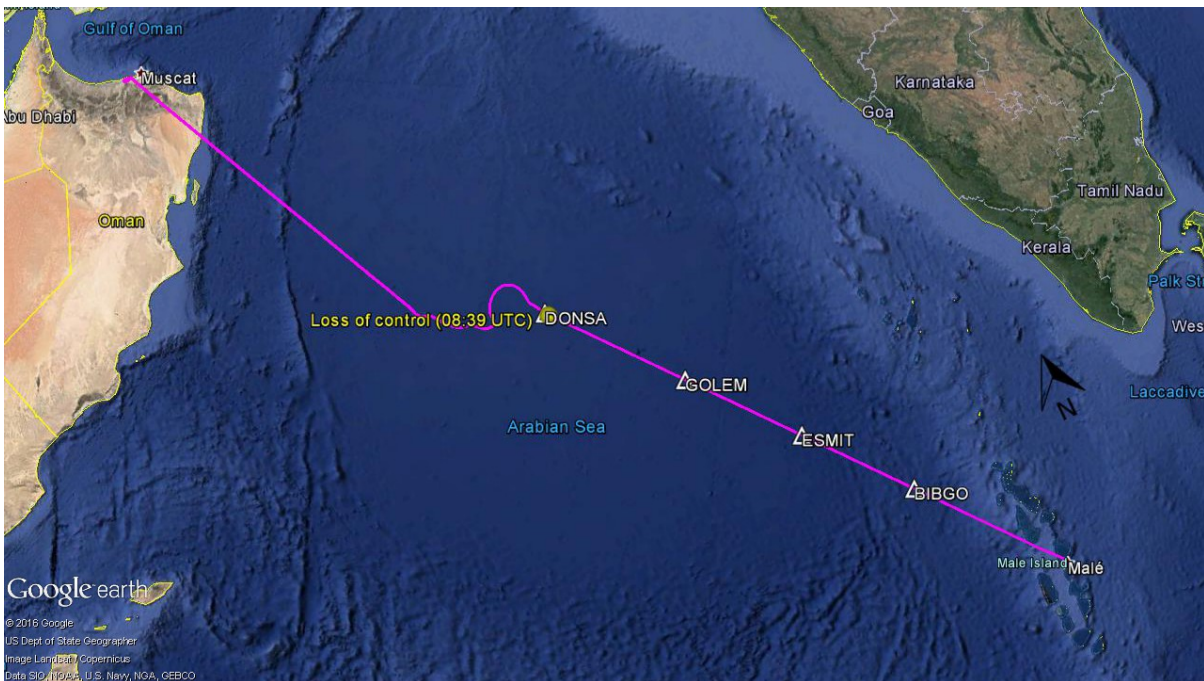
Reconstruction of the CL604 flight path (according to FDR data)

Between 0839:09 UTC and 0839:41 UTC the FDR recorded a loss of altitude of approximately 8,700 ft. Large control surface deflections and acceleration were recorded. The speed increased and at 0839:31 UTC reached approximately 330 KIAS. At 0839:30 UTC the spoilers extended and 13 seconds later were retracted again. The N1 of the left engine had decreased to approximately 40% when the Interstage Turbine Temperature (ITT) began to increase and nine seconds later had reached 850°. The left engine was shut off.

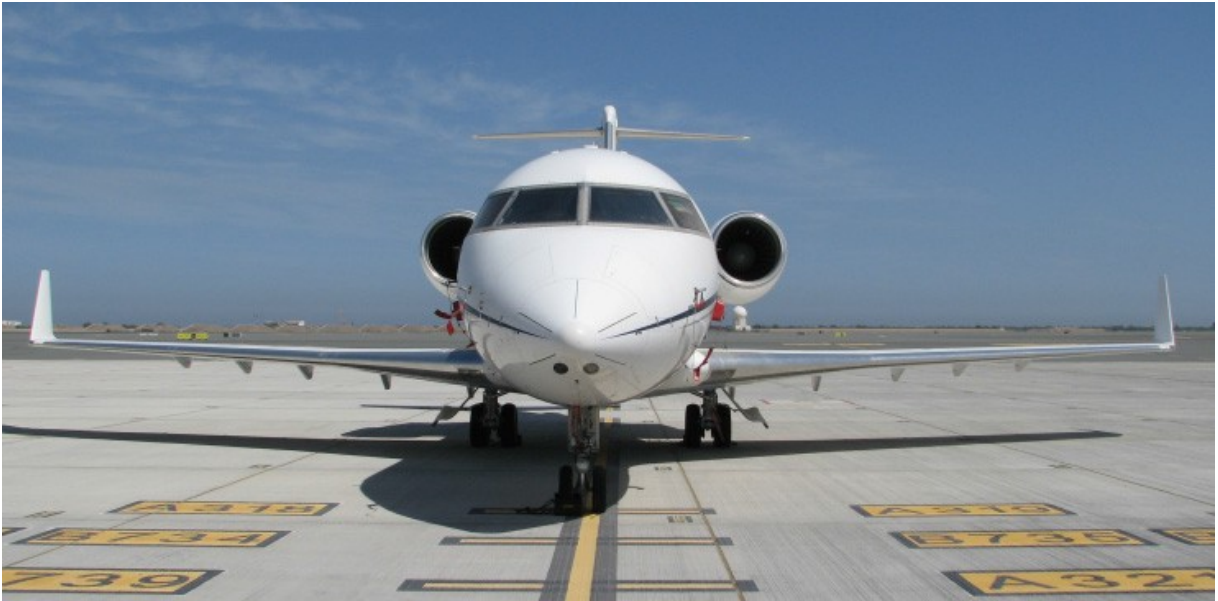
Outer condition of the airplane

The aircraft manufacturer determined that the airframe structure could not be restored to an airworthy state as it exceeded the airframe certification design load limits during the upset encounter. Therefore the aircraft is considered to be damaged substantially.

During a BFU investigation of the airplane no outer damages on fuselage, wings, and empennage, including control surfaces, were visible. There was no evidence of leakages (oil, fuel).

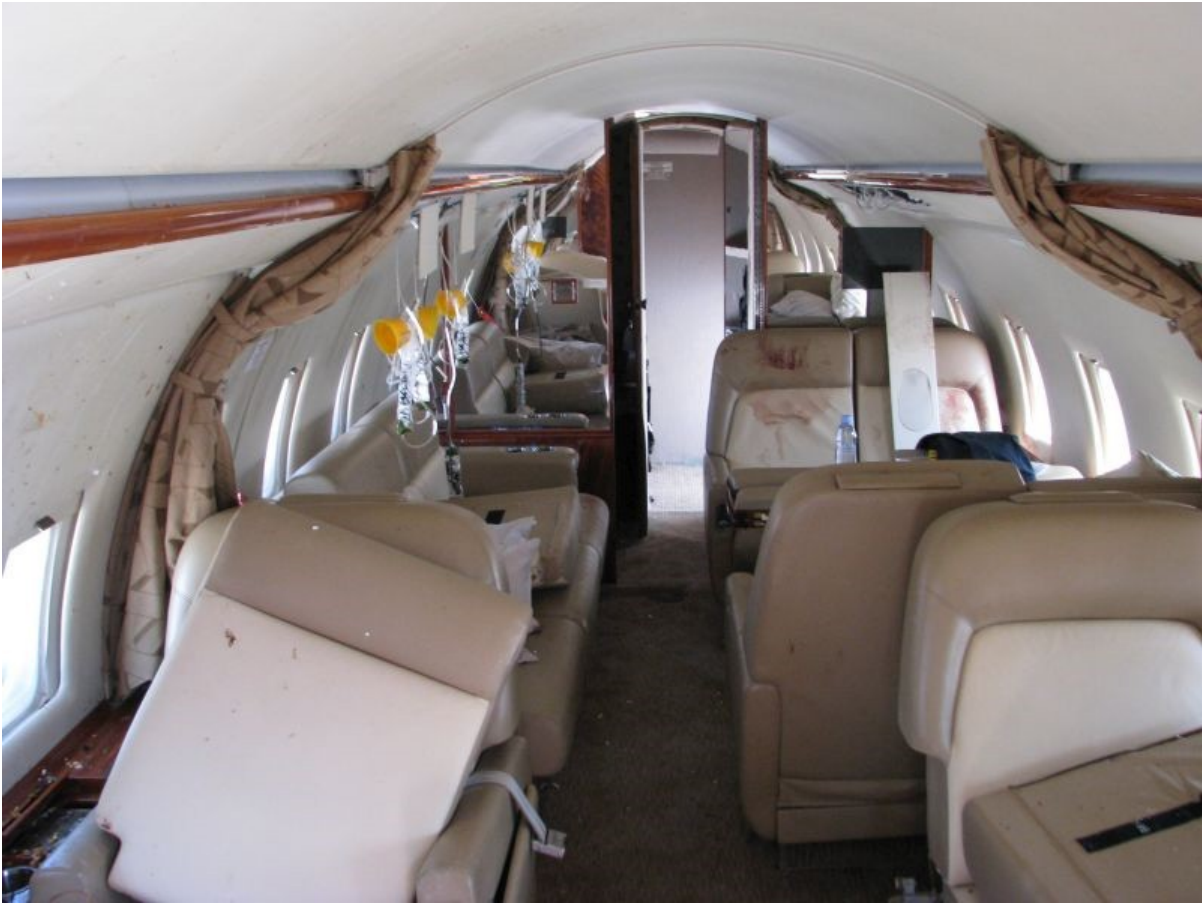
Damages in the cabin (viewed opposite to the direction of flight)

The inside of the passenger cabin showed damages on the seats and the panelling, as well as traces of blood. The armrests of the four seats in the front, installed in club arrangement, were either deformed or had fractured.

On the left side of the cabin two oxygen masks had fallen from their casings.

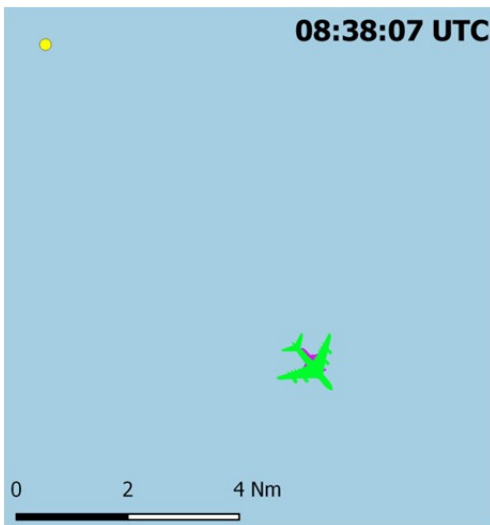
At about 0838:07 UTC the A380 passed the CL604 overhead with a vertical distance of 1,000 ft slightly to the right.

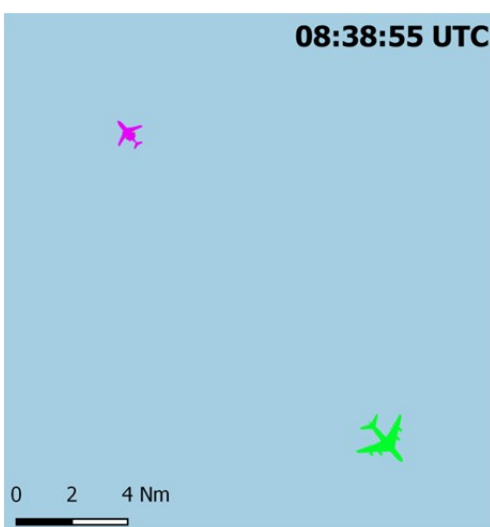
At about 0838:55 UTC at FL340 the CL604 encountered the wake vortex. At that time the A380 was about 15 NM south-east.

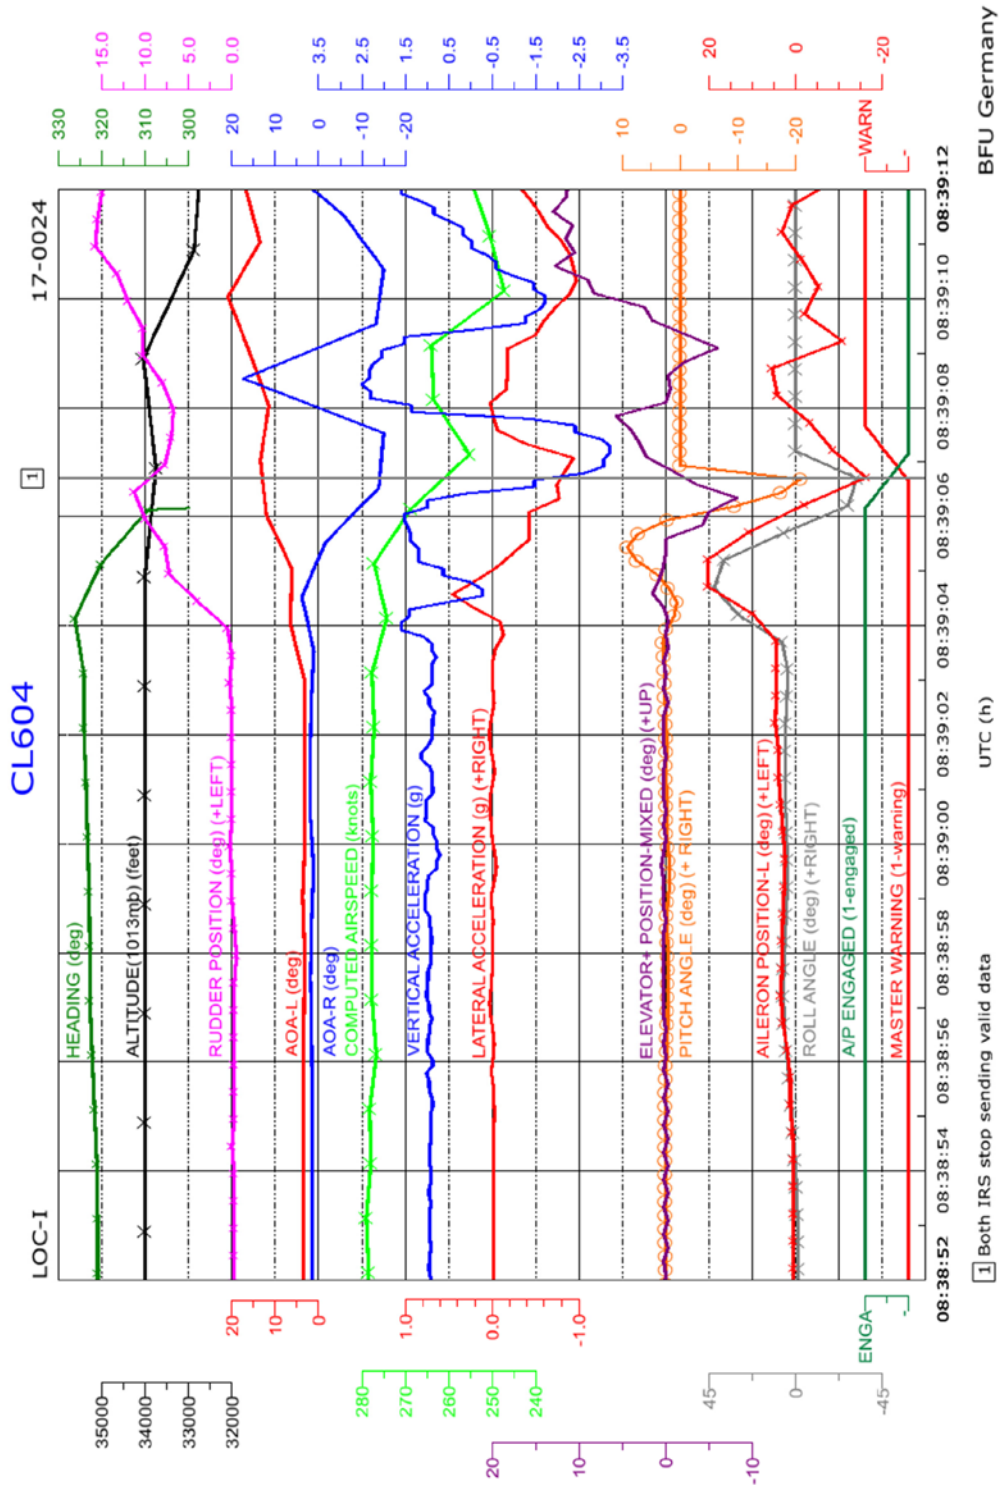
Excerpt of the CL604 FDR at the beginning of the occurrence

began to increase. Within one second the bank angle increased to 42° to the right. At the same time the aileron deflection to the left increased to 20° and the vertical acceleration to 1.6 g. In the following second vertical acceleration changed to -3.2 g.

At 0839:04 UTC a lateral acceleration of 0.45 g to the right was recorded. The pitch angle changed from about 3° to about 1°, then within one second increased to 9° and decreased again in the following second to -20°. At the same time the FDR recorded a rudder deflection to the left reaching 11.2° after about two seconds whereas the bank angle changed from 42° right to 31° left.

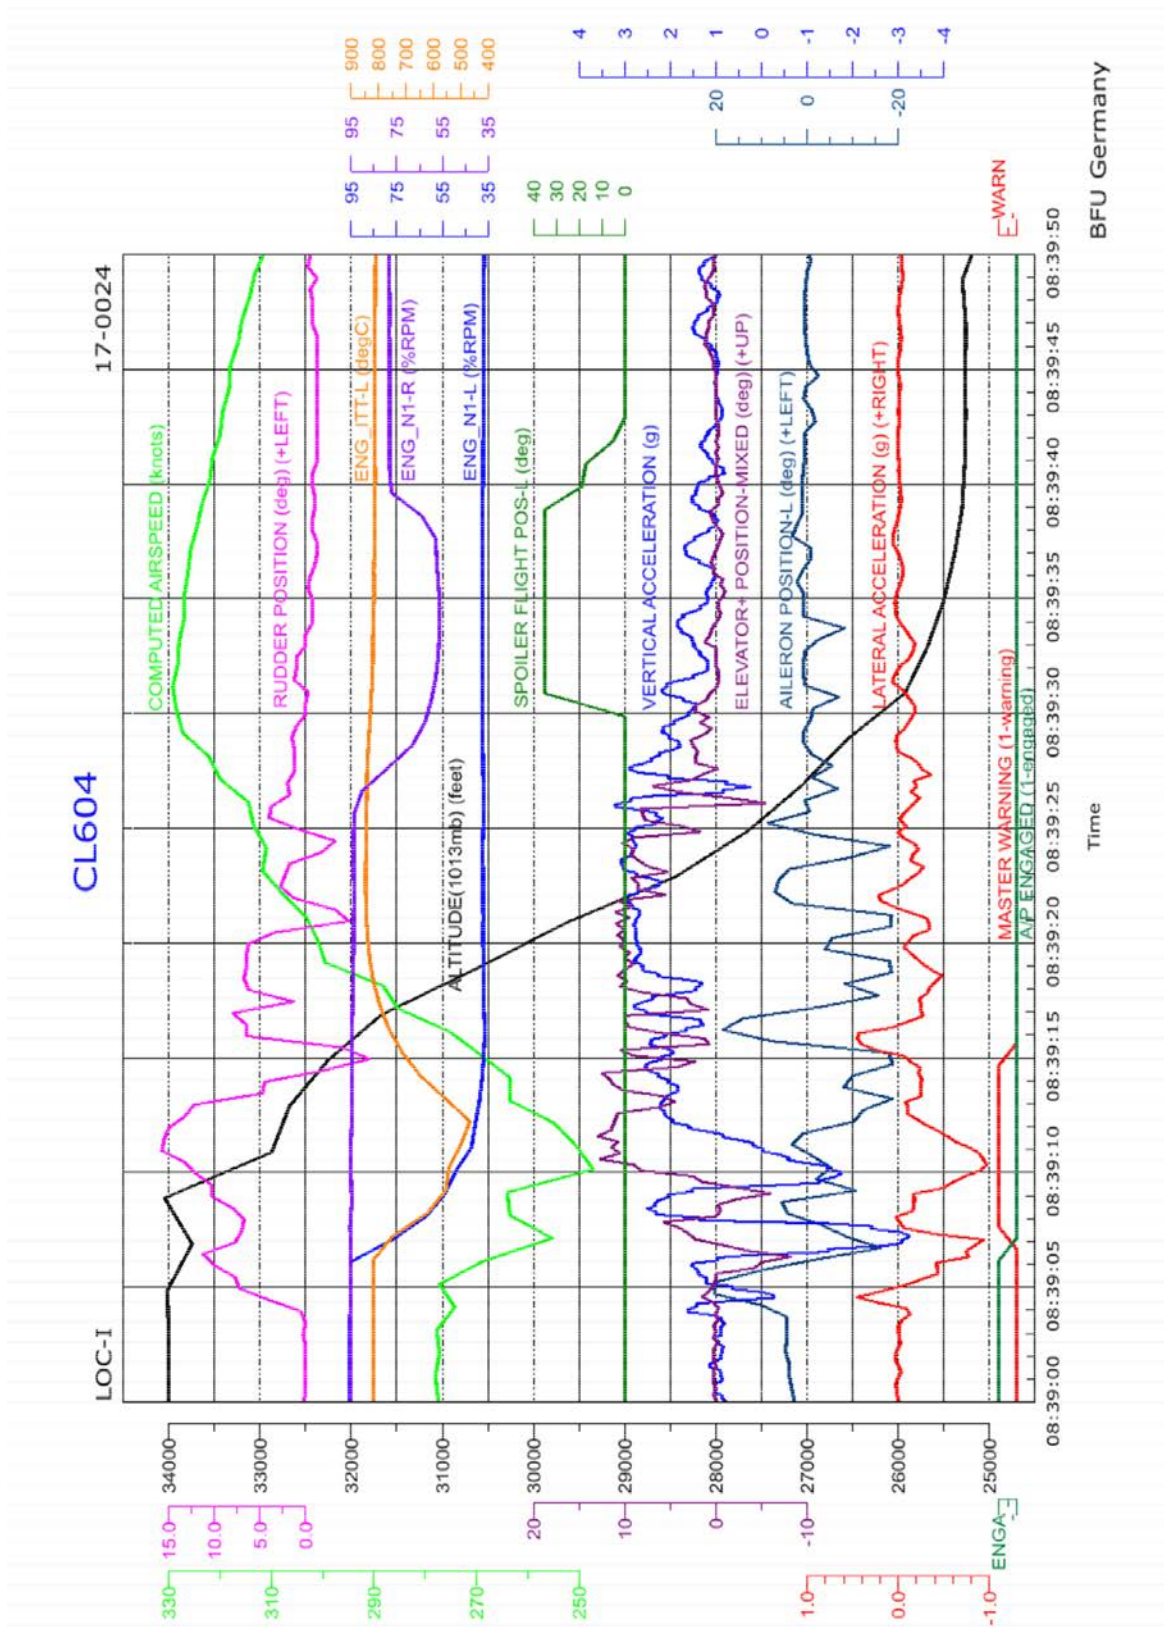
Excerpt of the CL604 FDR during altitude loss

Both IRS stop sending valid data
