Background

Upset Accidents and Incidents

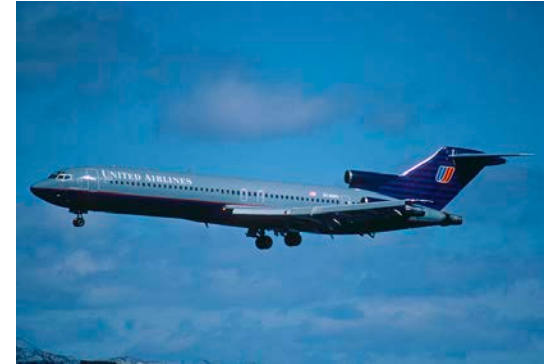
United 241 incident

Started rapid climb at 4700 ft maintaining 1G

At 6000 ft in 20-deg bank, aircraft encountered an abnormal meteorological condition

Bank increased to 40 degs and an abnormal climb rate

Captain applies forward pressure and nose-down trim

High rate of descent and difficulty recovering

-1.5G at 8700 ft and 4.7G at 1200 ft

- Why: Trim overcontrol in recovery

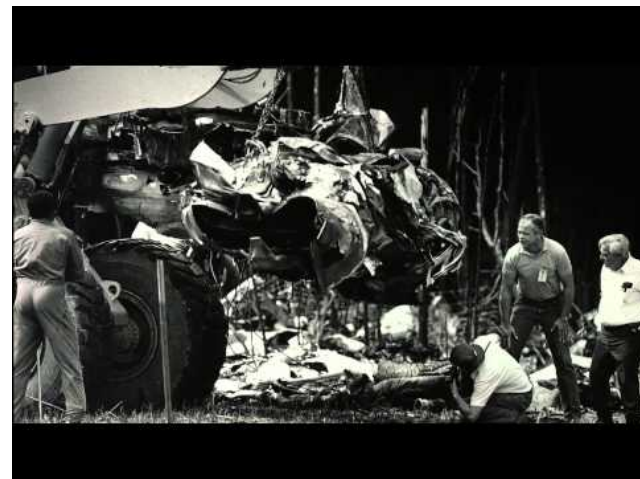
Midwest Express 105

Right engine failure on takeoff at 450 ft

Correct then incorrect pedal, followed by aft column

Continued climbing to 700 ft, rolled right near 90 degs

Accelerated stall

- Why: Improper response to engine failure, lack of crew coordination

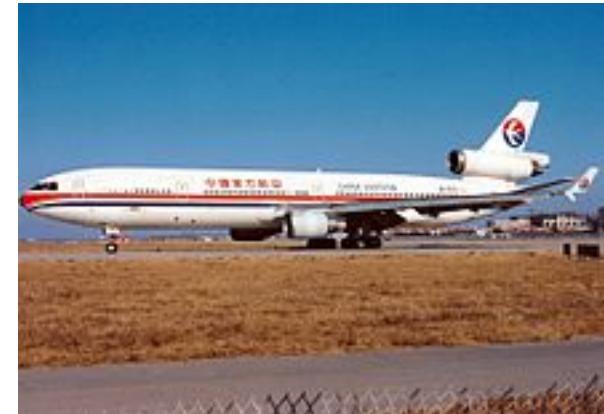
China Eastern Airlines 583

Inadvertent deployment of leading-edge wing slats

Several violent pitch oscillations in ensuing recovery

Simultaneous shaker and slat overspeed chime

+2.1G to -1.2G

- Why: Light control forces and reduced pitch stability made overcontrol easy to do

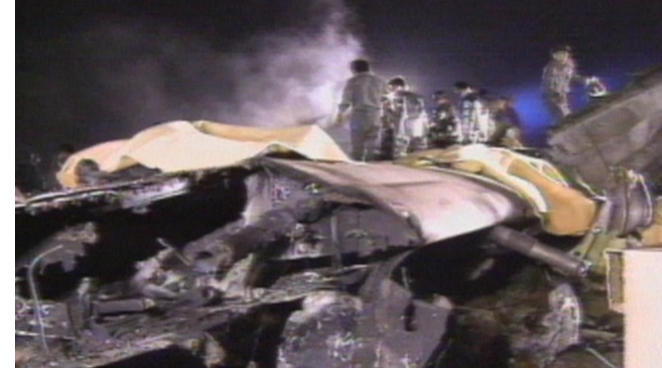
China Airlines 140

At 1000 ft, GO lever inadvertently triggered
A/T disengaged. A/P trimmed stab nose up
PF tries to return to path countering with elevator
Captain takes control at 500 ft. Go around.
Surprised by mistrim, compounded by thrust
Pitch up to 52 degs. Stall until impact

Why: Lack of trim awareness, lack of mode awareness

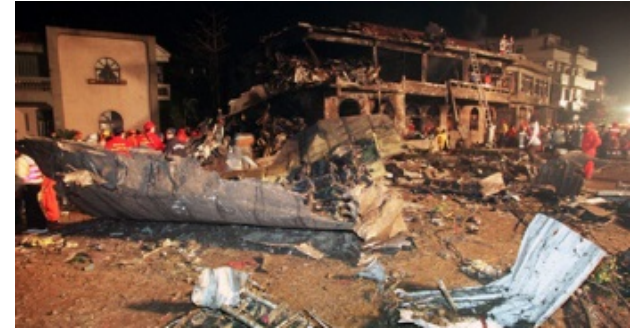
China Airlines 676

1000 ft high at 1.2nm from threshold

A/P disconnected, crossed threshold at 1475 ft

Go around...pitched up rapidly to 35 degs

At 2330 ft, pitch was 42.7 deg...9 sec later, speed 43 kt

- Why: Unstable approach, inadequate CRM, for 12 secs the pitch-up from go-around thrust not countered, stall

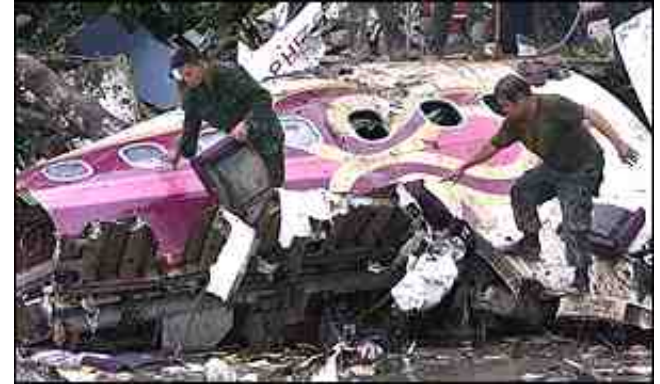
Thai Airways 261

Two go-arounds in low visibility

On third attempt, runway not visible at MDA

Autopilot disconnected, and captain decides go around

Pitch increases to 40 degs, countered back to 32 degs

Counter inputs stop and pitch to 48 degs, airspeed 100

Stall

- Why: Stress and possible expectation that 3rd go-around would be like the first two. Similarity with China Air 140.

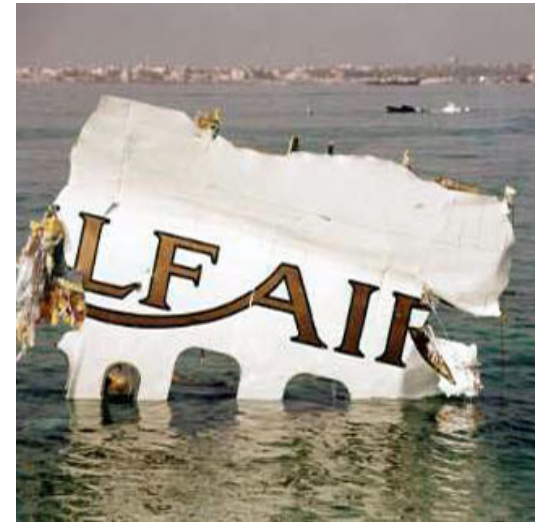
Gulf Air 072

On second go-around, captain command half the pitch req'd and did not maintain runway heading
With TOGA and low pitch, aircraft rapid accel
Flap overspeed warning; commanded flaps up
Captain deflected stick forward and got -15 deg pitch
Did not respond to multiple GPWS alerts

- Why: Likely spatial disorientation, incorrect go-around procedure, poor CRM

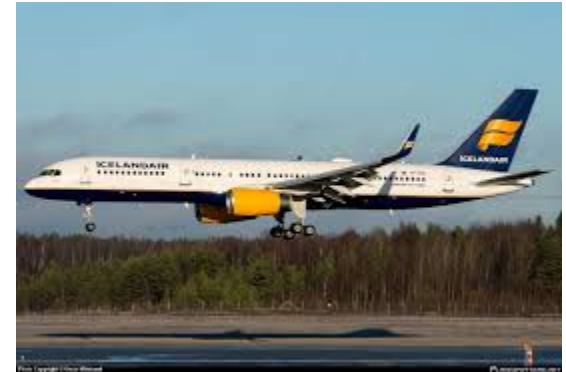
Icelandair 315 incident

Go around after unstable approach (near MCP alt)

After go-around transient, aircraft tries to level and
slow to MCP speed of 150 kts

Captain put in inputs to prevent stall

Pitch goes between +40/-49;

Load factor goes between 3.6 and -0.6g's

Aircraft had two more flights afterwards w/o inspection

- Why: Loss of situational awareness; mode switching challenges

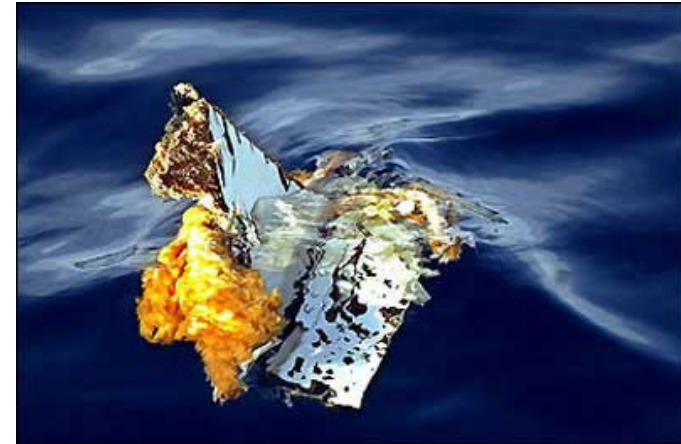
Flash Airlines 604

Left turn to intercept VOR after takeoff

Aircraft banked right after heading select

Co-pilot warned that bank was increasing

Captain neutralizes wheel, then increases right bank

Banks 111 degs and 43 pitch down

- Airplane hits water at 24 degs right bank and 4G's
- Why: Findings inconclusive (disorientation? System failure?)

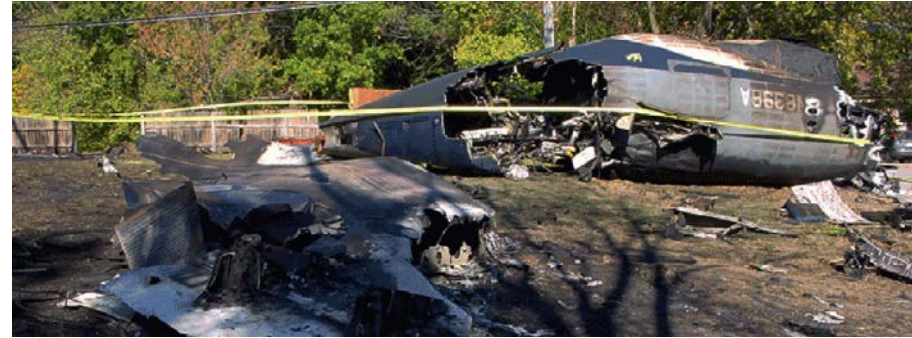
Pinnacle Airlines 3701

Reposition flight; Climbed to FL410

Shaker and pusher activations; Dual engine flameout

Recovered from upset at FL340

Started performing double engine failure checklist

Did not obtain necessary speed for restart (300 kts)

Moved to APU-assisted start; unable due to core lock

- Why: Unprofessional behavior; lack of airspeed monitoring; improper response to stall; improper engine restart

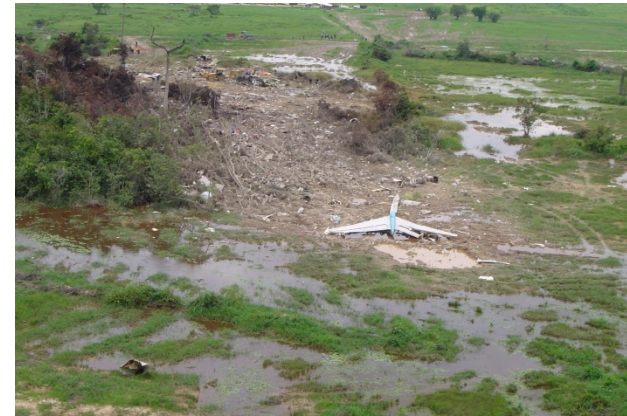
West Caribbean Airways 708

Vertical speed mode climb to FL330...Mach EPR limited

Engine anti-ice cycled

Tried to cruise at FL 330, $M=0.75$. Again Mach EPR lim

Poor weather. Continuous speed drop.

Buffeting started. Descent requested.

Shaker activated in descent at FL320 and remained on

- Why: Lack of knowledge on operating limits, lack of speed monitoring, lack of proper response to stall

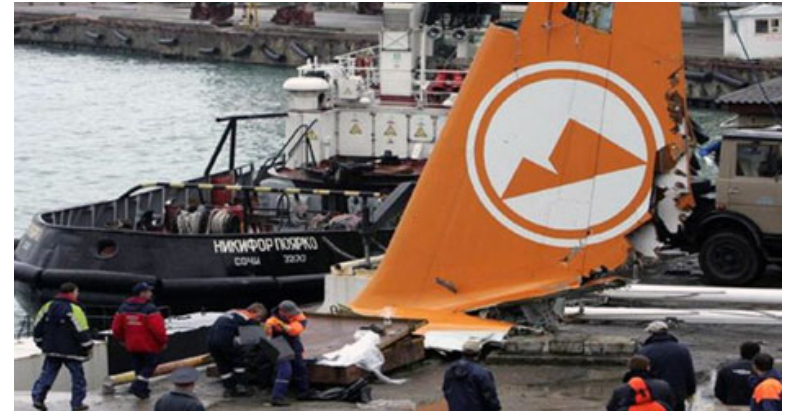
Armavia 967

Decided to divert, then decided to land

ATC instructed go-around after Wx dropped below mins

Thrust levels placed into climb; flaps and gear extended

“Speed, speed, speed” alert; Levers moved to TO/GA

Disengaged A/P, decrease pitch, banked right, used rudder

- Why: Likely spatial disorientation; poor CRM, improper go-around procedure; dual (and opposite) sidestick inputs

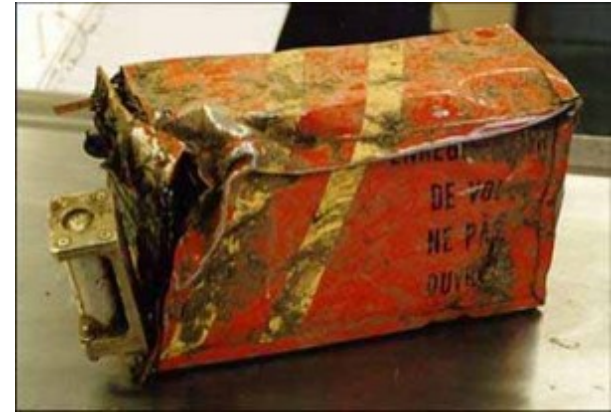
Adam Air 574

- When: January 2007
- Where: Makassar Strait off Indonesia
- What: 737-400
 - Day, IMC; stormy weather
 - FL350; slow right roll began “bank angle” alert
 - Bank angle reached 100 degs; pitch 60 degs down
 - Vertical speed of 54,000 ft/min recorded
 - Airplane had structural failure at 9000 ft
- Why: Preoccupation with troubleshooting INSS; inadvertent A/P disconnect; possible spatial disorientation

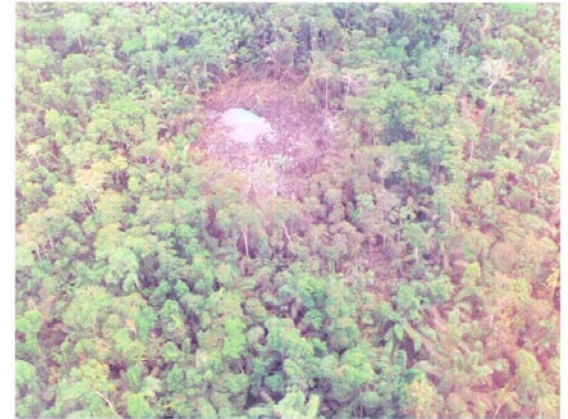
Kenya Airways 507

After takeoff, captain gave command to engage A/P

Command not acknowledged; A/P not engaged

Several heading changes input into MCP, but no A/P

Captain engages A/P and increases bank angle

Bank reaches 115 degs and pitches down at 2900 ft

Pilots used opposite inputs during attempted recovery

Bank is 60 degs at impact

- Why: Lack of monitoring, spatial disorientation, lack of crew coordination

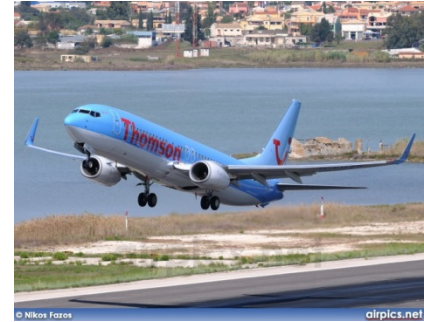
Thomsonfly G-THOF incident

Uncommanded autothrottle disengagement

Autopilot trims stabilizer up to stay on path

Go around called after aircraft slows below speed

Pitch up to 44 degs, speed 82 kts

Full column forward ineffective, trim not applied

Thrust reduced to 86%. Recovered.

- Why: Unnoticed autothrottle disconnect, lack of trim awareness and application

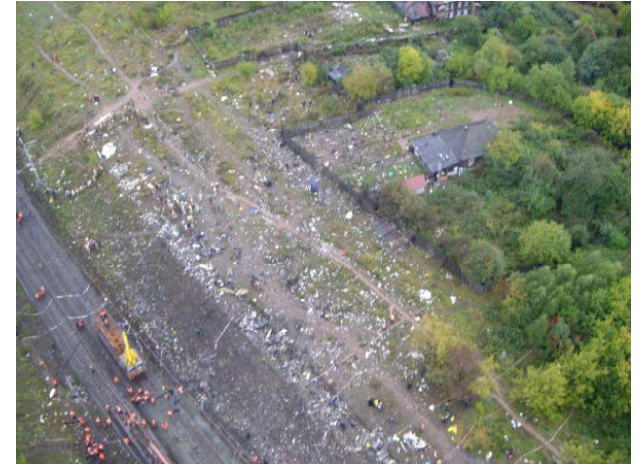
Aeroflot 821

Approach was not stabilized

Possible western versus eastern attitude display issue

Significantly below V_{ref} during approach

After base turn, aircraft roll 360 degs

- Why: Poor crew coordination, fatigue, spatial disorientation, captain alcohol consumption

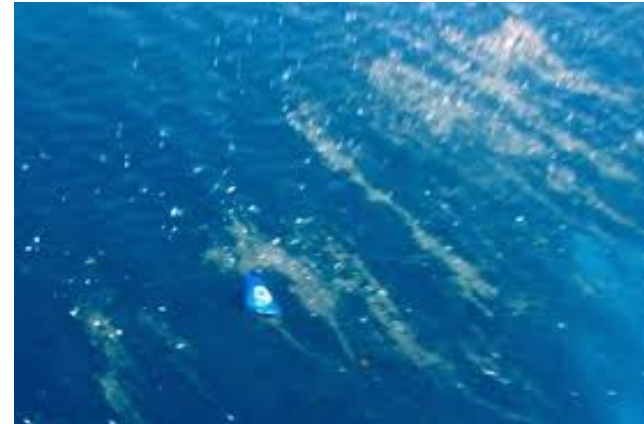
XL Airways GXL888T

Water penetrated AoA sensors during a rinse

At FL320, AoA sensors 1 and 2 stopped moving (froze)

Later on approach, crew checked normal law protections

Stabilizer trimmed full nose up during decel

Drop to Direct Law likely unnoticed

Loss of control and crash into sea

- Why: System failure due to AoA vanes freezing. Lack of trim awareness. Lack of understanding in stall recognition

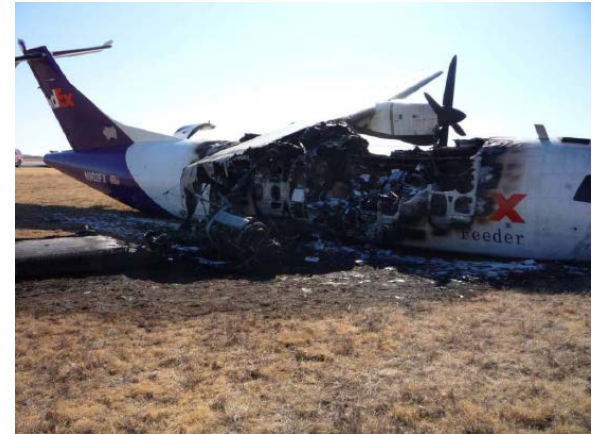
Empire Airlines 8284

Flap asymmetry (at F15, one side 0 and other 8-10 deg)

During troubleshooting, speed 160 to 125 kts in 26 sec

- Why: Continued approach after flap anomaly; lack of monitoring to maintain safe speed

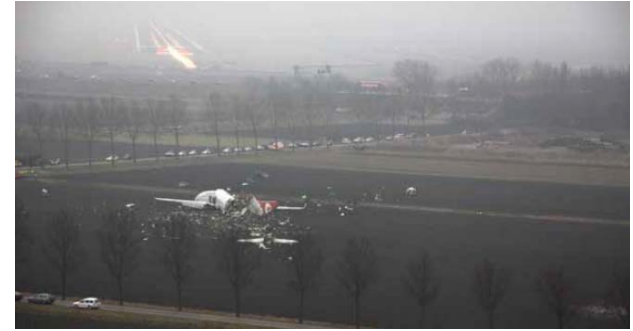
Turkish Airlines 1951

Nonstandard ATC approach; then unstabilized approach

Left radio altimeter passed -8 feet to autothrottle

Autothrottle moved to 'retard flare' mode on approach

Autopilot increased AoA to stay on path during decel

Speed decay unnoticed until shaker activation at 460 ft

- Why: Unstable approach, lack of monitoring speed, pitch increase, and A/T mode. Stall recovery procedure improperly applied.

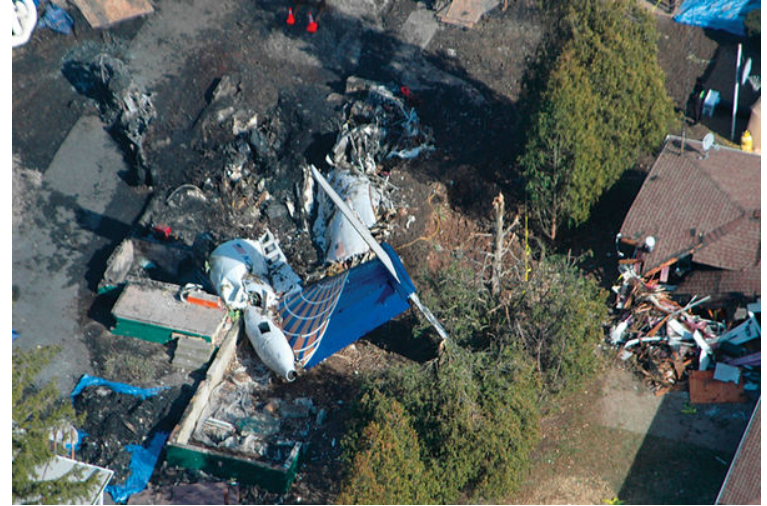
Colgan Air 3407

Briefed Vref of 118 kts, but ref speeds switch “increase”

Shaker engaged at 131 kts, likely causing surprise

Captain pulled and resisted shaker

Tried to control roll during stall until impact

- Why: Lack of airspeed monitoring, unexpected stall warning activation, inappropriate response to stick shaker and pusher

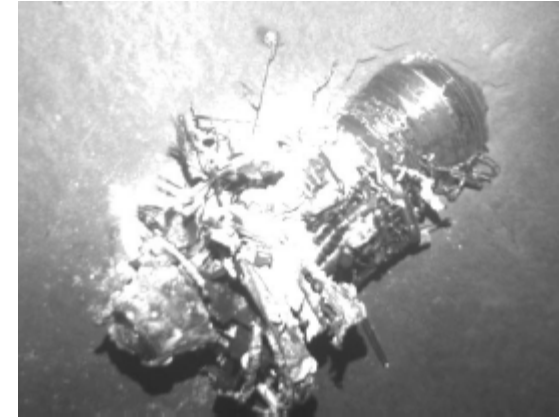
Air France 447

- When: June 2009
- Where: International waters, Atlantic Ocean
- What: A330
 - Night IMC
 - Unreliable airspeed caused ALT 2B flight control law
 - Pilot inputs resulted in a stall
 - Stabilizer moved to nose-up limit and remained there
 - Tried to control roll during stall until impact
- Why: Unreliable airspeed procedure not applied, lack of stall recognition, recovery inputs disallowed return to safe flight

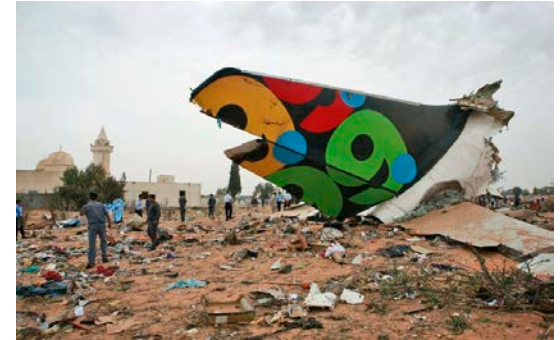
Afriqiyah Airways 771

Continued below NDB MDA without ground visual ref
TAWS activated, then go-around

Go around pitch not maintained (nor FD commands)

Dual inputs, but not enough to cause warning

Captain took control and pushed down (F/O pulled)

- Why: Spatial disorientation, poor CRM, dual inputs, possible fatigue

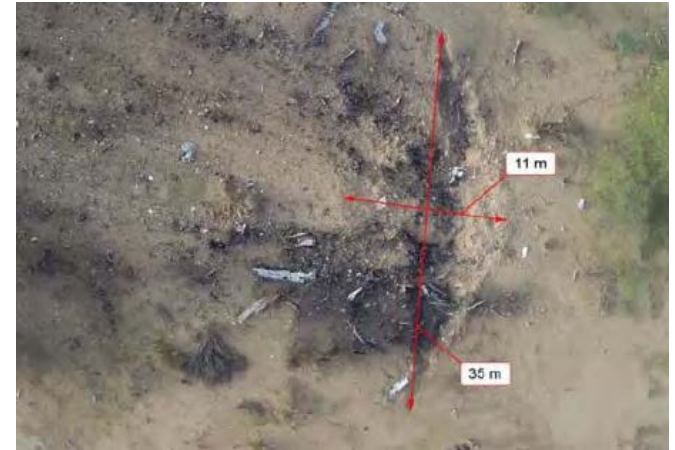
Air Algerie 5017

FL310, several heading changes to fly around cell

EPR erroneous on both engines (likely icing of sensors)

A/T then did not apply enough thrust

A/C slowed from 290 kts to 200 kts in 5.5 mins

A/P disengaged 20 sec after stall begins (AoA=25 deg)

Roll 140 degs, pitch down 80 degs

- Why: Crew did not activate engine anti-ice; lack of speed monitoring; lack of proper stall recovery inputs

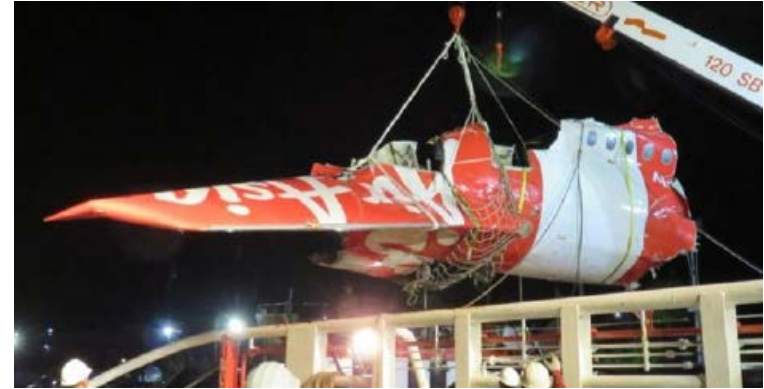
Air Asia 8501

Repeated Rudder Travel Limit Unit failure at FL320

Alternate law entered after reset of FAC CBs

Sideslip from rudder causes roll and rise of FD

Pilot flying inputs results in stall

Continuous stall warning during last 3 mins

- Why: Potential ambiguous guidance on clearing failure, lack of upset training on how to recover from a full stall

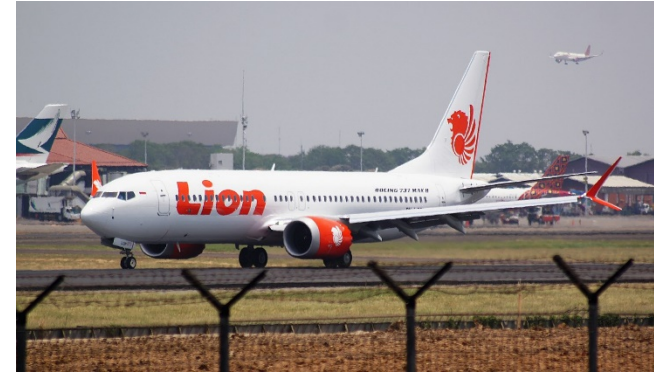
Lion Air 610

AOA sensor miscalibration (undetected on installation)

Repeated activation of nose-down stabilizer trim

from Maneuvering Characteristics Augmentation
System

Unexpected FO trim actions

Pilot flying inputs results in stall

- Why: Inadequate maintenance actions, potentially questionable assumptions in MCAS logic, unexpected pilot actions
