ICAO Accident/Incident Investigation Workshop, Mexico 2015

Ricardo Asensio,
Air Safety Investigator
Textron Aviation
316-676-7824
rasensio@txtav.com

Case Studies

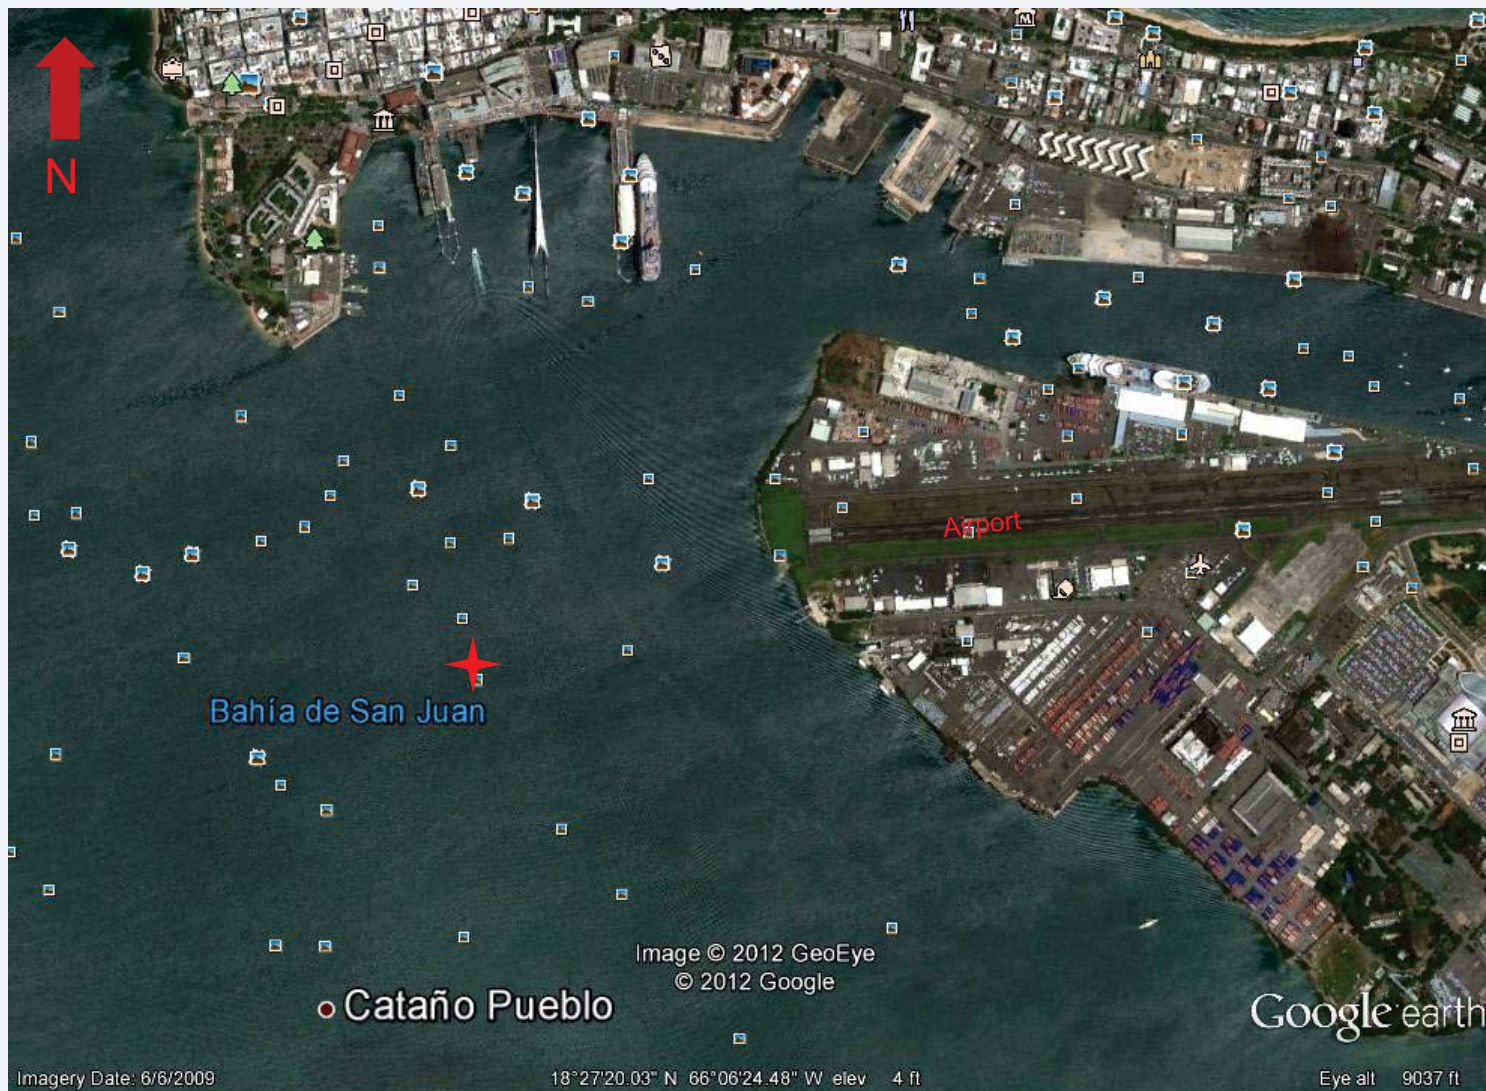
- Cessna 172M
- San Juan, PR
- During final approach
 - Fernando Luis Ribas Dominicci Airport (TJIC)
- Pilot reported problems with aileron control
- Aircraft impacted the water surface with the right wing tip
 - The aircraft cart wheeled and disappeared below the water surface
- Pilot received fatal injuries

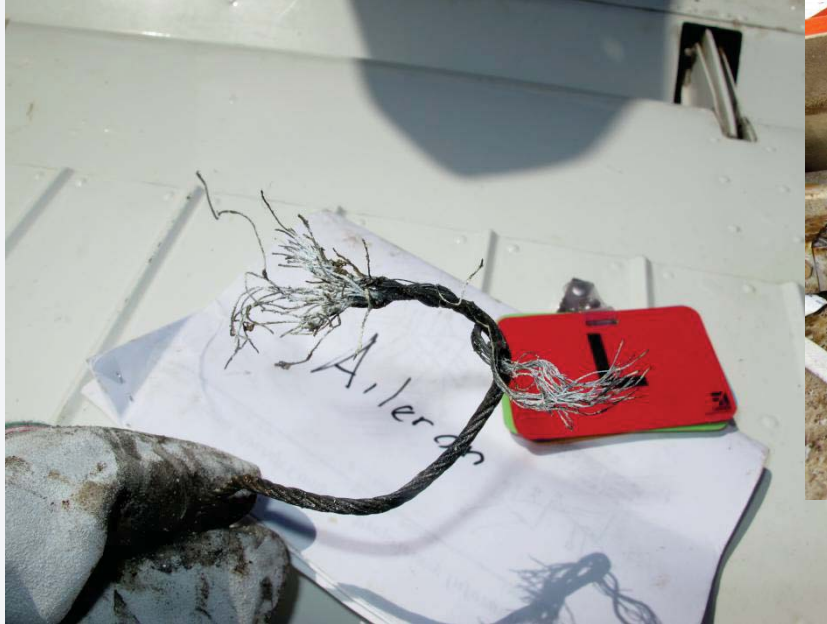
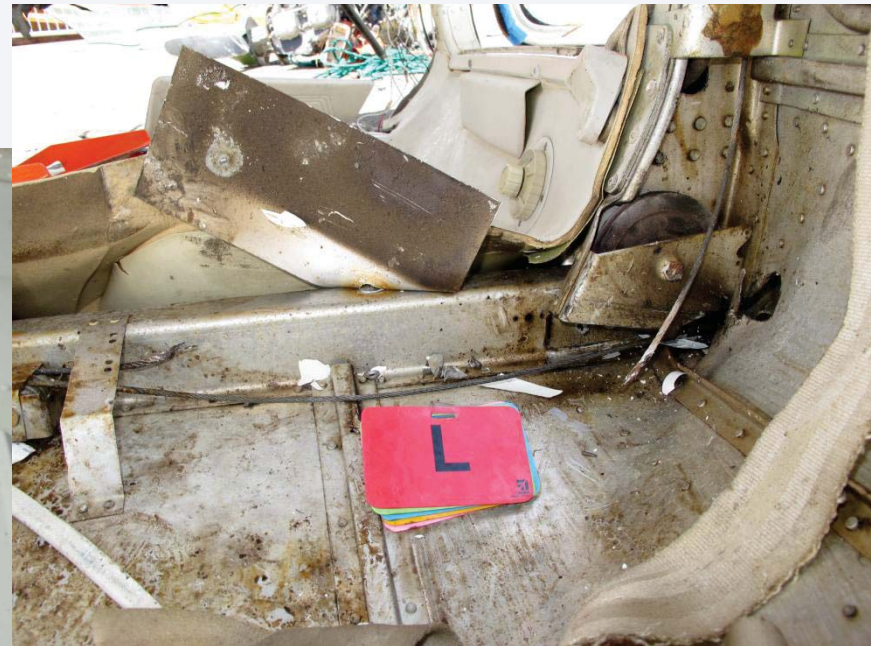
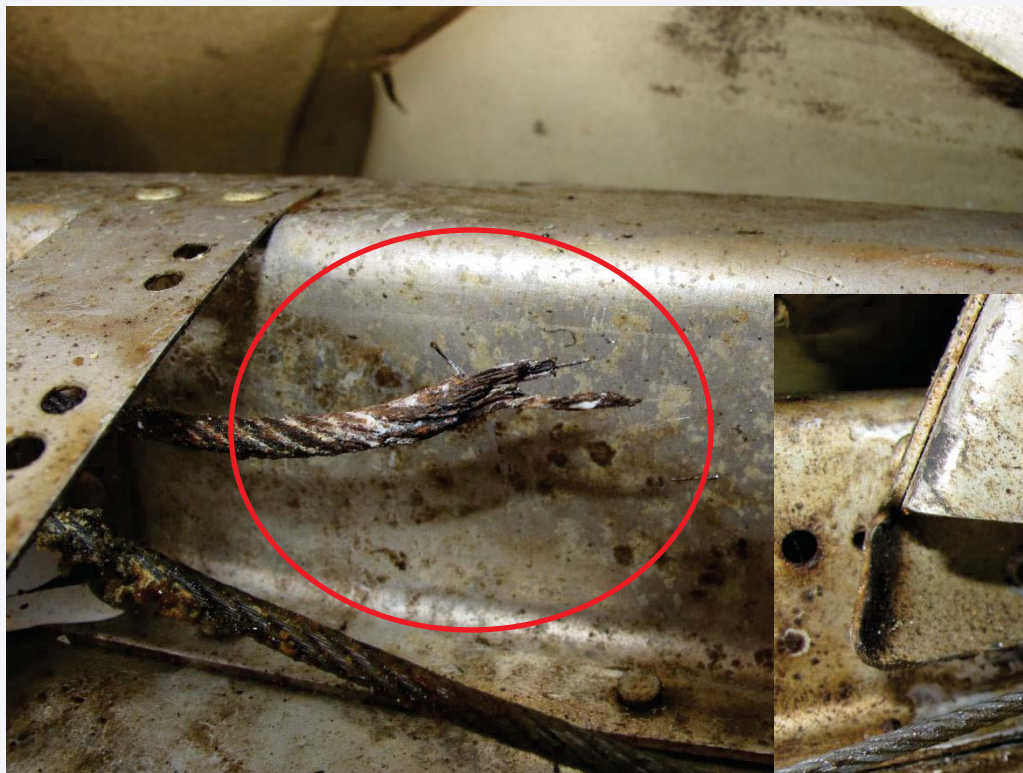
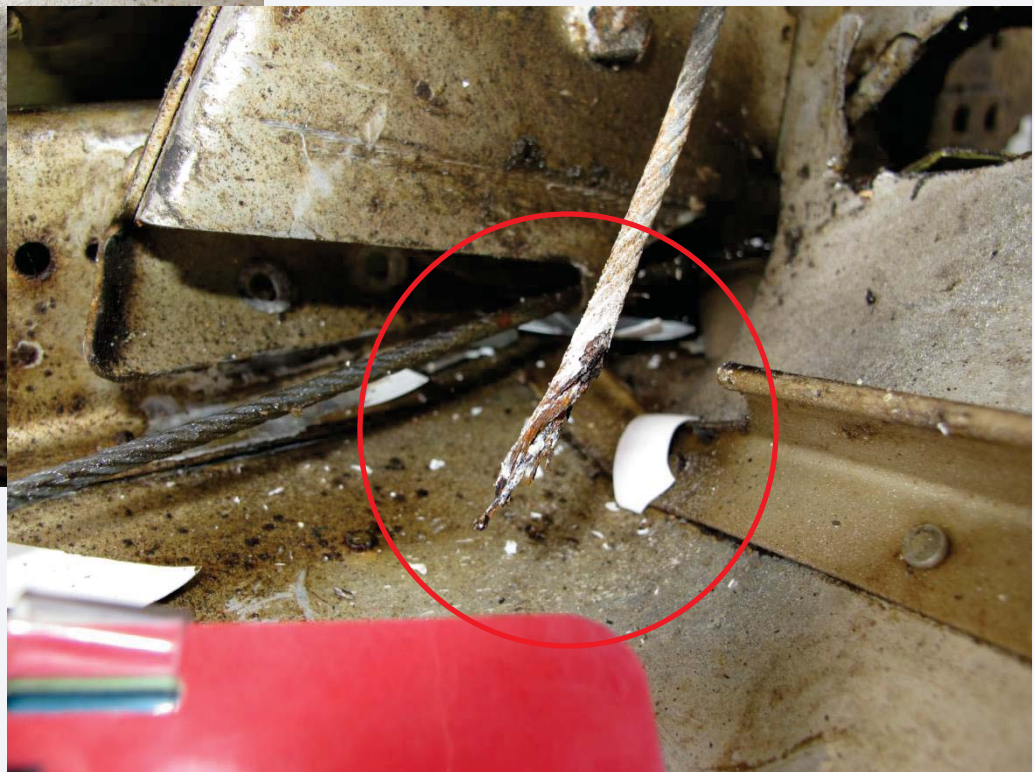
- Ailerons interconnect control cable exhibited broomstrawing
- Right aileron direct control cable was found separated
- Top left doorpost pulley exhibited signs of scoring on the rim

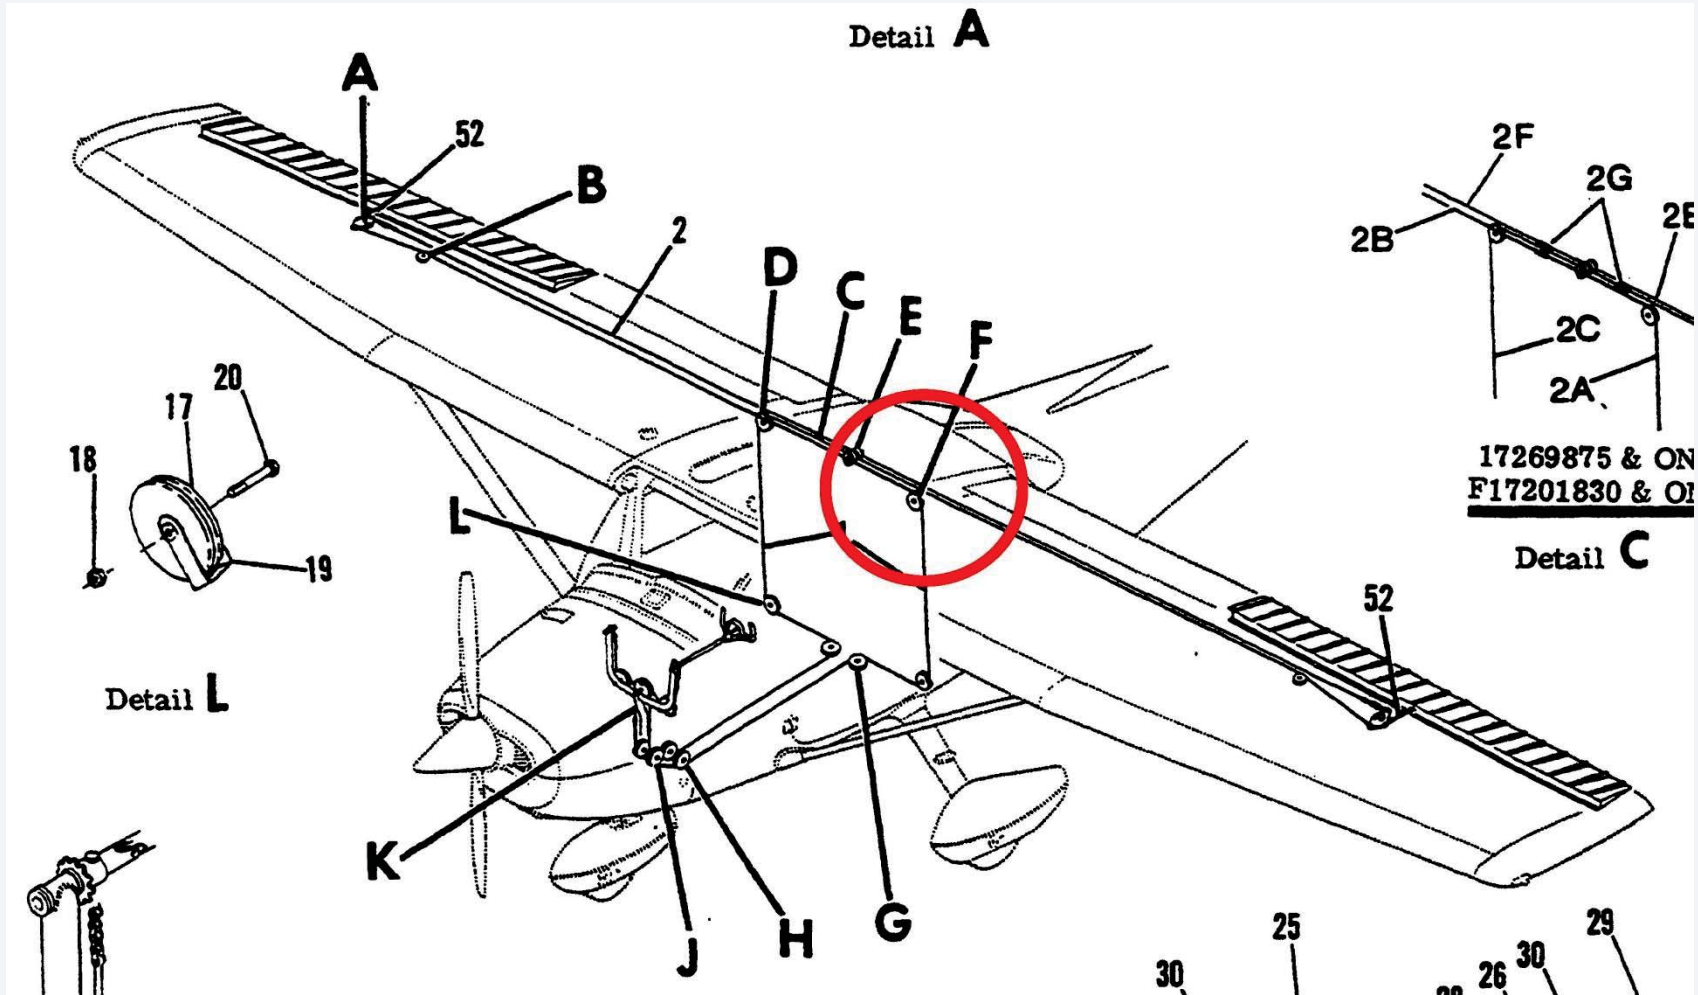
Aileron Pulley

“Maintenance personnel’s improper lubrication of the right direct aileron control cable and failure to detect the severe corrosion of the cable during a maintenance inspection, which resulted in the in-flight failure of the cable, the pilot’s subsequent inability to maintain aircraft control, and the airplane’s impact with terrain.”

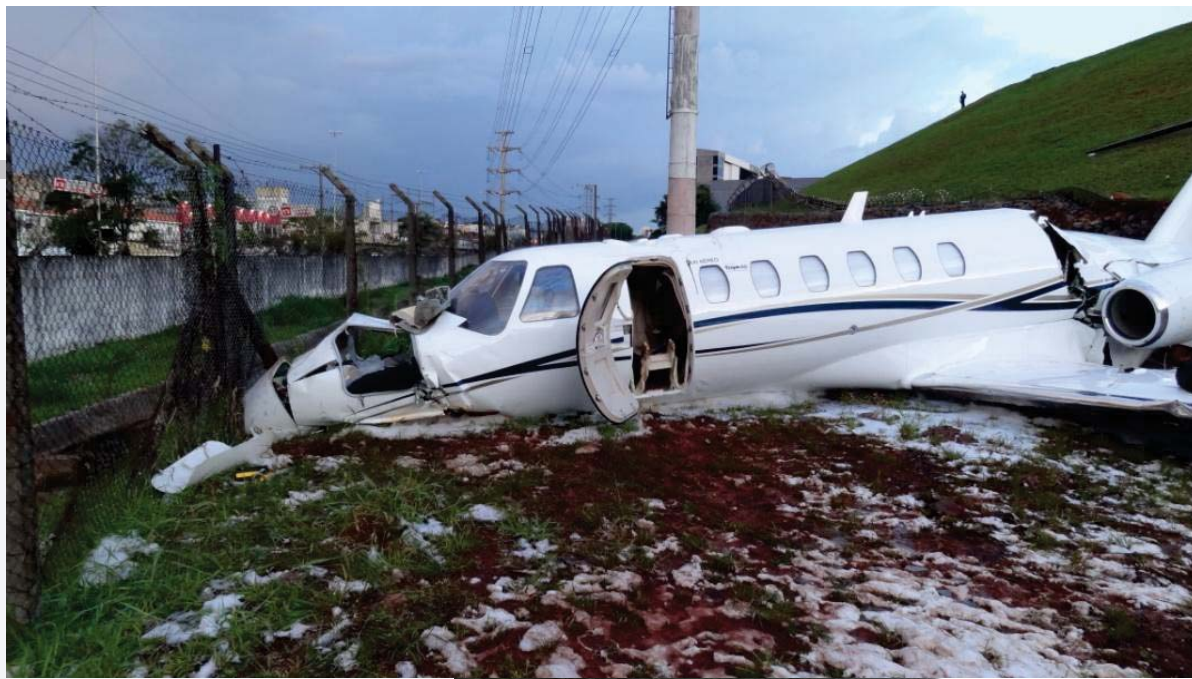
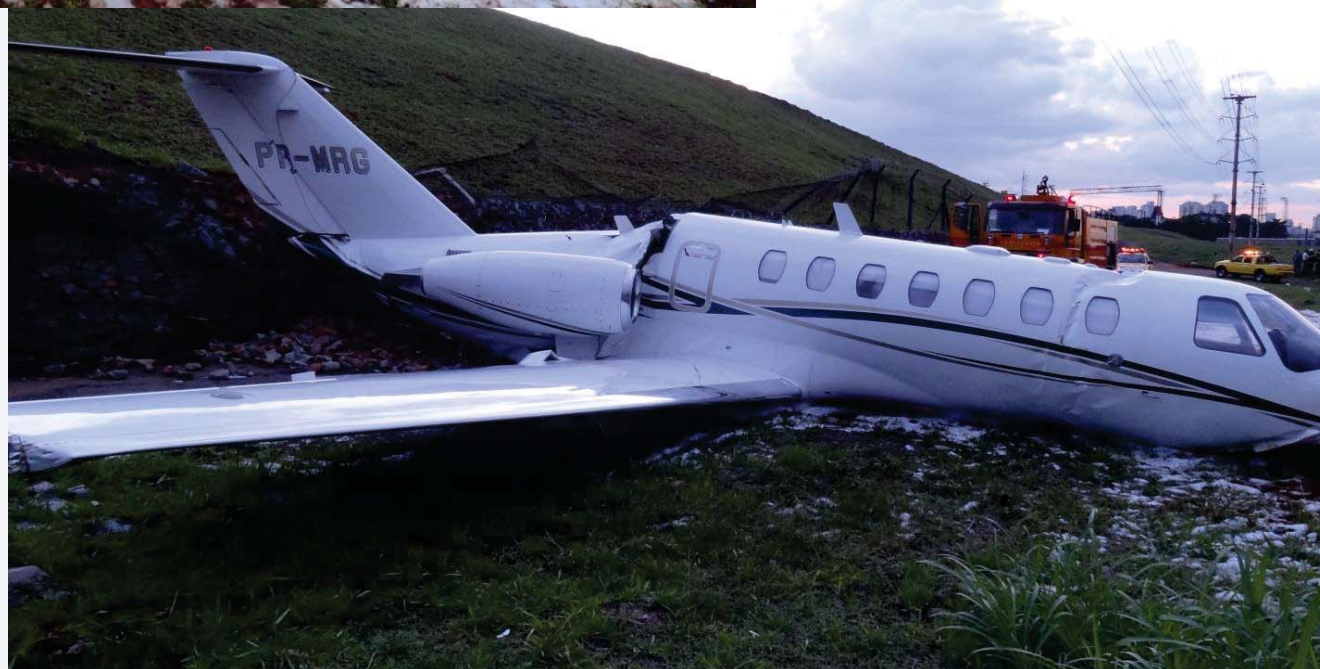
- 525B (CJ3)
- Sao Paulo, Brazil
- Owner is PIC
- Low time co-pilot
- Landed at Congonhas Airport (SBSP)
 - Runway 35R (4,708' x 148' Asphalt)
- Aircraft exited the end of Runway 35R
 - Impacted the perimeter fence
- Crew reported brake issues to SERIPA

- Aircraft flying too fast and too high.
- Aircraft touched-down halfway down the runway and bounced.
- Touched-down a second time almost at end of runway.
- Radar shows aircraft airspeed of 170 knots
 - 100' from Runway 35R threshold
- Landing calculations
 - Approach Speed (V_{app}) of 117 knots
 - Touchdown Speed (V_{ref}) of 107 knots
- Flaps 15° (Takeoff and Approach)
- The tires had no flat spots, the wheels spun normally, and the brake pads were not worn.
