**National  
Transportation  
Safety Board**

# Accident Case Studies

Tim LeBaron, IIC / US Acc Rep  
Washington, DC

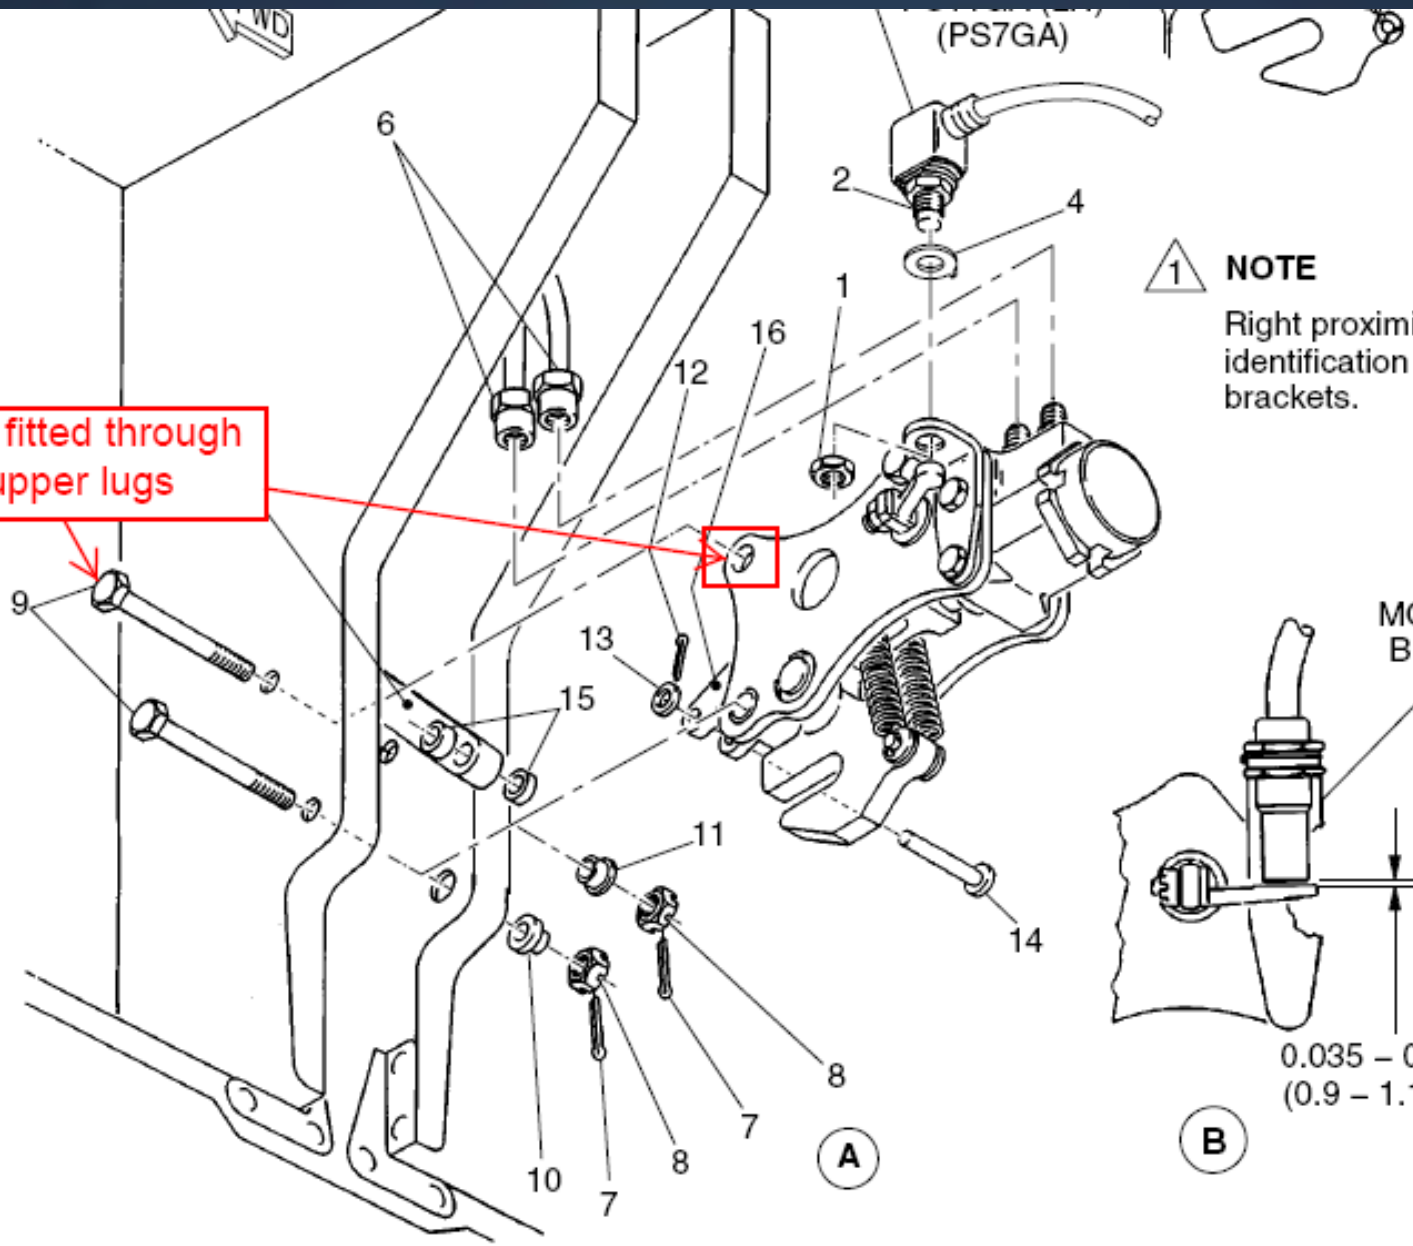
Bolt not fitted through uplock upper lugs

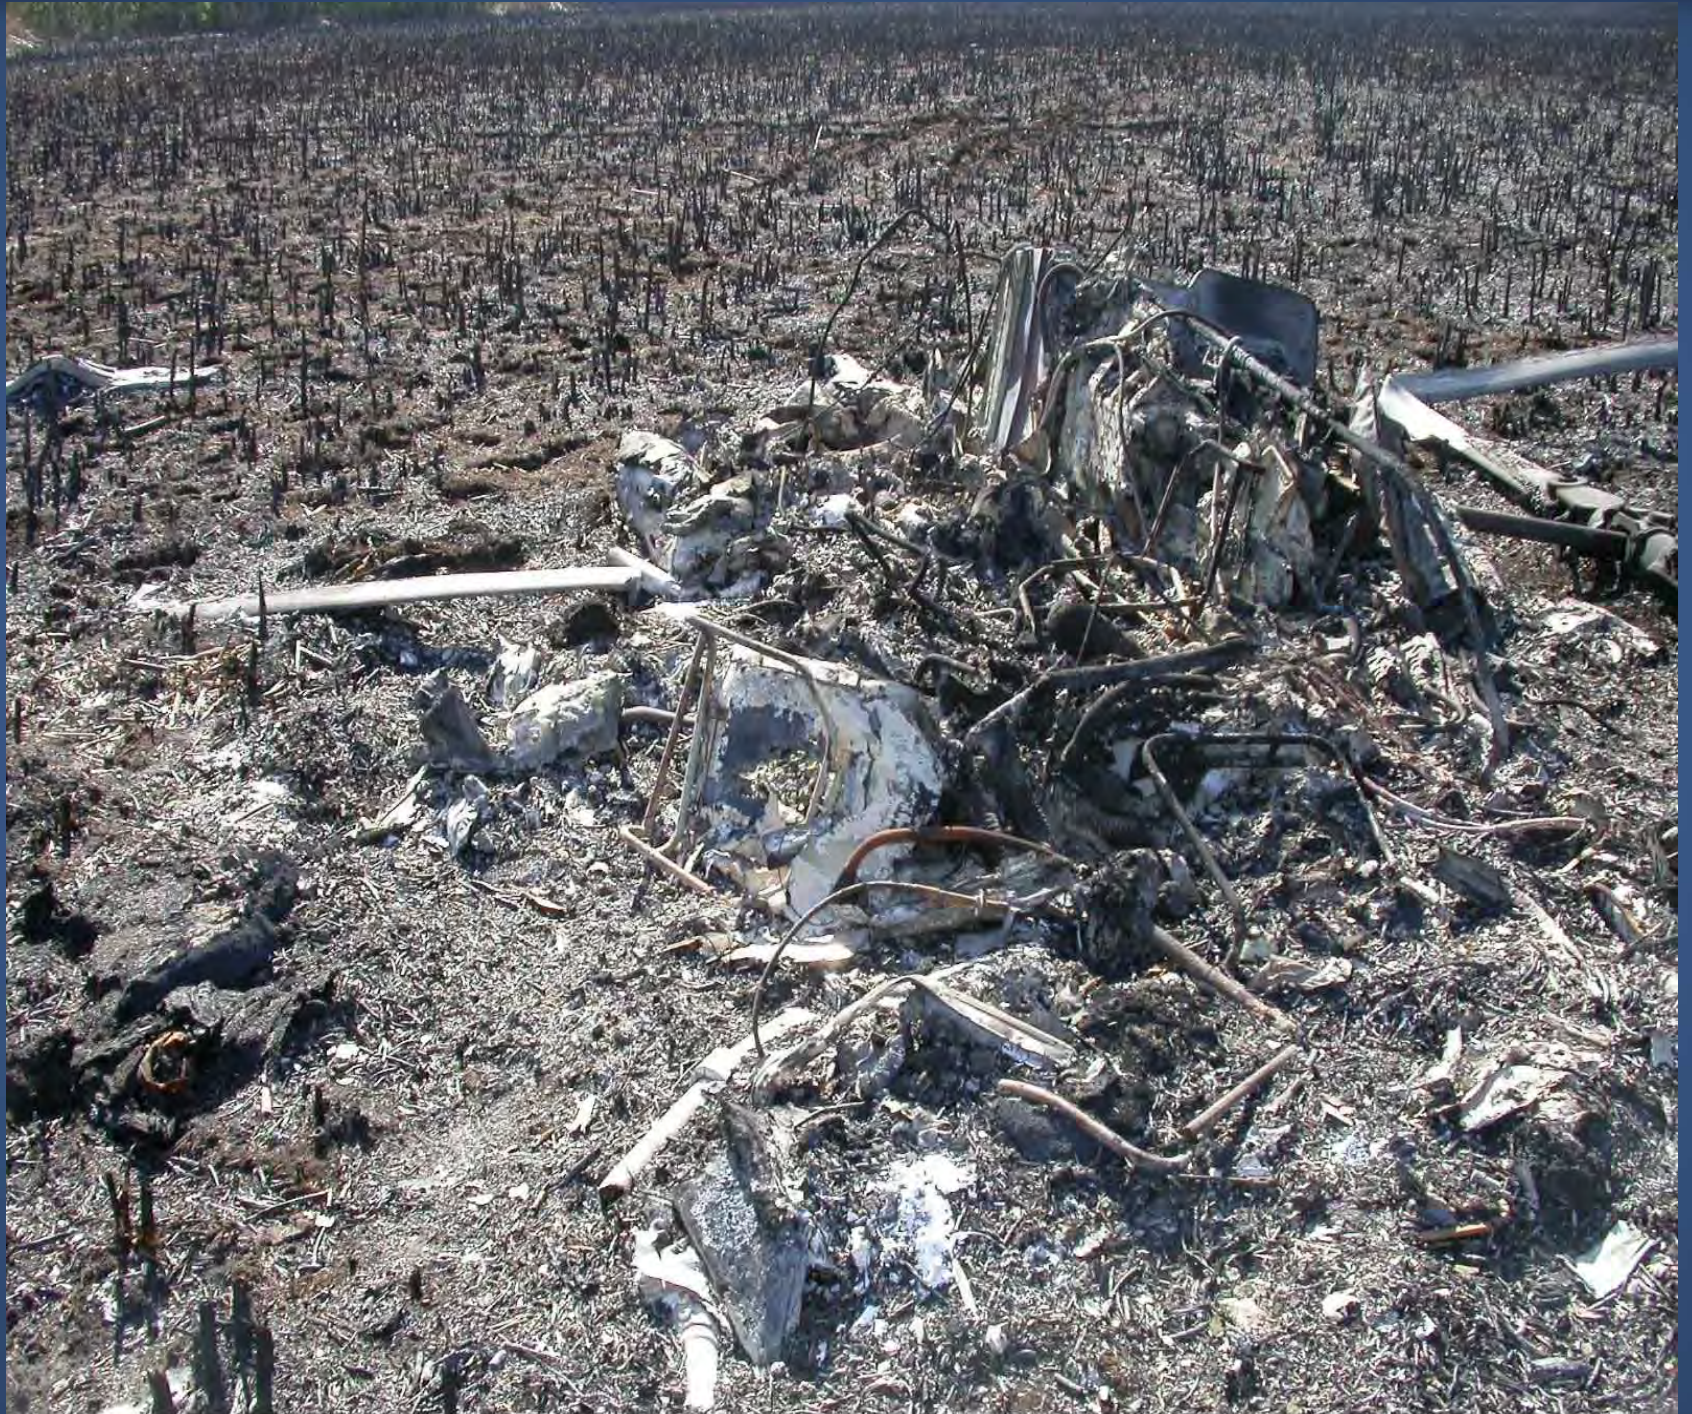
Digital Photo 5, View of wreckage looking south.

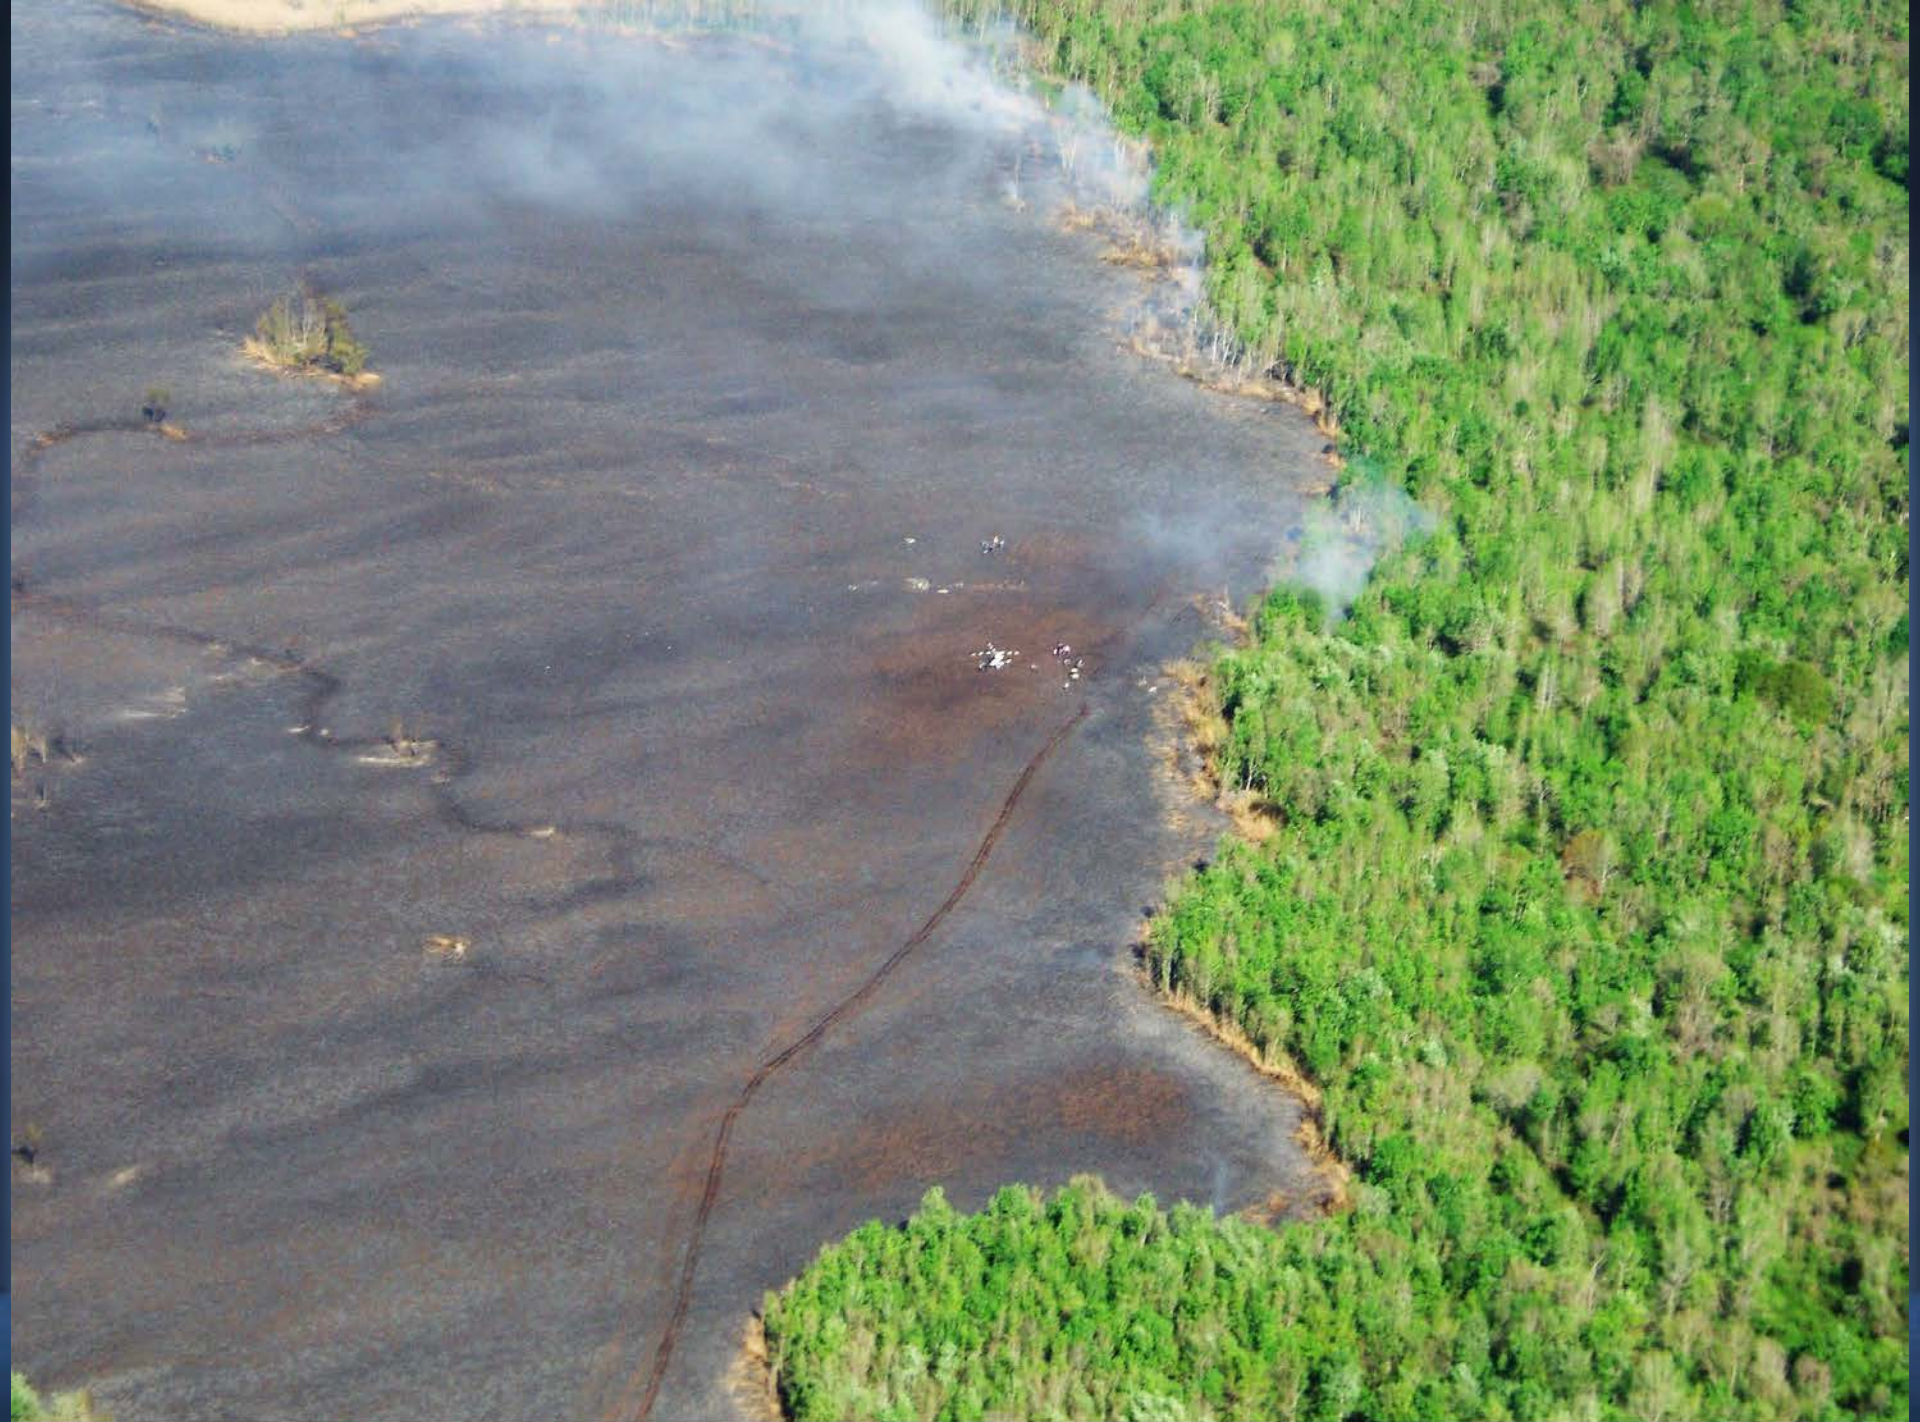
Digital Photo 1, Aerial View

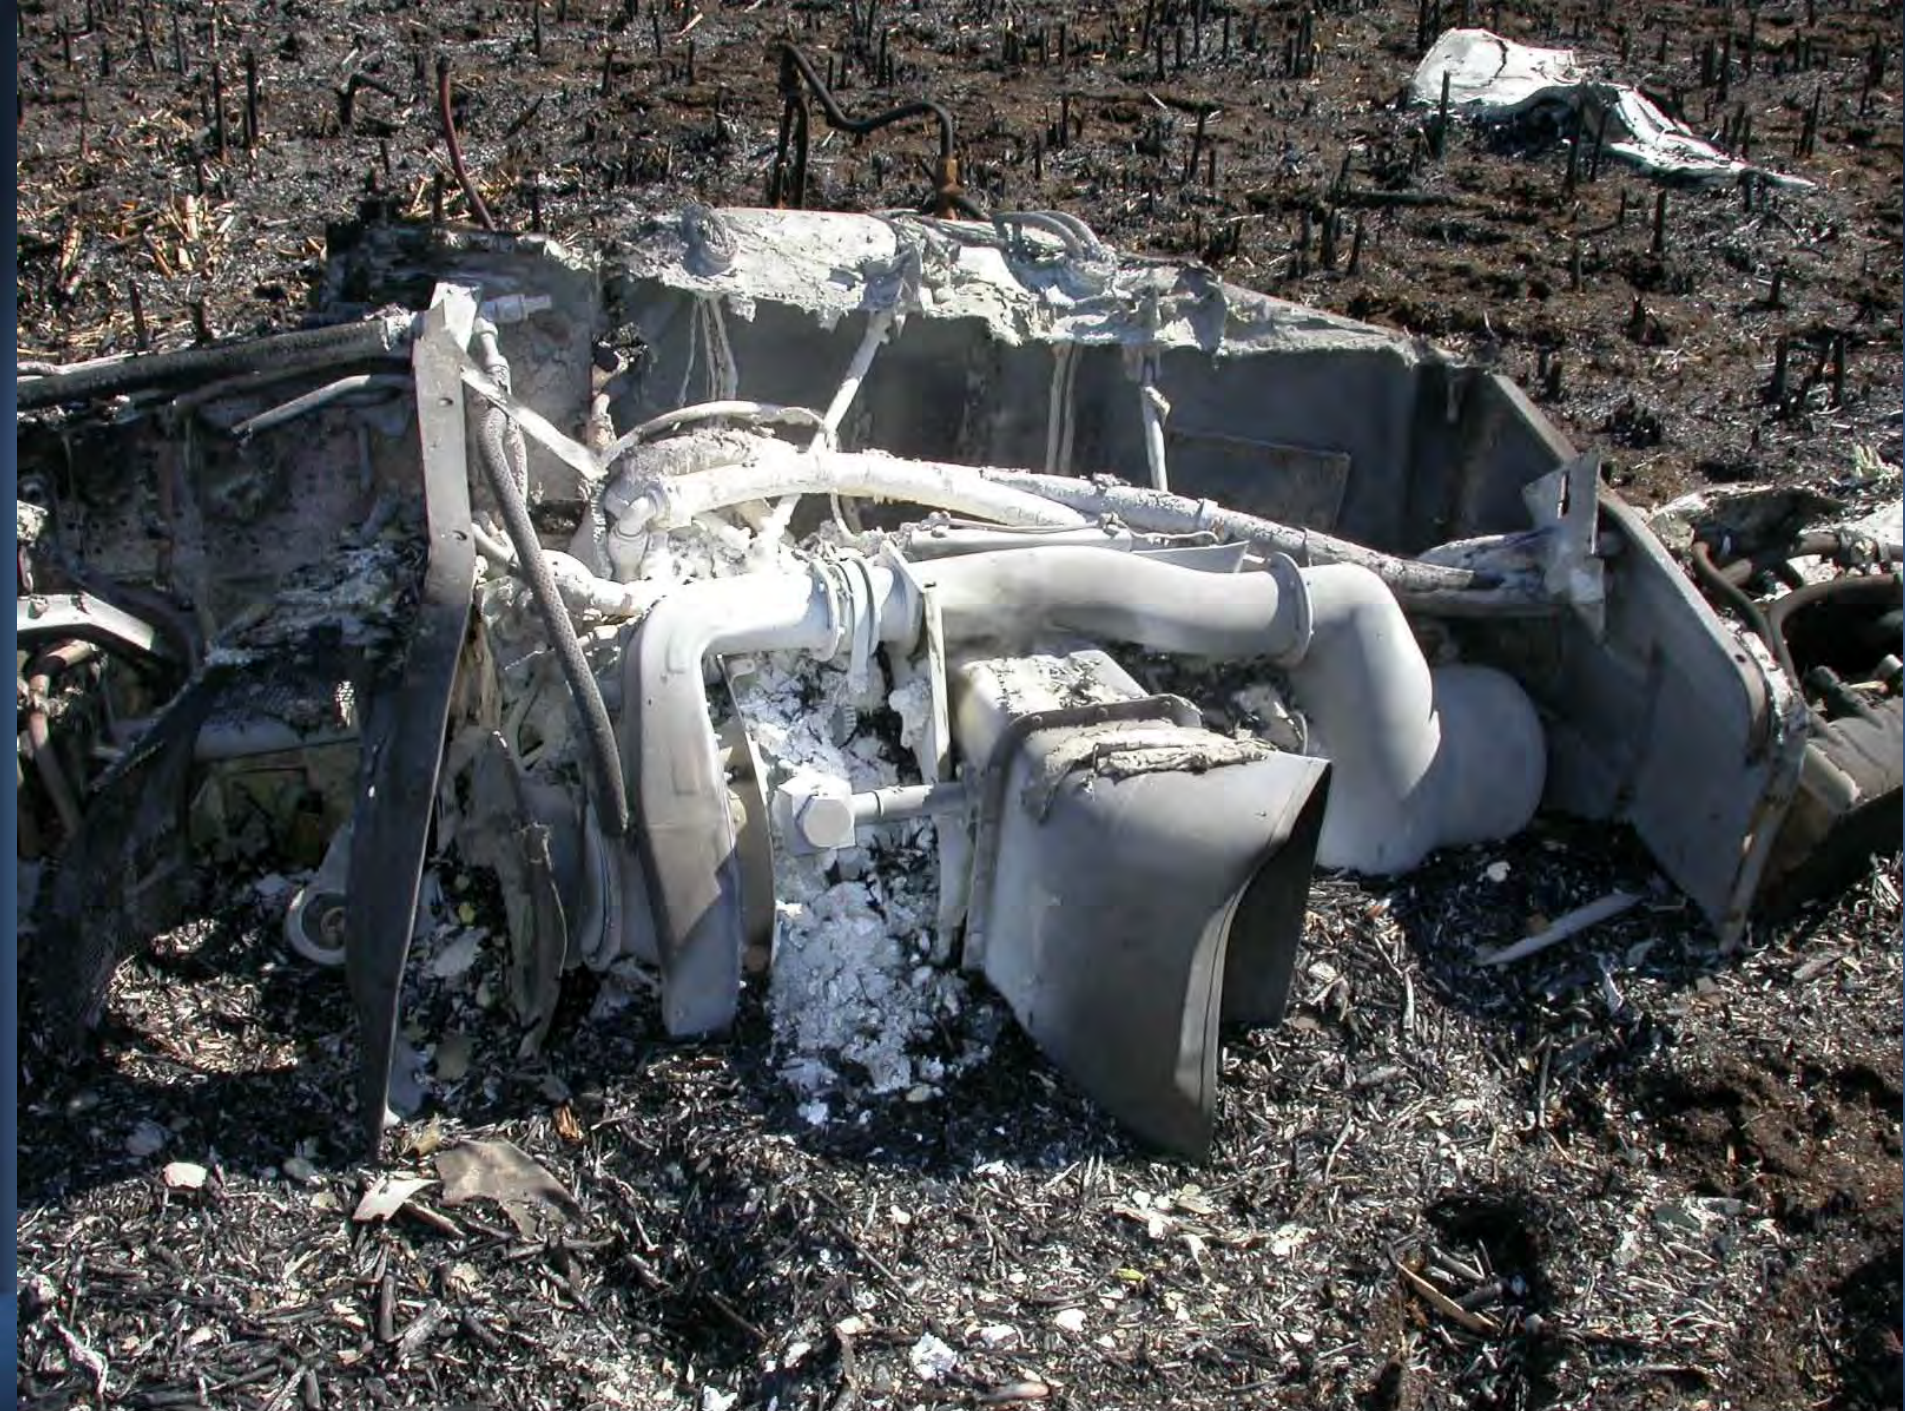
Digital Photo 6, View of engine

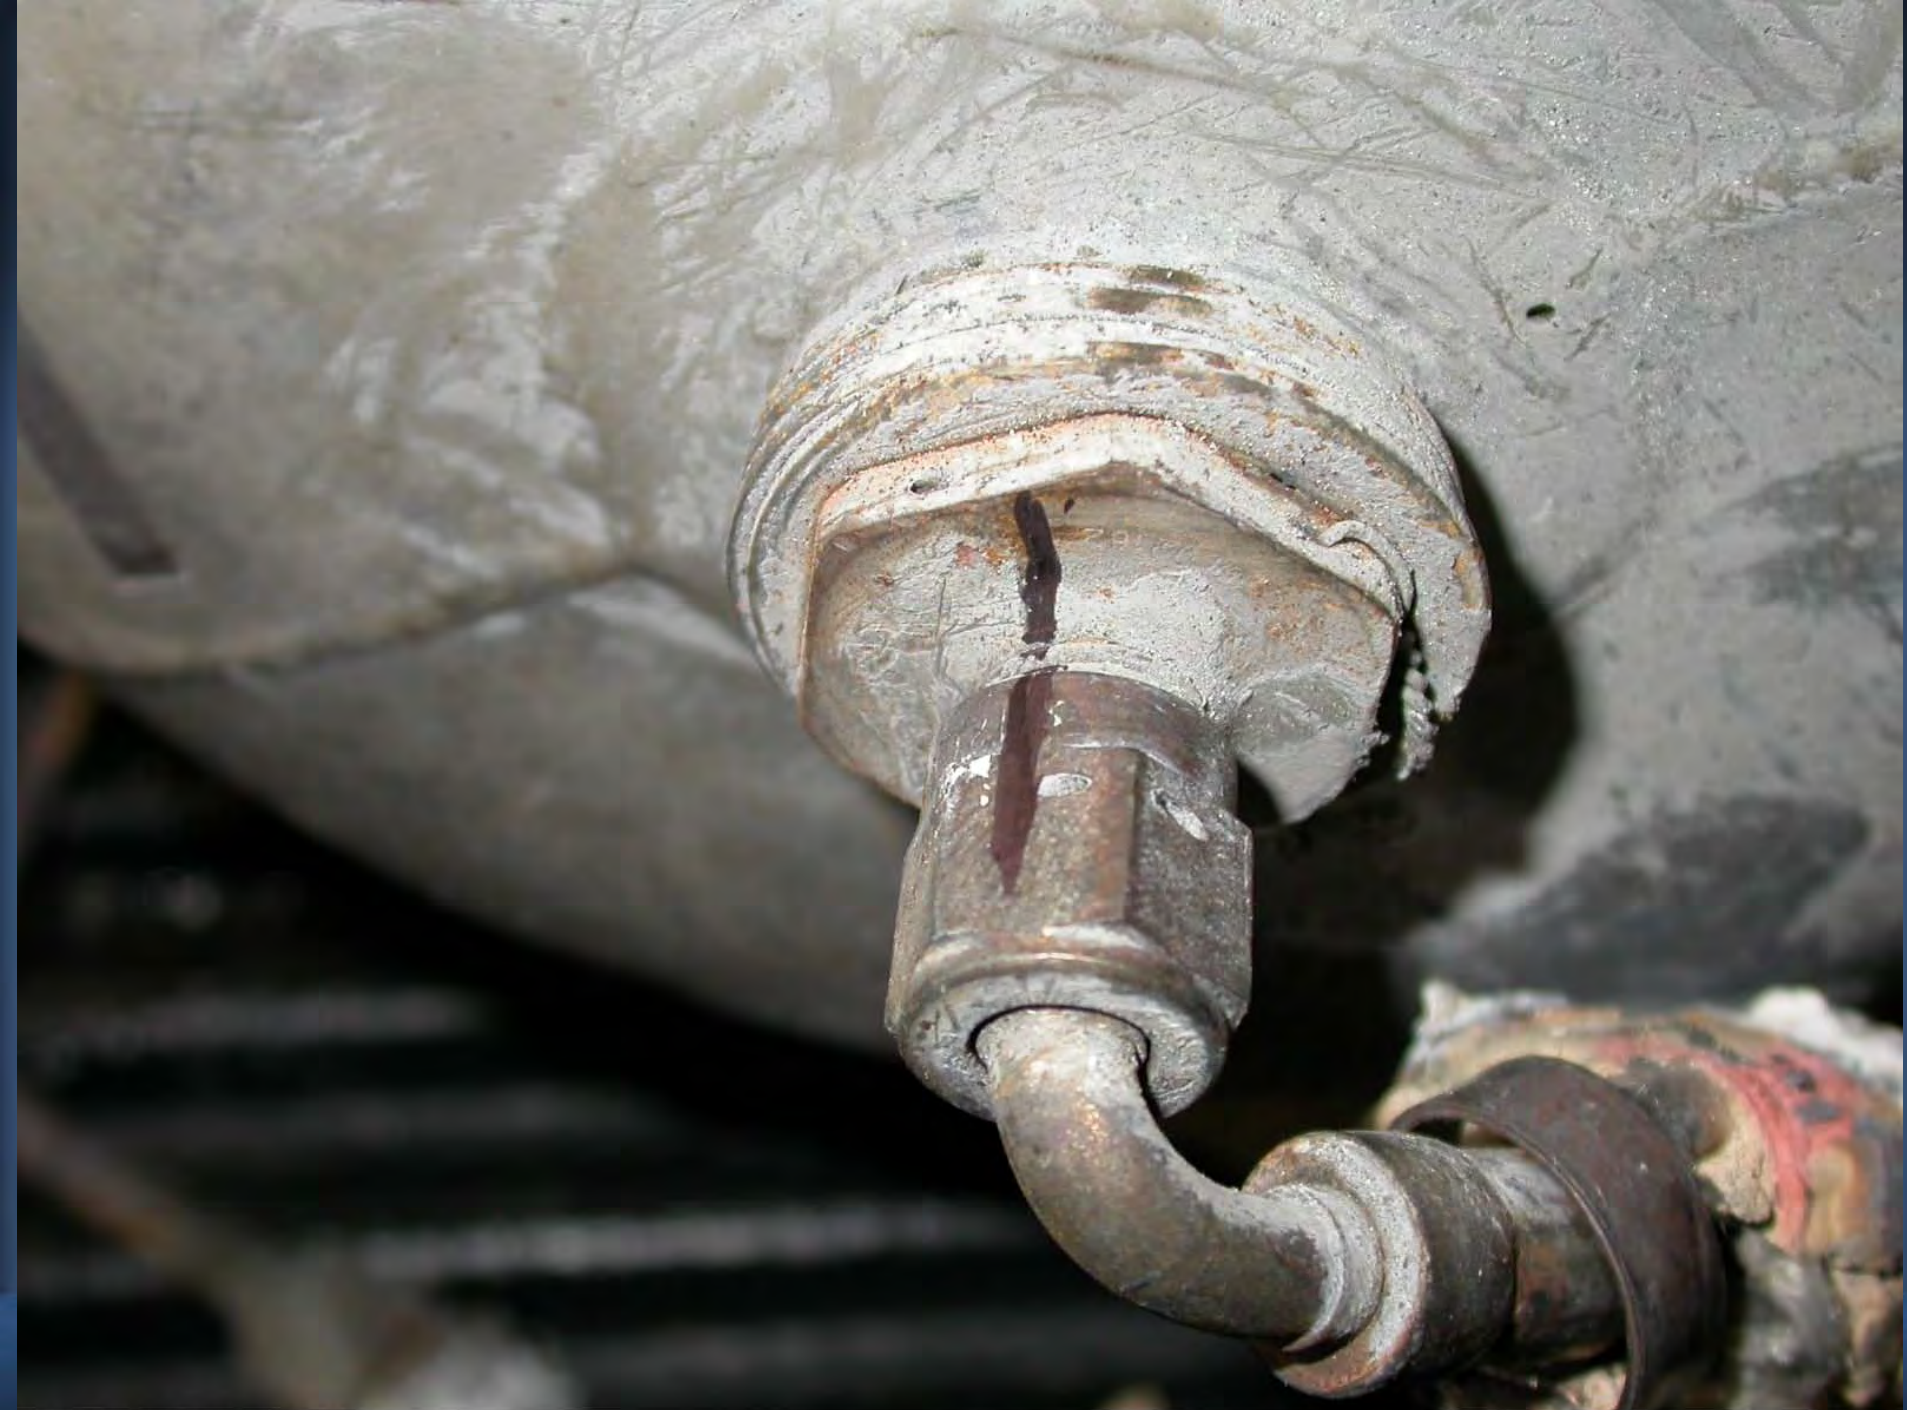
Digital Photo 7, View of Fuel nozzle "B" nut.

- Log entry revealed that a 50-hour fuel nozzle inspection had been performed the night before
- The mechanic reinstalled the fuel nozzle into the engine combustion chamber, “torqued it and lockwired it”
- Engine run-up was not performed
- The inspector stated that he performed a visual inspection of the fuel nozzle installation

- The improper installation of an engine fuel line by maintenance personnel, which resulted in a loss of engine power during cruise flight. Factors associated with the accident are a tailwind, and the lack of a suitable site for a forced landing

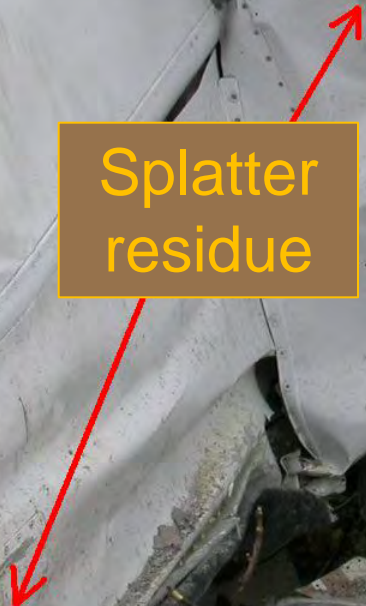
Splatter  
residue
