Central Reporting Agency (CRA) Issues List

Global Operational Data Link (GOLD)

Problem Report Briefing

**FANS Interoperability Team Meeting
(FIT/24)**

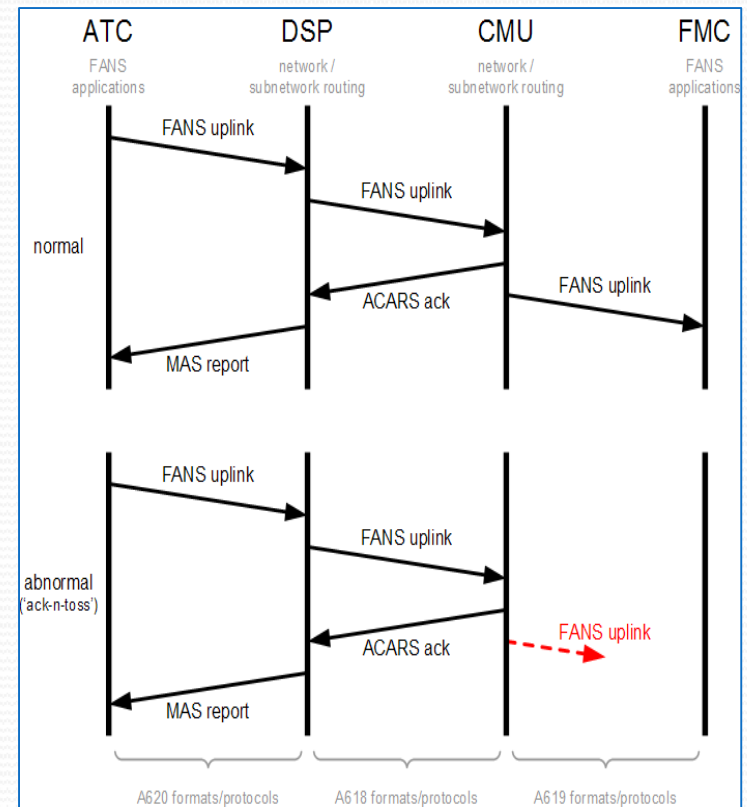
Ack-n-Toss Issues Affecting Boeing Aircraft

- Three behaviors found in DSP log reviews are symptomatic of ack-n-toss:
 1. FMC/FMF responds to CR1 with DR1 after successful logon (CMU ack'd FN_AK)
 2. Flight crew does not respond to uplink
 3. Connection fails to transfer or terminate
- Boeing has received several FANS PRs and DCL OPRs where aircraft exhibit above behavior
