DANGEROUS GOODS PANEL (DGP)

TWENTY-FIFTH MEETING

DANGEROUS GOODS INCIDENT INVOLVING LITHIUM ION BATTERIES

This Information Paper contains details of an incident involving a consignment of lithium ion batteries that were involved in a fire at Heathrow Airport, United Kingdom on 12 August 2015

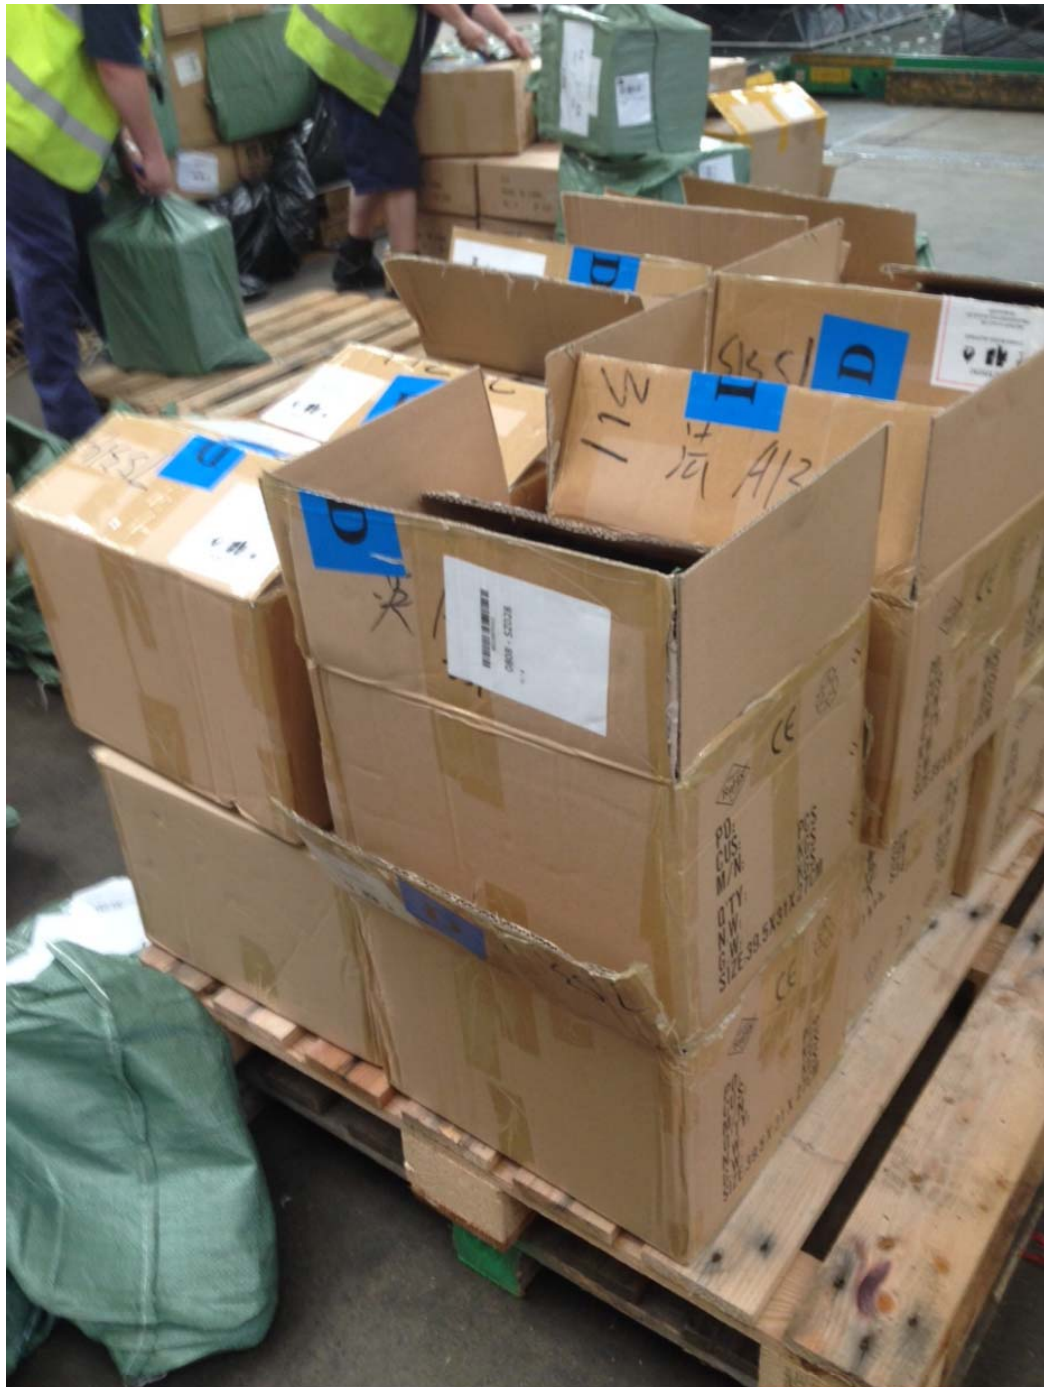
Photograph 1
Photograph showing some of the boxes in the consignment. In the background are further boxes being removed from their green woven bags

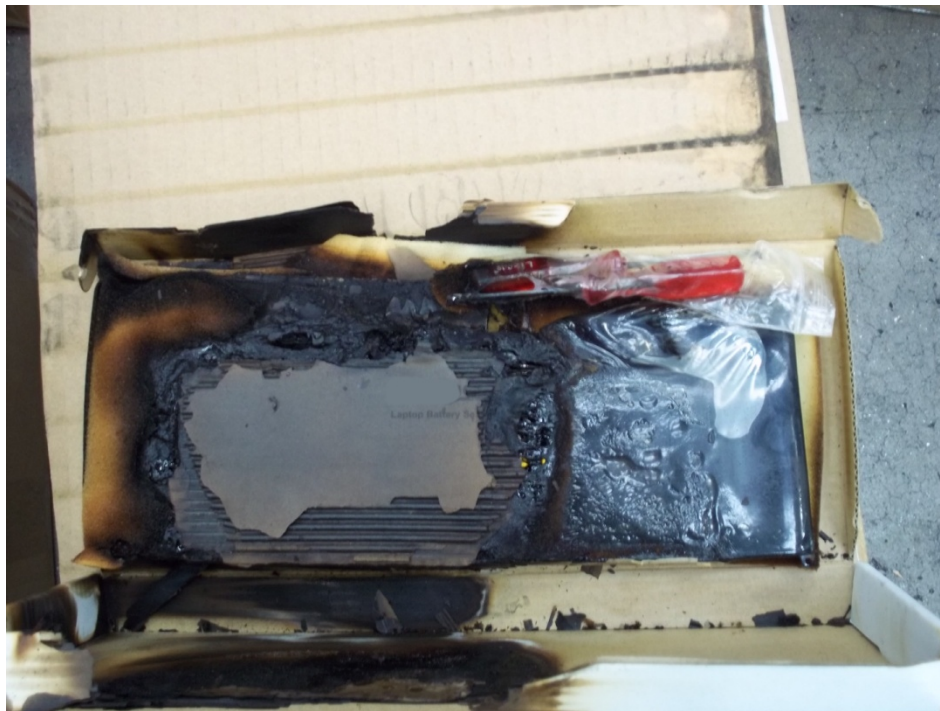
Photograph 2

Photograph of the open carton (lid at bottom of the photograph), showing the general arrangement with two red screwdrivers in separate plastic bag.

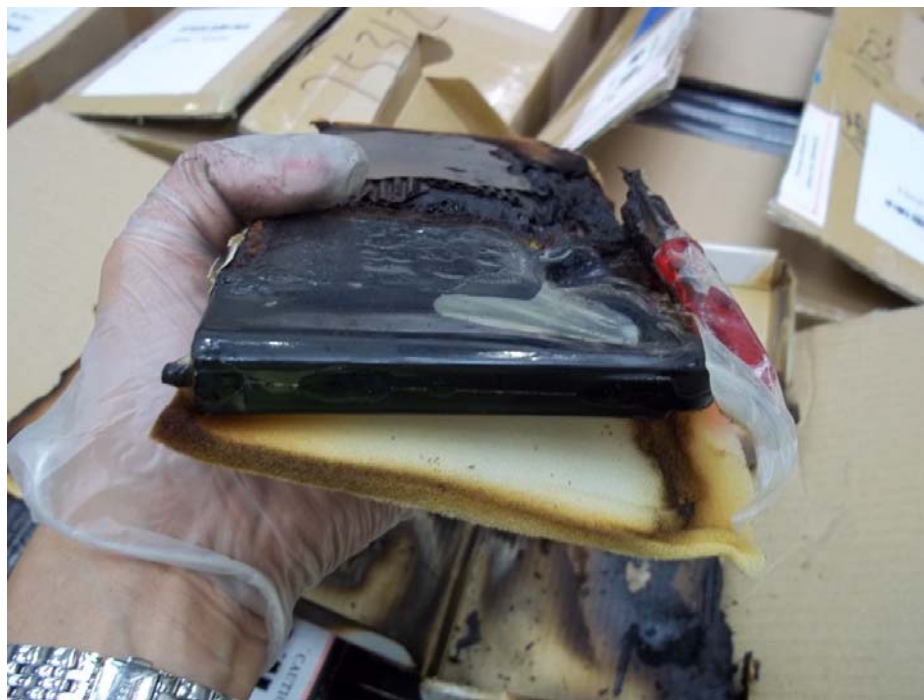
Photograph 3

Photograph showing battery with foam cushioning and screwdrivers

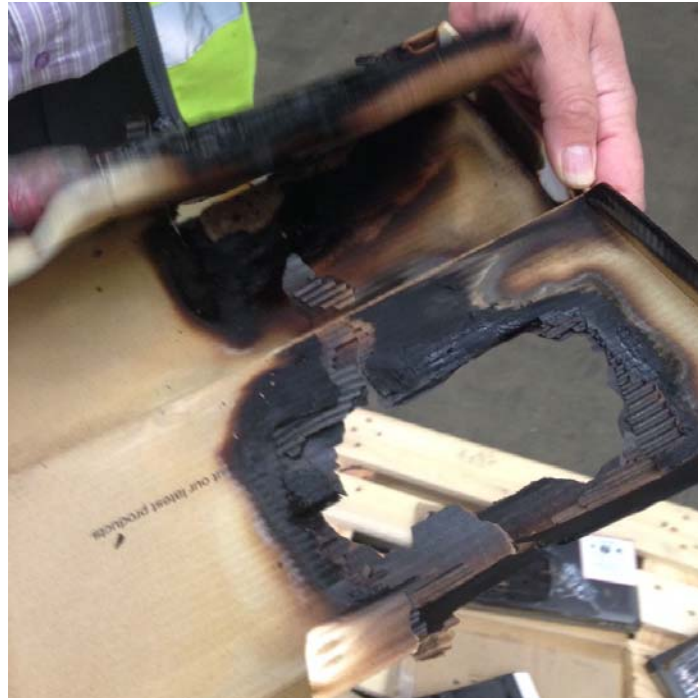
1.3 Upon inspection of the box that emitted smoke, it was found that one of the batteries in one of the cartons had ignited and burnt through one side of the carton. There was scorching on the inside surface of the outer box and to the cartons adjacent to the one that burned, but none of the other batteries within the box appeared to have ignited and the outer surface of the box was not penetrated. It is unlikely that the use of the carbon dioxide fire extinguisher had any effect on the fire and it is likely the fire self-extinguished once the cells within the battery were consumed.

1.9 A video taken from a security surveillance camera in the cargo facility at Heathrow covering the area where the aircraft pallet was broken down was available and showed that the box in question was fairly roughly handled when being placed on the wooden pallet. It is likely that this handling initiated the fire.

- It is likely that the cause of the battery igniting was due to the way in which it was handled, but it is considered that the handling was not such that it would be expected to cause a fire involving a battery that was of a type that passed the required tests.

Photograph 4
Photograph showing burnt carton.

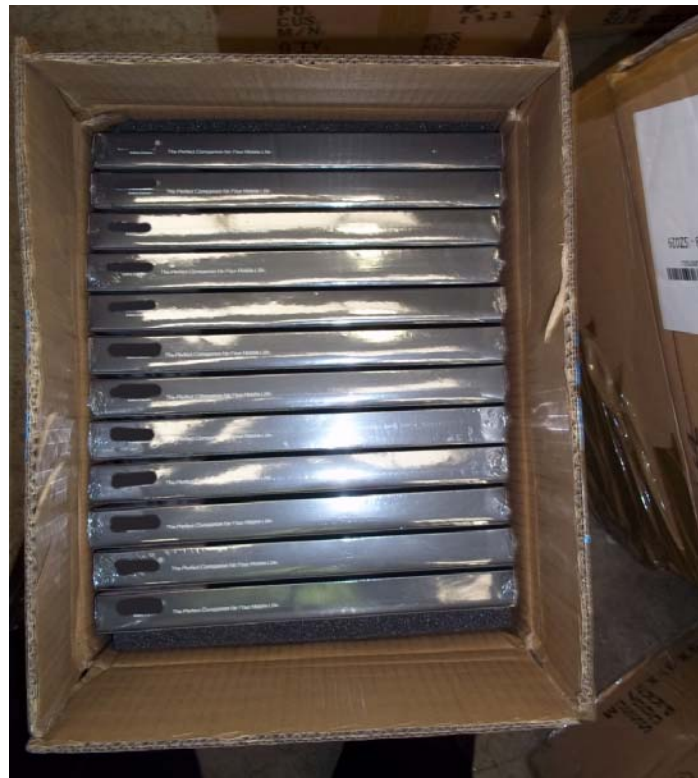
Photograph 5
Photograph showing general arrangement of cartons inside an outer box.

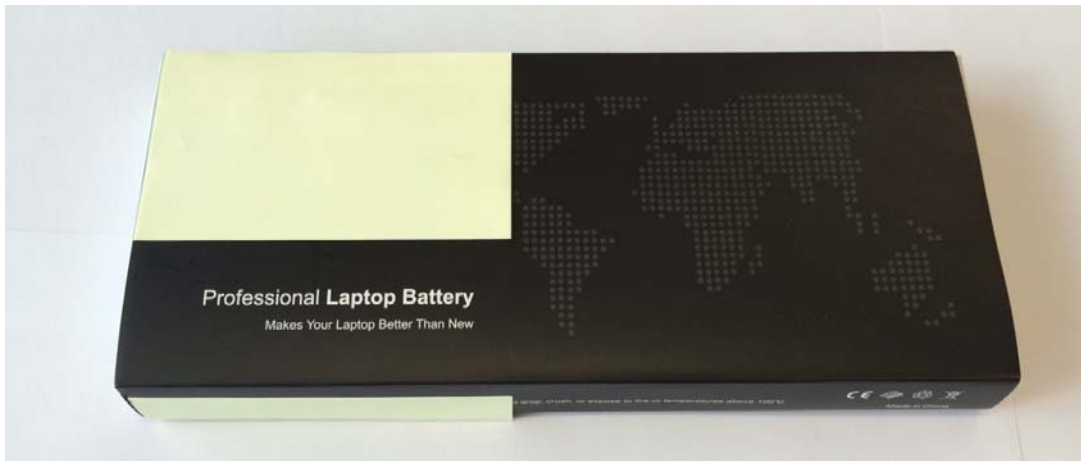
Photograph 6
Photograph of card sleeve around carton

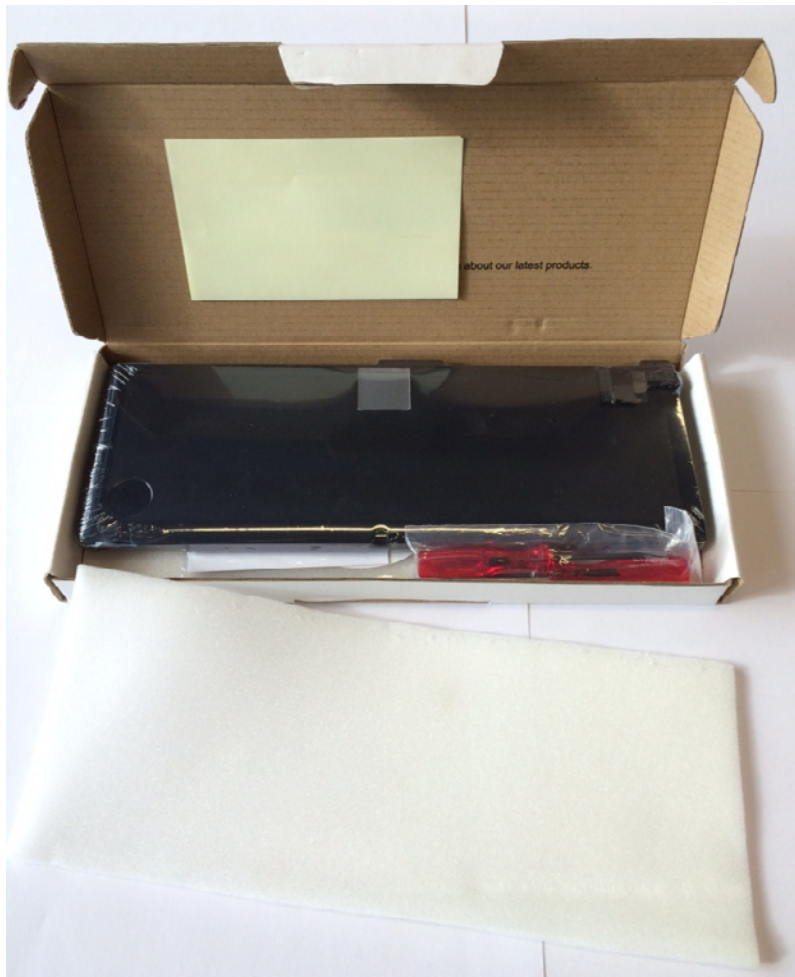
Photograph 7
Photograph of unaffected battery, foam padding (bottom of picture) and screwdrivers in carton
