AUTOMATIC DEPENDENT SURVEILLANCE – BROADCAST SEMINAR AND FOURTEENTH MEETING OF AUTOMATIC DEPENDENT SURVEILLANCE – BROADCAST (ADS-B) STUDY AND IMPLEMENTATION TASK FORCE (ADS-B SITF/14)

Christchurch, New Zealand, 14 – 17 April 2015

## **BOEING 787 ADS-B DEFICIENCY**

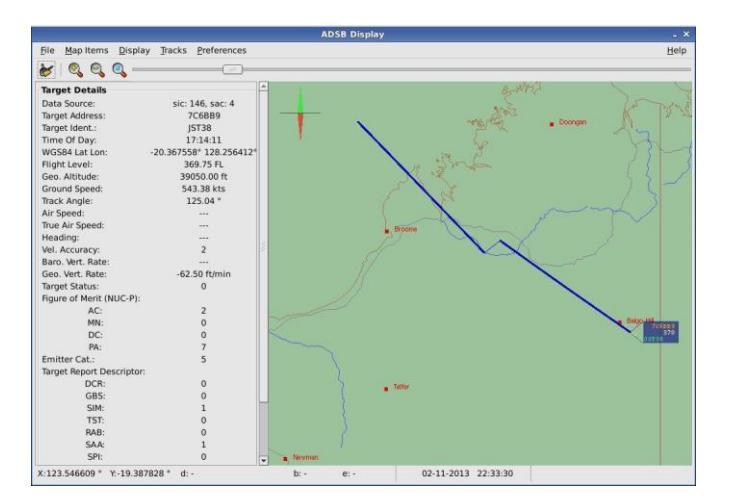
2.1 On 29<sup>th</sup> October 2014, an Australian registered B787 aircraft was observed by ATC to be transmitting inaccurate ADS-B positional data whilst declaring the data as high integrity.

2.2 In this case, following a heading change, the ADS-B data appeared to be extrapolated along the previous heading until it auto-corrected. The correction was observed as a "jump" shown below. The aircraft is flying from the north-west towards the south-east.

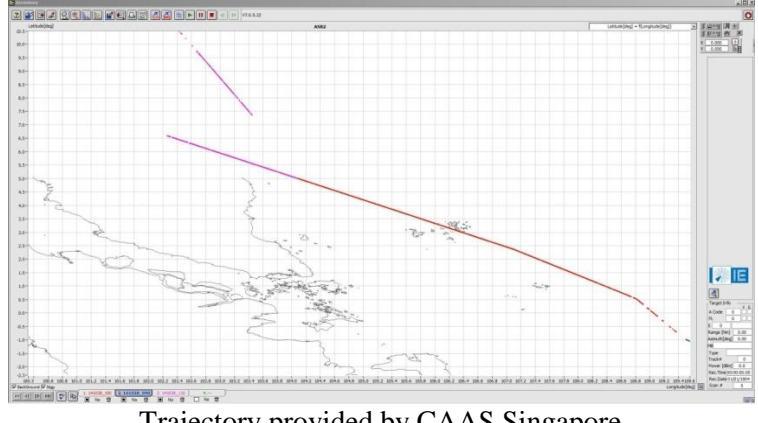
Trajectory provided by CAAS Singapore

Airservices subsequently became aware of similar incidents, both for this particular 2.6 aircraft, and for other B787 aircraft operating internationally including Singapore, USA, Canada and Europe. Data was collected from a number of Asia Pacific ANSPs supporting the investigation.

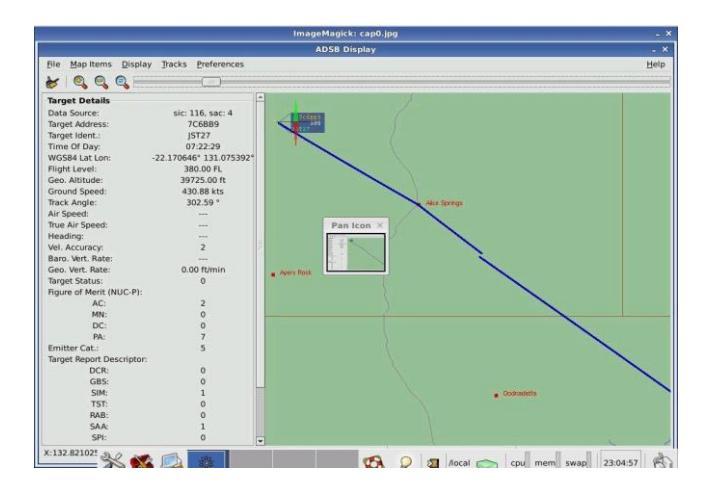
2.7 Investigation of historical data of B787 aircraft was undertaken by Airservices Australia and additional "jumps" from the same B787 aircraft were identified.
