White list to Black List Plan by Australia

Greg Dunstone

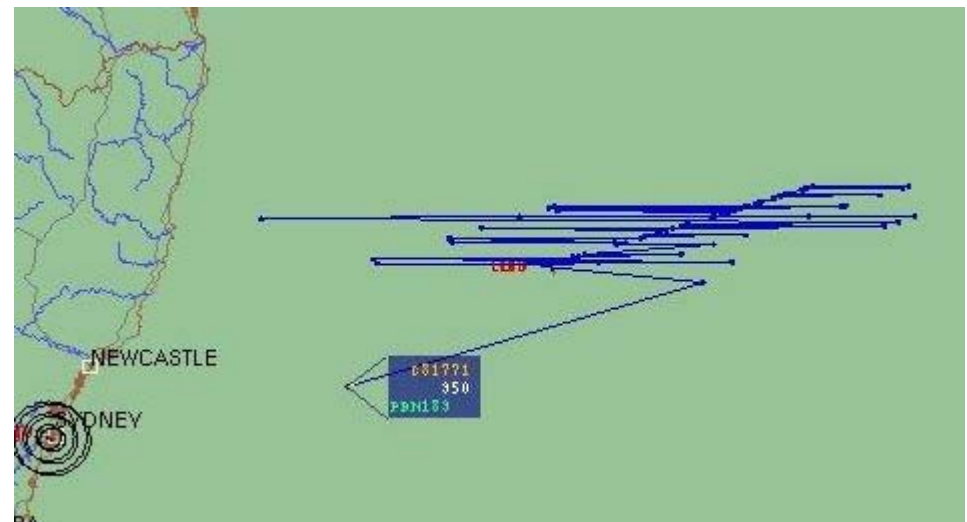
Rockwell TPR Problem (43 airframes)

- Wild positional jumps
- Detected on APPROVED aircraft
- Misleading data – must be corrected
- Large percentage NUC=0 (not displayed)
- Obvious and annoying problem
- Fix available
- Black list will be used if not fixed.
- United (now fixed), Delta, Korean, Pacific Blue, VirginAustralia (B777)

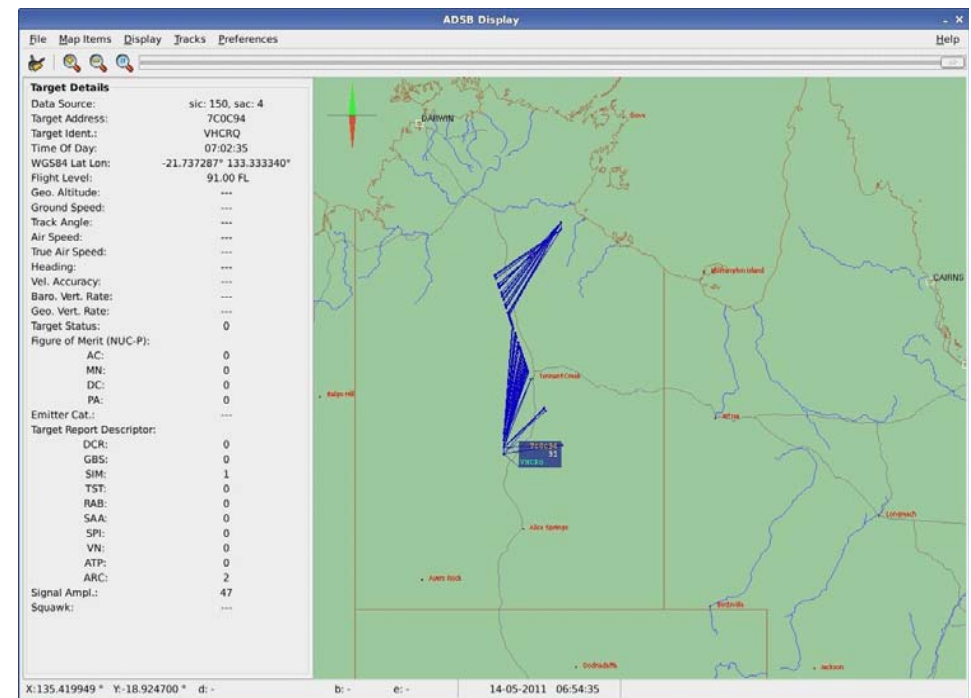
Rockwell Collins TDR94 Old version

- Software version before -108
- Not APPROVED (transmission contrary to Regs)
- Misleading data – must be disabled
- Large percentage NUC=0 (not displayed)
- Obvious and annoying problem
- Fix available – disable or upgrade.
See Service Information Letter 1-05 July 19, 2005
- Black list will be used if not fixed.
- USA based Gulfstream V biggest offenders
- Could ask CASA for Airworthiness Directive

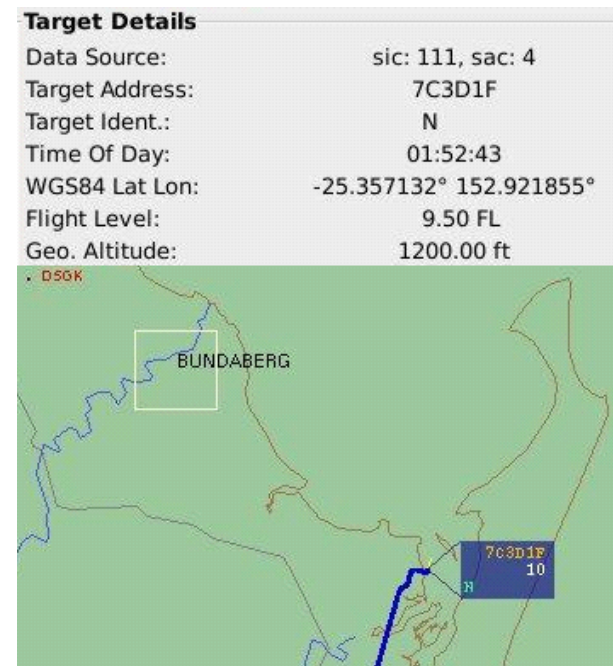
Flight ID Garmin "N" Problem (1 * airframe)

- Incorrect installation procedure.
Reports Flight ID as "N"
- FAA advised
- Obvious and annoying problem
- Easily fixed (Front panel entry)
- Black list will be used if not fixed.

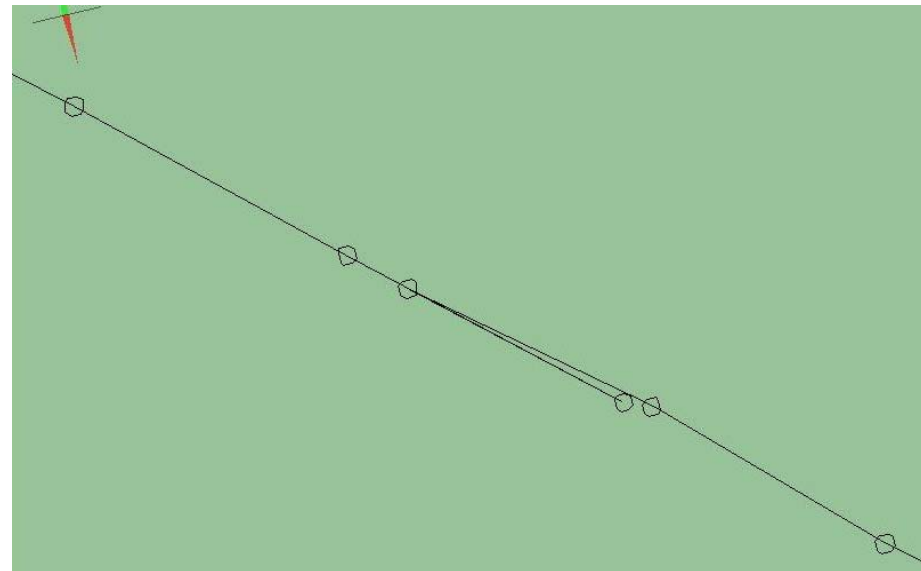
Older Airbus

- Very small position jump backwards
- One in 100 reports
- Size ~0.1 Nautical mile

- Root cause not fully analysed
