**EIGHTEENTH MEETING OF THE COMMUNICATIONS/NAVIGATION
AND SURVEILLANCE SUB-GROUP (CNS SG/18) OF APANPIRG**

**ENHANCING AVIATION SAFETY THROUGH ESTABLISHMENT OF A REGIONAL
ADS-B AVIONICS PROBLEM REPORTING DATABASE (APRD)**

(Presented by Hong Kong China)

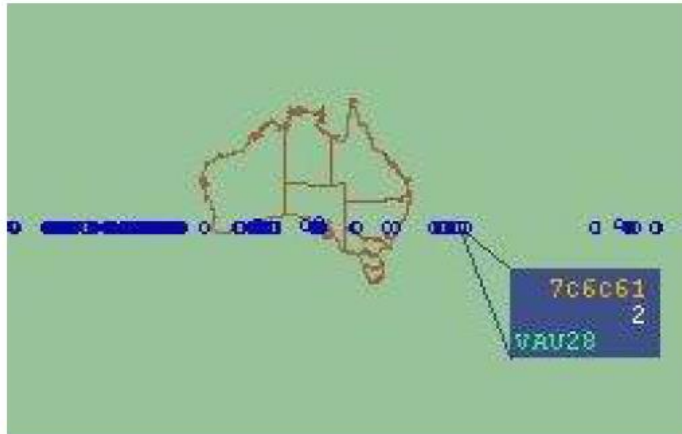
| Ref. | Problem | Cause | Safety Implications to ATC (Yes / No) | Recommendations |
|---|---|---|---|---|
| 1. | Track Jumping problem with Rockwell Collins TPR901 (See Figure1) | <p>Software issue with TPR901 transponder initially only affecting Boeing aircraft. Does not occur in all aircraft with this transponder.</p> <p>Subsequent investigation by Rockwell Collins has found that the particular transponder, common to all of the aircraft where the position jumps had been observed, had an issue when crossing ± 180 degrees longitude.</p> <p>On some crossings (10% probability), errors are introduced into the position longitude before encoding. These errors are not self-correcting and can only be removed by a power reset of the transponder. The problem, once triggered can last days, since many transponders are not routinely powered down.</p> | <p>Yes.</p> <p>Will present as a few wild/large positional jumps. Nearly all reports are tagged as low quality (NUC=0) and are discarded, however, some occasional non zero reports get through.</p> <p>Problem is very “obvious”. Could result in incorrect longitudinal position of Flight Data Record track. Can trigger RAM alerts.</p> | <p>Rockwell Collins has successfully introduced a Service Bulletin that solves the problem in Boeing aircraft.</p> <p>The problem is known to exist on Airbus aircraft. Rockwell has advised that a solution will not be available in the near future because of their commitment to DO260B development.</p> <p>Rockwell Collins may not have a fix for some time. Workaround solutions are being examined by Airbus, Operators and Airservices Australia.</p> <p>The only workaround identified at this time is to power down the transponders before flight to states using ADS-B – after crossing longitude 180. It can be noted that in Airbus aircraft it is not possible to safely power down the transponder in flight.</p> <p>Airbus have prepared a procedure to support power down before flight. Airservices Australia have negotiated with 2 airlines to enact this procedure prior to flights to Australia.</p> |

Figure 1 - Track Jumping problem with TPR901

| Ref. | Problem | Cause | Safety Implications to ATC (Yes / No) | Recommendations |
|---|---|---|---|---|
| | | | | <p>An additional partial workaround is : to ensure that procedures exist for ATC to ask the pilot to changeover transponders if the problem is observed. Since there is a 10% chance of the problem occurring on each crossing of ± 180 degrees longitude, the chance that both transponders being affected is 1%.</p> <p>There is no complete workaround available for flights that operate across 180 degrees longitude directly to destination without replacing the transponder. Airbus advise that a new TPR901 transponder compliant with DO260B will be available in 2014. This new transponder will not exhibit the problem.</p> |

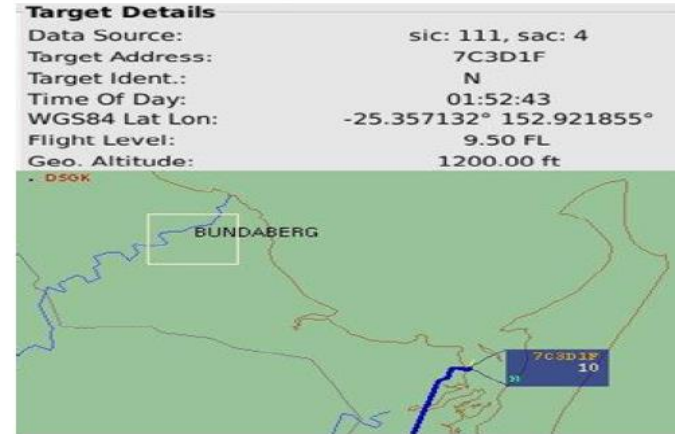
| Ref. | Problem | Cause | Safety Implications to ATC (Yes / No) | Recommendations |
|---|---|---|---|---|
| 5. | Garmin “N” Flight ID problem (See Figure 3) | Installers of Garmin transponder incorrectly set “Callsign”/Flight ID. This is caused by poor human factors and design that assumes that GA aircraft are US registered. | Yes. Flight ID appears as “N”. Inhibits proper coupling. | Can be corrected by installer manipulation of front panel. Does not warrant “black list” activity. |

Figure 3 - Garmin "N" Flight ID problem

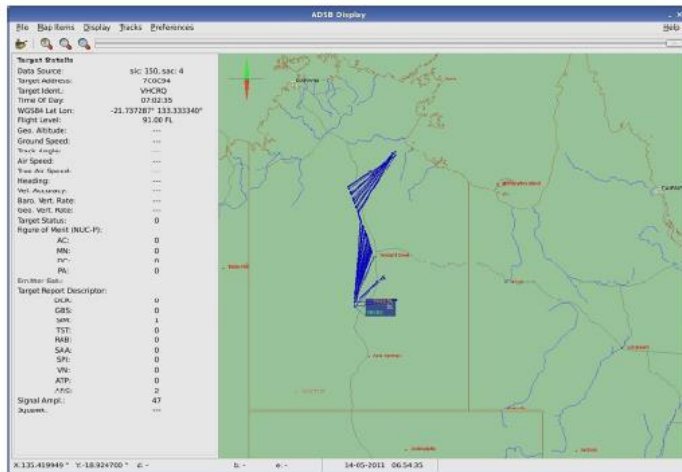
| Ref. | Problem | Cause | Safety Implications to ATC (Yes / No) | Recommendations |
|---|---|---|---|---|
| 2. | <p>Rockwell Collins TDR94 Old version.</p> <p>The pattern of erroneous positional data is very distinctive of the problem. (See Figure 2)</p> | <p>Old software typically before version -108. The design was completed before the ADS-B standards were established and the message definitions are different to the current DO260.</p> <p>Rockwell has recommended that ADS-B be disabled on these models.</p> | <p>Yes.</p> <p>Will present as a few wild positional jumps. Nearly all reports are tagged as low quality (NUC=0) and are discarded, however, some occasional non zero reports get through. Also causes incorrect altitude reports.</p> <p>Problem is very “obvious”.</p> | <p>Problem well known. Particularly affects Gulfstream aircraft which unfortunately leave the factory with ADS-B enabled from this transponder model.</p> <p>Rockwell has issued a service bulletin recommending that ADS-B be disabled for aircraft with this transponder software. See Service Information Letter 1-05 July 19, 2005. It is easy to disable the</p> |

Figure 2 - Rockwell Collins TDR94 Old version. The pattern of erroneous positional data is very distinctive of the problem

| Ref. | Problem | Cause | Safety Implications to ATC (Yes / No) | Recommendations |
|---|---|---|---|---|
| | | | | <p>transmission.</p> <p>If a new case is discovered, an entry needs to be made to the black list until rectification has been effected.</p> |

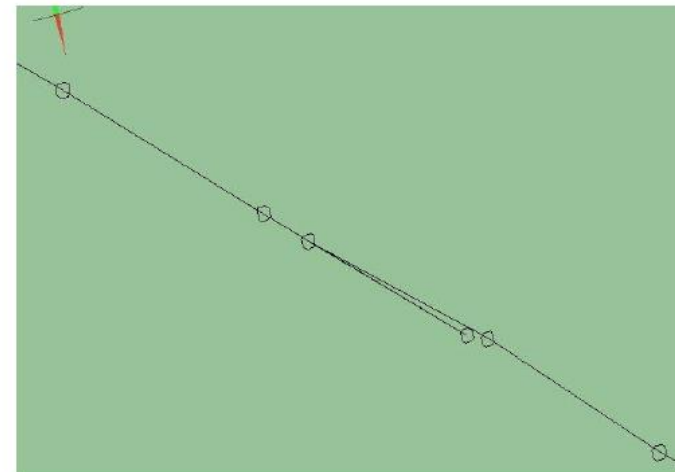
| Ref. | Problem | Cause | Safety Implications to ATC (Yes / No) | Recommendations |
|---|---|---|---|---|
| 10. | Occasional small position jump backwards (See Figure 4) | For some older Airbus aircraft, an occasional report may exhibit a small “jump back” of less than 0.1 nm Root cause not known | No. Not detectable in ATC due to extrapolation, use of latest data and screen ranges used. | ATC ground system processing can eliminate these. |

Figure 4 - Occasional small position jump backwards

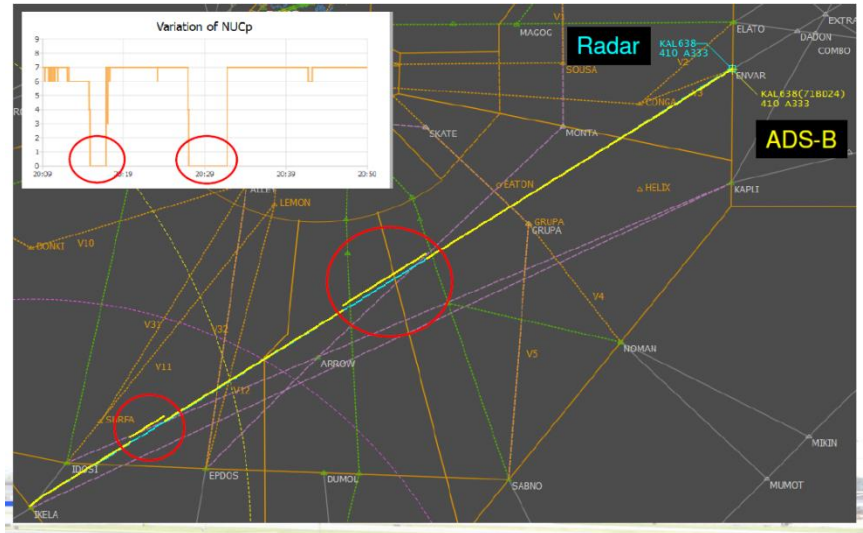
| Ref. | Problem | Cause | Safety Implications to ATC (Yes / No) | Recommendations |
|---|---|---|---|---|
| 14. | Toggling between high and low NUC (See Figure 5) | Faulty GPS receiver/ADS-B transponder | No. ATC will see tracks appear and disappear discretely. No safety implications to ATC. | While it is normal for NUC value to switch between a high and low figure based on the geometry of GPS satellites available, it is of the view that more should be done to examine this phenomenon. It is observed that |

Figure 5 - NUC value toggling

| Ref. | Problem | Cause | Safety Implications to ATC (Yes / No) | Recommendations |
|---|---|---|---|---|
| | | | | <p>such switching between high and low NUC occurs on certain airframe and not on others. The issue was raised to the airlines so as to get a better understanding. On one occasion, the airline replied that a module on their GPS receiver was faulty. On another occasion, the airline replied that one of the ADS-B transponder was faulty. Good NUC was transmitted when the working transponder was in use and poor NUC was transmitted when the faulty ADS-B transponder was in use.</p> |

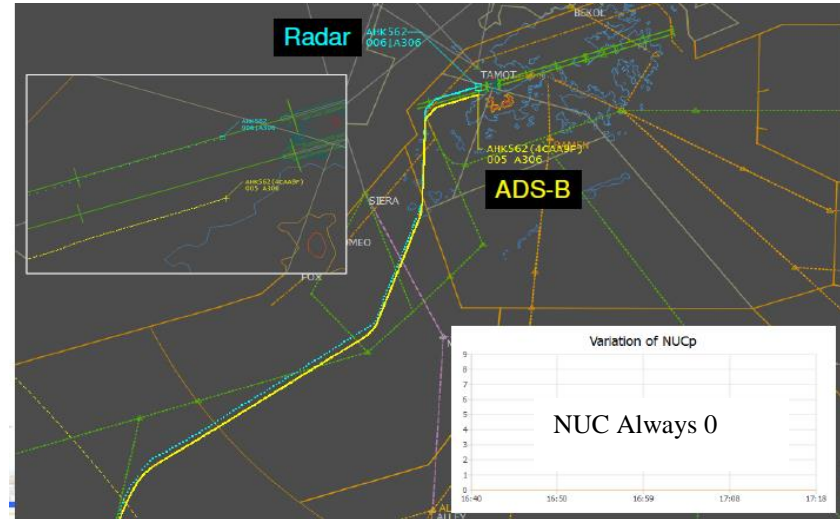
| Ref. | Problem | Cause | Safety Implications to ATC (Yes / No) | Recommendations |
|---|---|---|---|---|
| 15. | Consistent Low NUC (See Figure 6) | GNSS receivers are not connected to the ADS-B transponders. | <p>No.</p> <p>Data shall be filtered out by the system and not detectable in ATC</p> | <p>Not considered a problem but a common phenomenon in the Region – the concerned aircraft will be treated equivalent to “aircraft not equipped with ADS-B”.</p> <p>While it is normal for aircraft to transmit low NUC, it is of the view that “consistent low NUC” could be due to the avionics problem (e.g. GNSS receiver is not connected to the ADS-B transponder).</p> <p>Concerned airline operators are required to take early remedial actions. Otherwise, their aircraft will be treated as if non-ADS-B equipped which will be requested to fly outside</p> |

Figure 6 – Consistent low NUC

| Ref. | Problem | Cause | Safety Implications to ATC (Yes / No) | Recommendations |
|---|---|---|---|---|
| | | | | the ADS-B airspace after the ADS-B mandate becomes effective. |

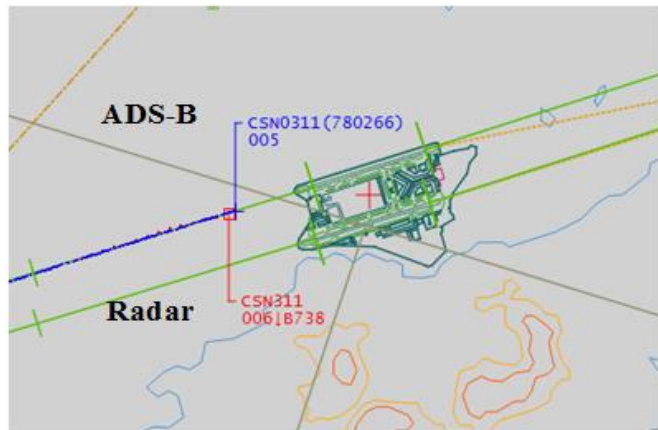
| Ref. | Problem | Cause | Safety Implications to ATC (Yes / No) | Recommendations |
|---|---|---|---|---|
| 17. | FLTID transmitted by ADS-B aircraft does not match with callsign in flight plan (see Figures 7a – 7d) | Human errors | Yes. Could lead to screen clutter - two target labels with different IDs (one for radar and another for ADS-B) being displayed, causing potential confusion and safety implications to ATC. | Issue regulations/letters to concerned operators urging them to set FLTID exactly match with callsign in flight plan. |

Figure 7a - Additional zero inserted

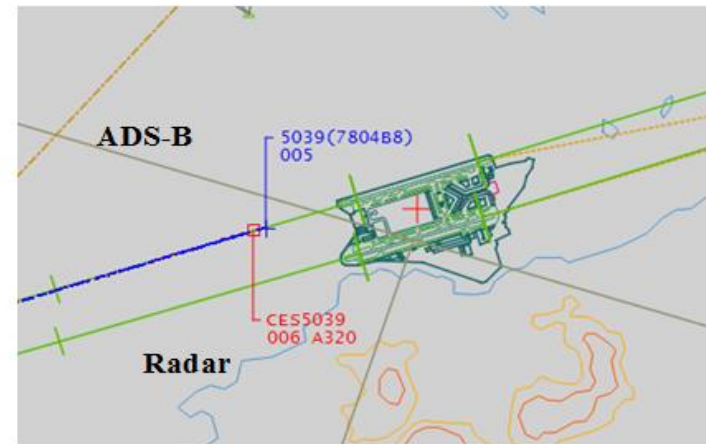
Figure 7b - ICAO Airline Designator Code dropped

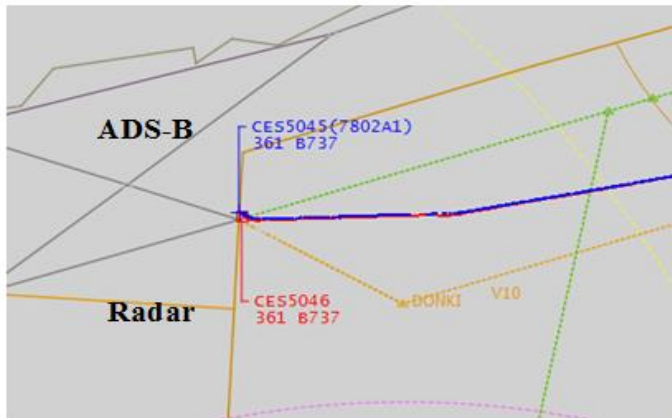
Figure 7c - Wrong numerical codes entered

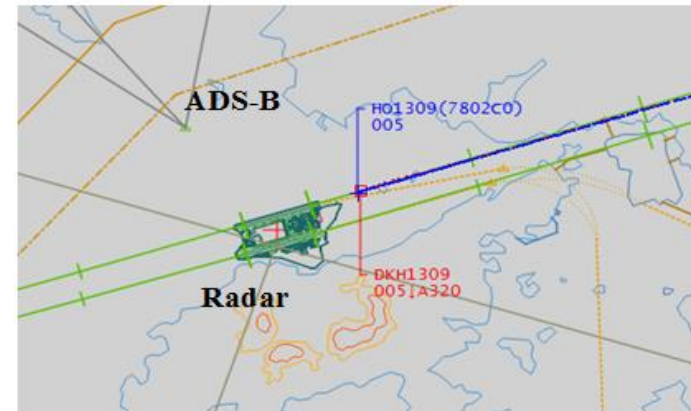
Figure 7d - IATA Airline Designator Code used
