**DEPARTMENT OF AIR ACCIDENT
INVESTIGATION**

Airplane Upset Recovery

Kenya Airways Flight 507 in Cameroon

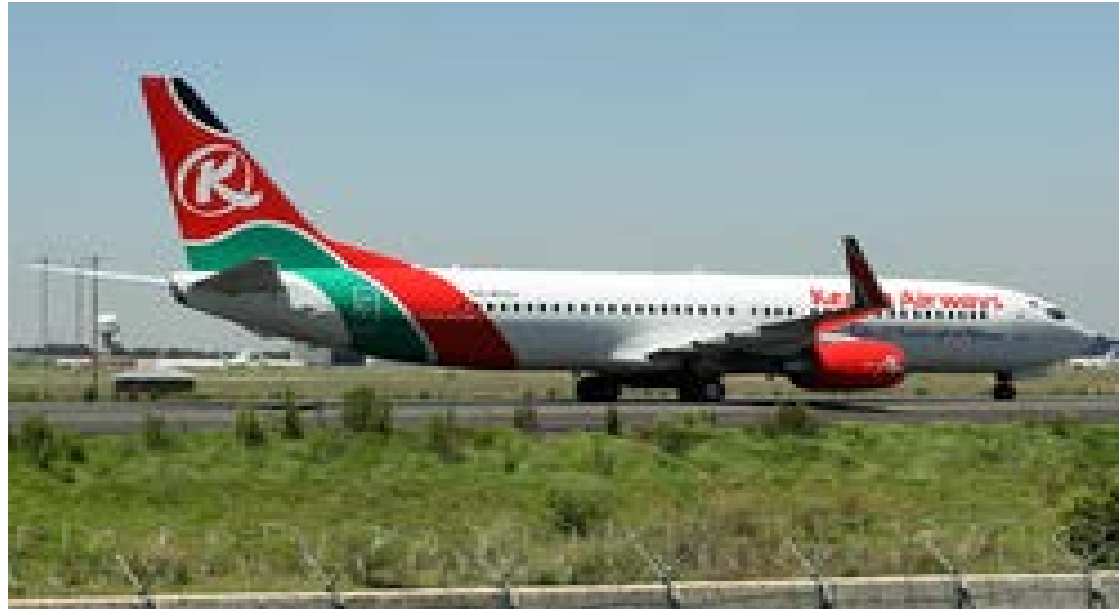
The aircraft involved in the accident is seen here at [OR Tambo International Airport](#) in January 2007.

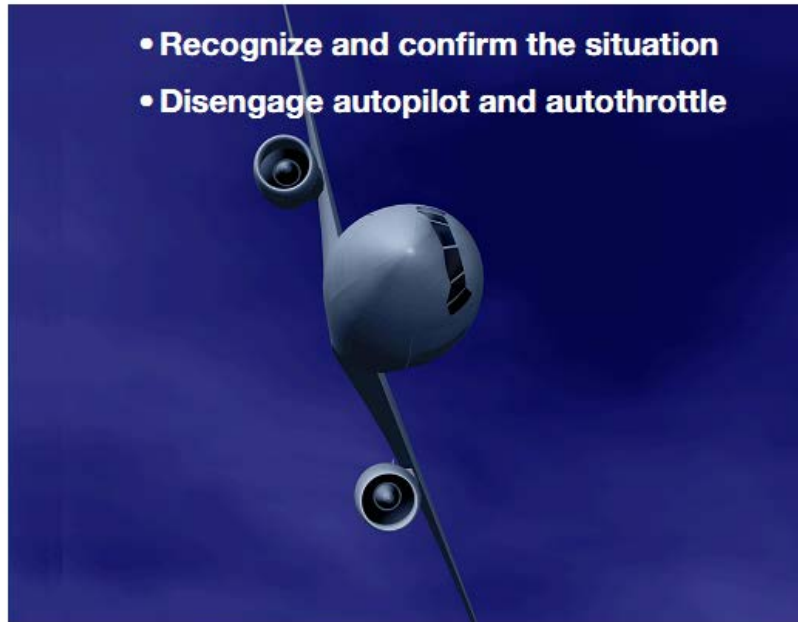
Figure 3-B.75

- Recognize and confirm the situation
- Disengage autopilot and autothrottle
