COMSOFT's TMG30 Presentation

- Agenda Item 3.1 (Final Status of MEVA III Matters)

Switch to Final Carrier Configuration

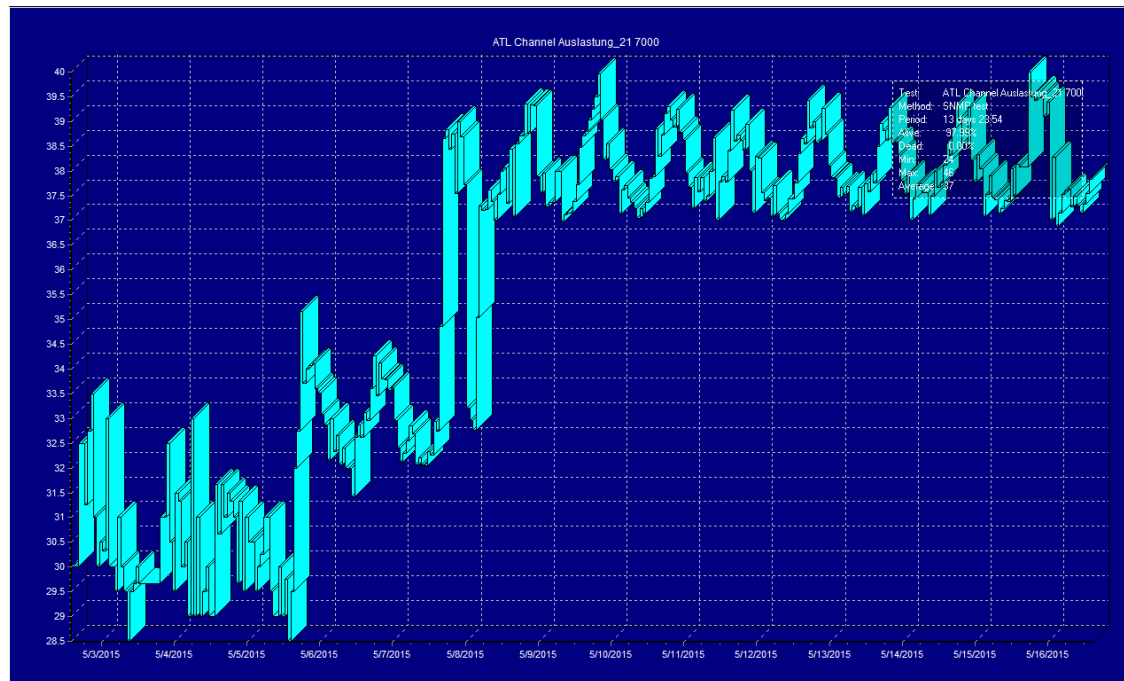
As of mid May 2015 the average network load is at 40% (Graph view May 3rd to May 16th).
Long term estimation is at 80% average load (incl. Mexico).
