Ground Collision Occurrence Yangon International Airport

On 12 February 2015

Mr. Myo Thant (MAIB)

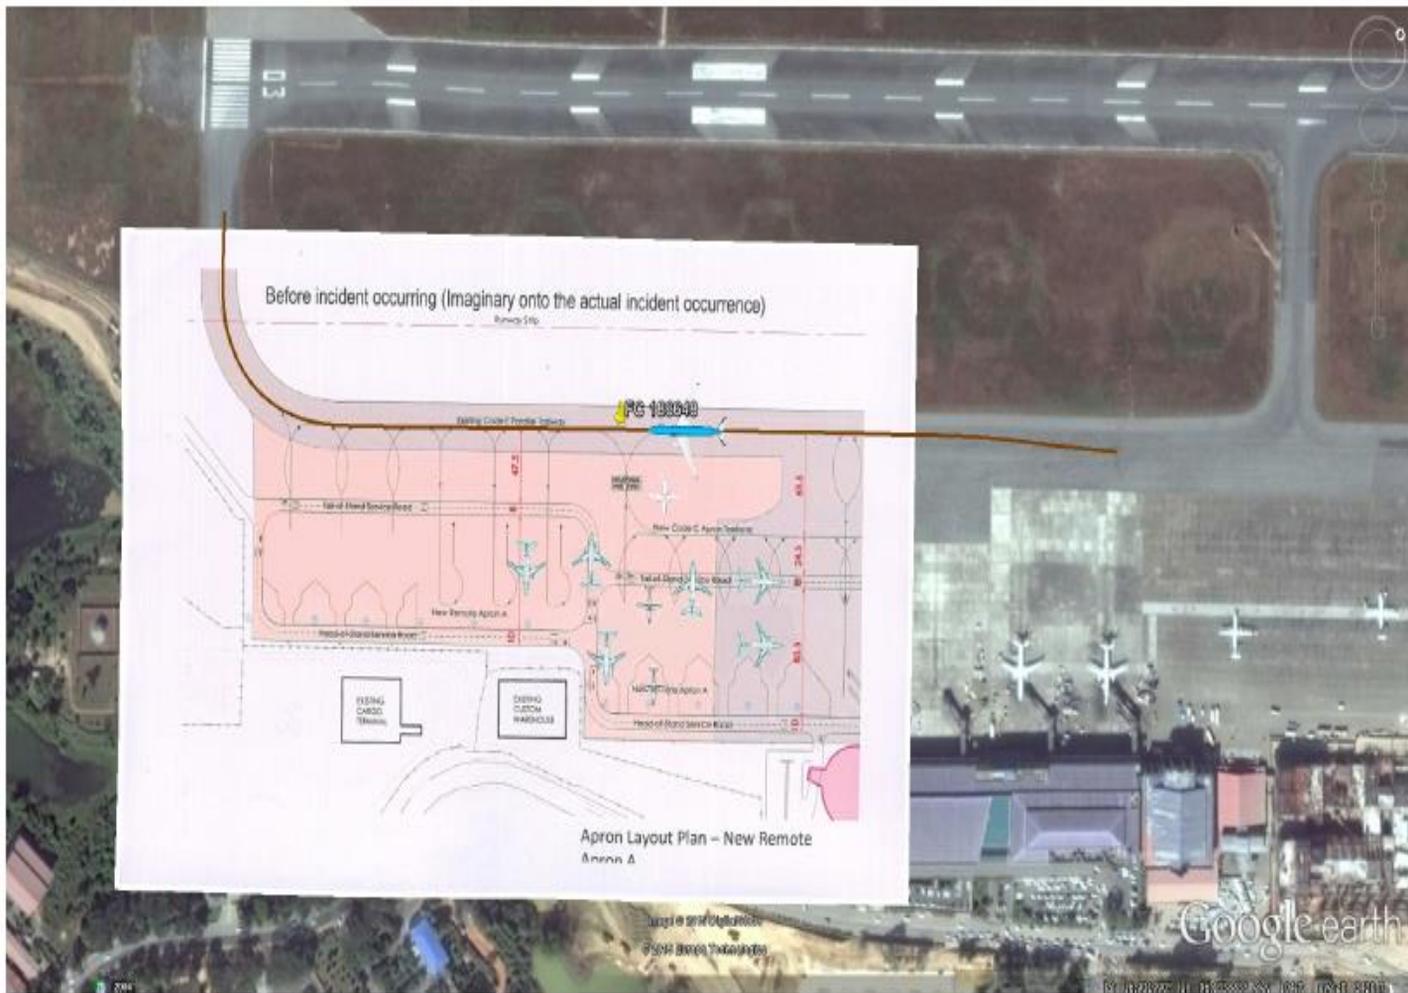
On 12th Feb 2015, 23:55 Local time, Korean Air, Airbus A.330-200 (HL- 7538) taxi out along the taxiway for take-off from Runway 03 of Yangon International Airport. The aircraft ground collision with left wingtip to the Bangkok Air, ATR-72-500 (HS- PGA) empennage which already park on the Apron A.

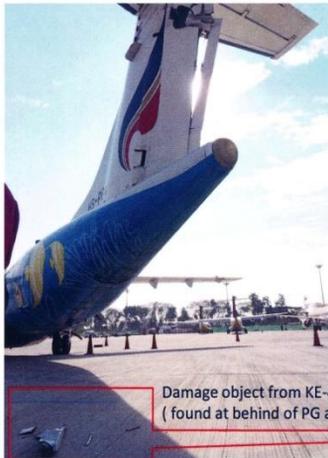
Damage object from KE-471
(found at behind of PG aircraft)

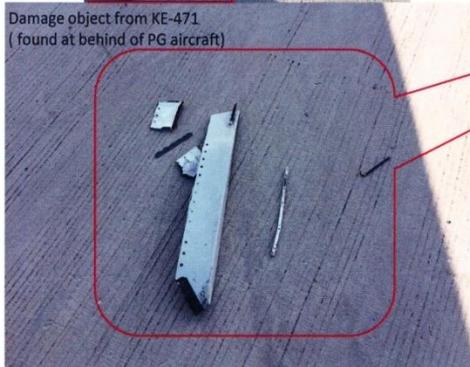
Damage object from KE-471
(found at behind of PG aircraft)

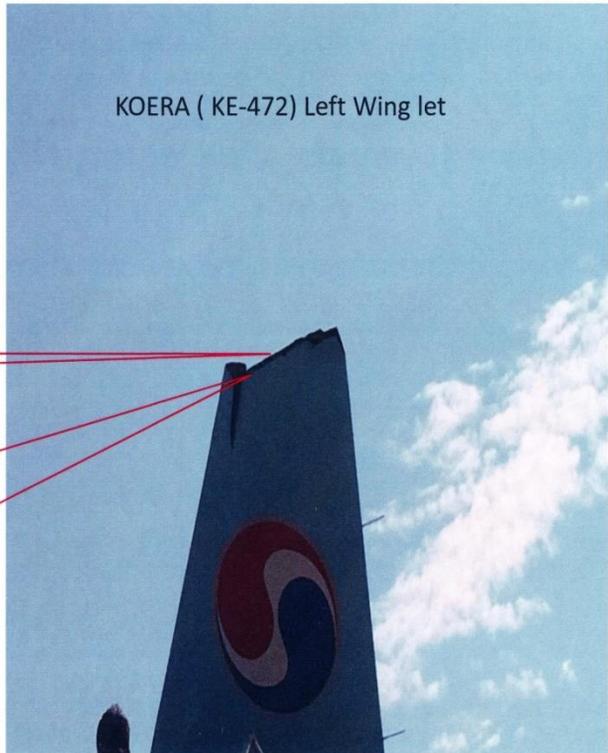
Damaged Wing let of KE-472 at Incident occurring area

KOERA (KE-472) Left Wing let

Damage of Korean Airway.

A-330-200 (HL-7538).

L/H wingtip let damage.

(Minor repair).

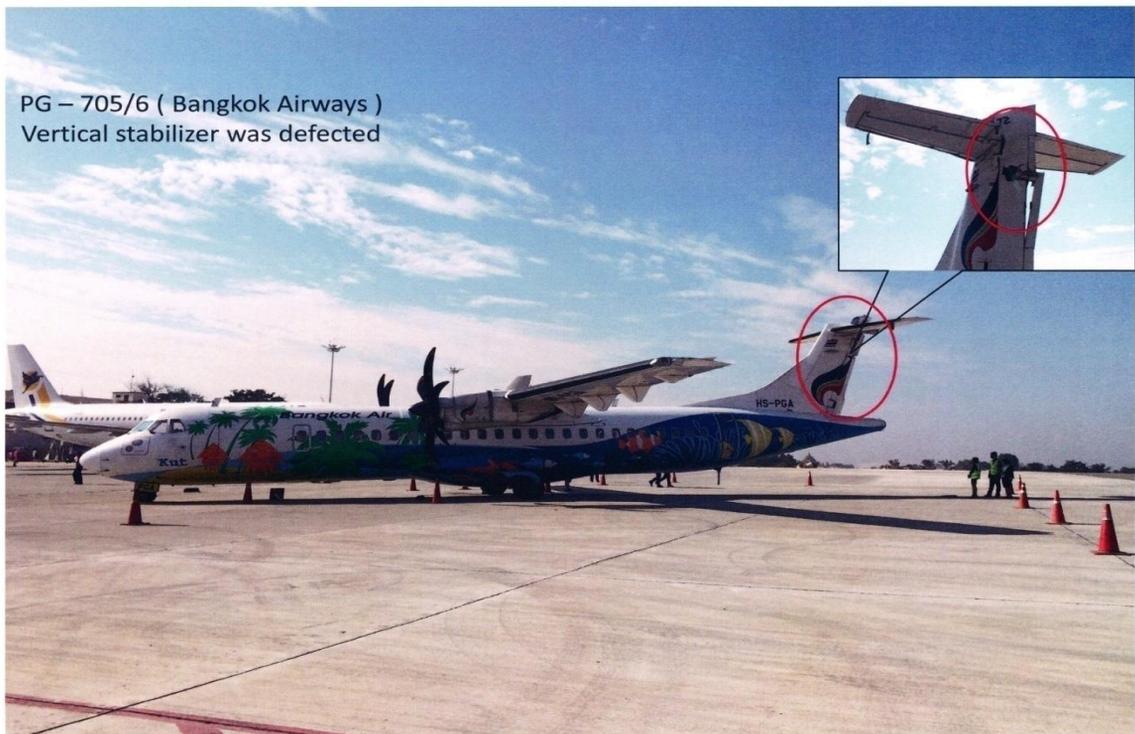
Damage of Bangkok Airways

ATR.72- 500 (HS- PGA)

- Horizontal stabilizer, leading edge.
- Vertical stabilizer trailing edge.
- Rudder damage
(sustains damage)

According to Annex.13 definition
damage accident.

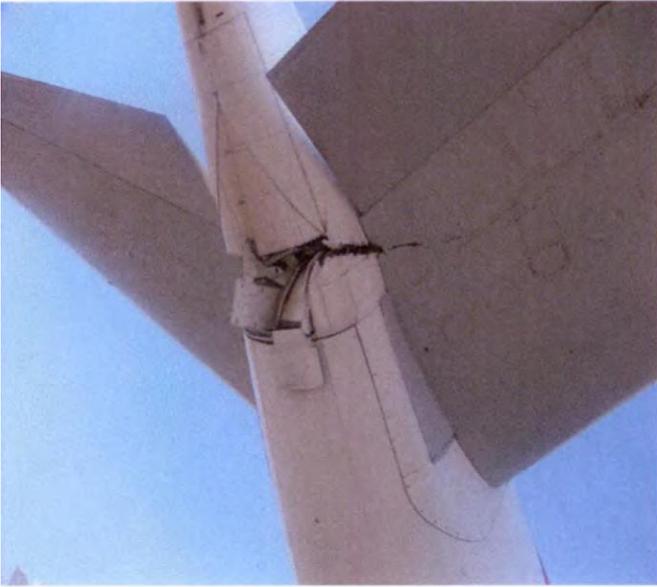
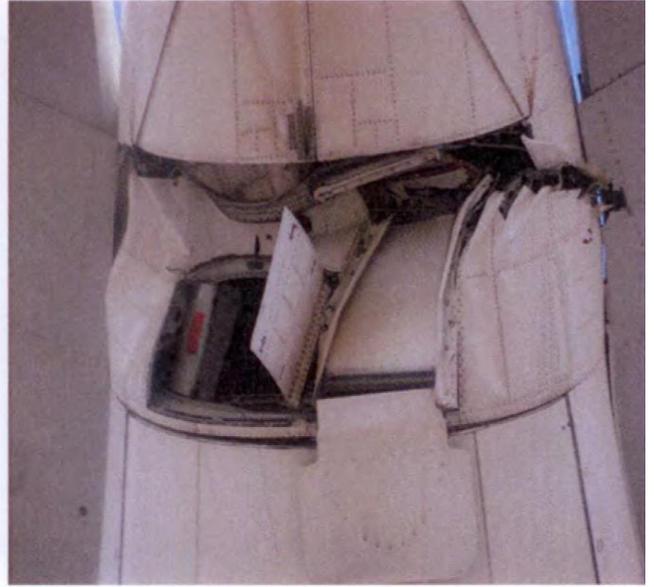
- **Damage to Aircraft**

A- 345 was substantially damaged and A- 332 was slightly damaged.

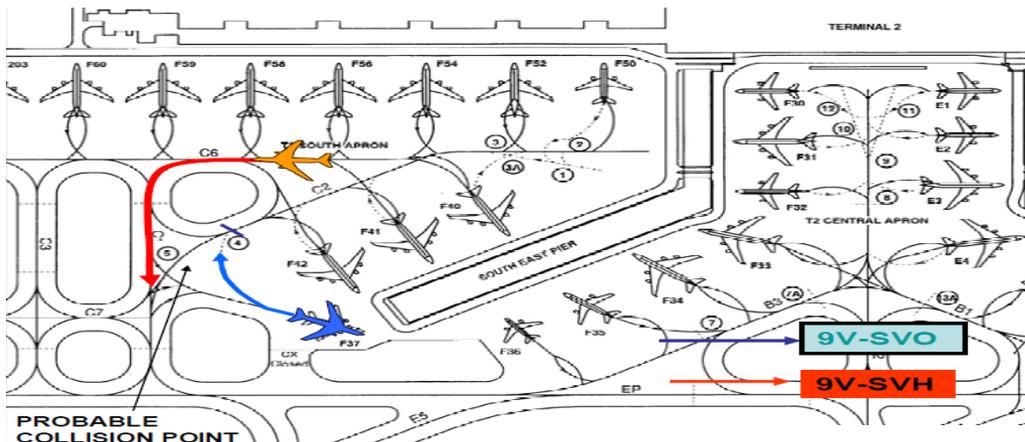
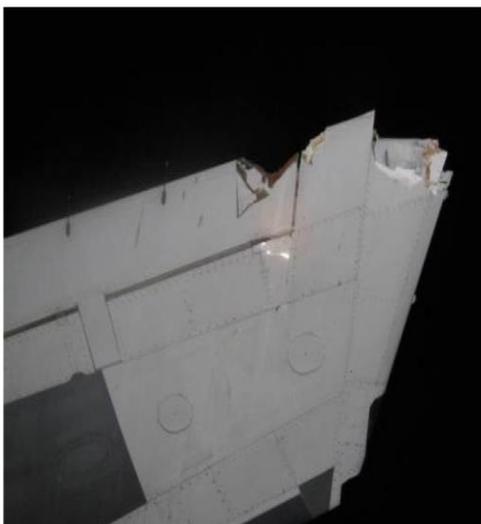
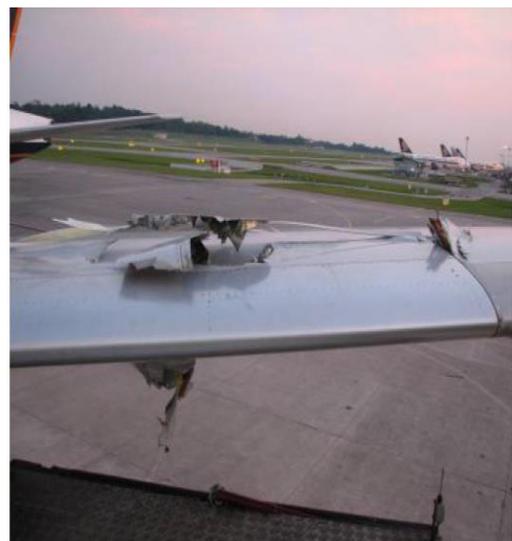
Damage of Aircraft

Boeing 777-200 ER (9V- SVH)

The left hand wingtips; leading edge slat, wing fiberglass panels were damaged.

Boeing 777- 200 ER (9V- SVO)
The right hand wingtip leading edge trailing edge fiberglass honey comb, R/H aileron were damaged. Investigation by AAIB, Singapore.

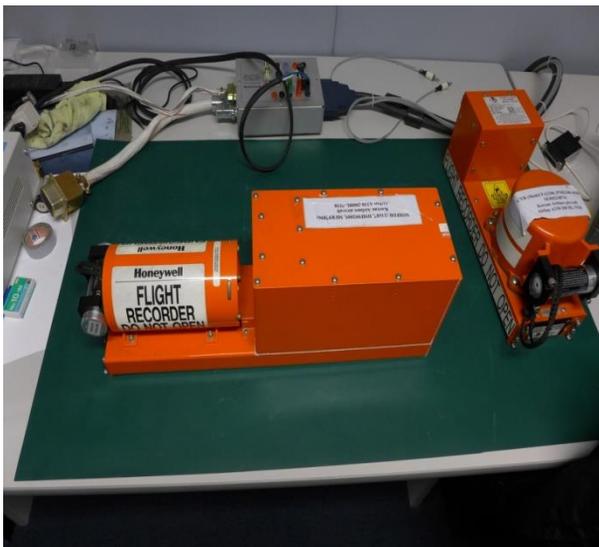
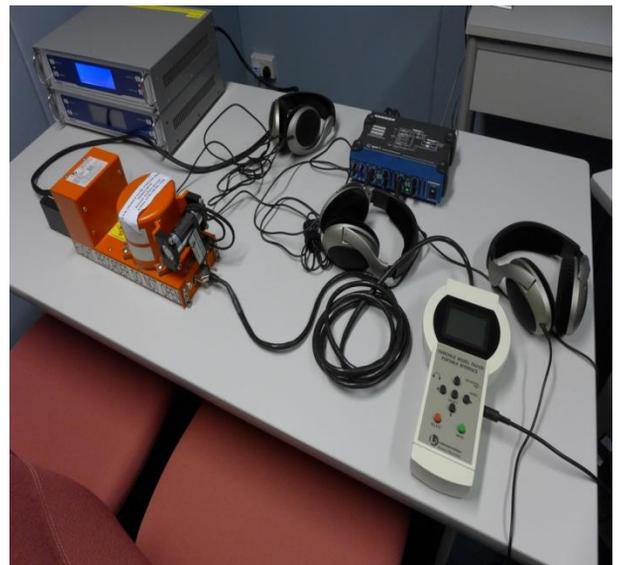
Flight recorders

The aircraft was fitted with a Honeywell Solid State Flight Data Recorder (SSUFDR) and a Honeywell Solid State Cockpit Voice Recorder. PN 980-4700/042 S/N- 11687. Recorder was successfully downloaded and analysed at AAIB, Singapore.
