## An International Airport Case Study

The Airport Authority has decided to perform total reconstruction of a third terminal (TB<sup>3</sup>). The project includes terminal building and its apron.

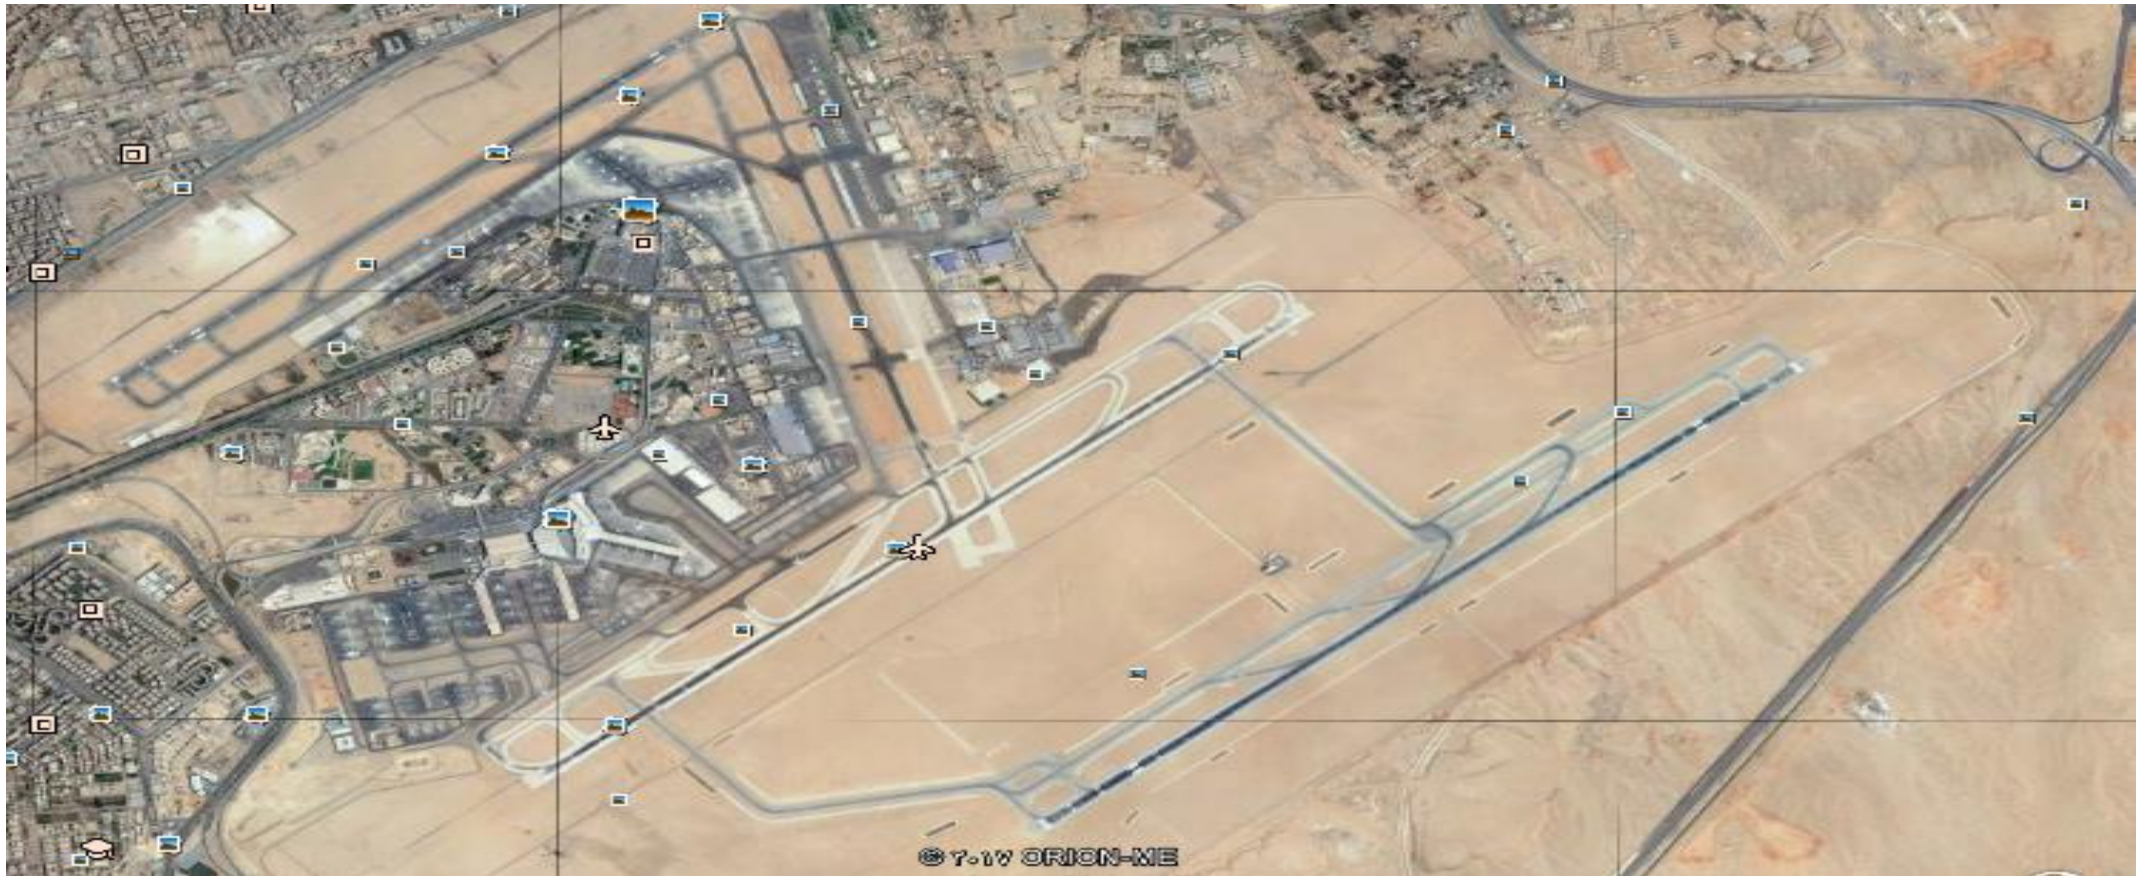
## General Layout

An International Airport has two serviceable terminals (TB1 & TB<sup>2</sup>).

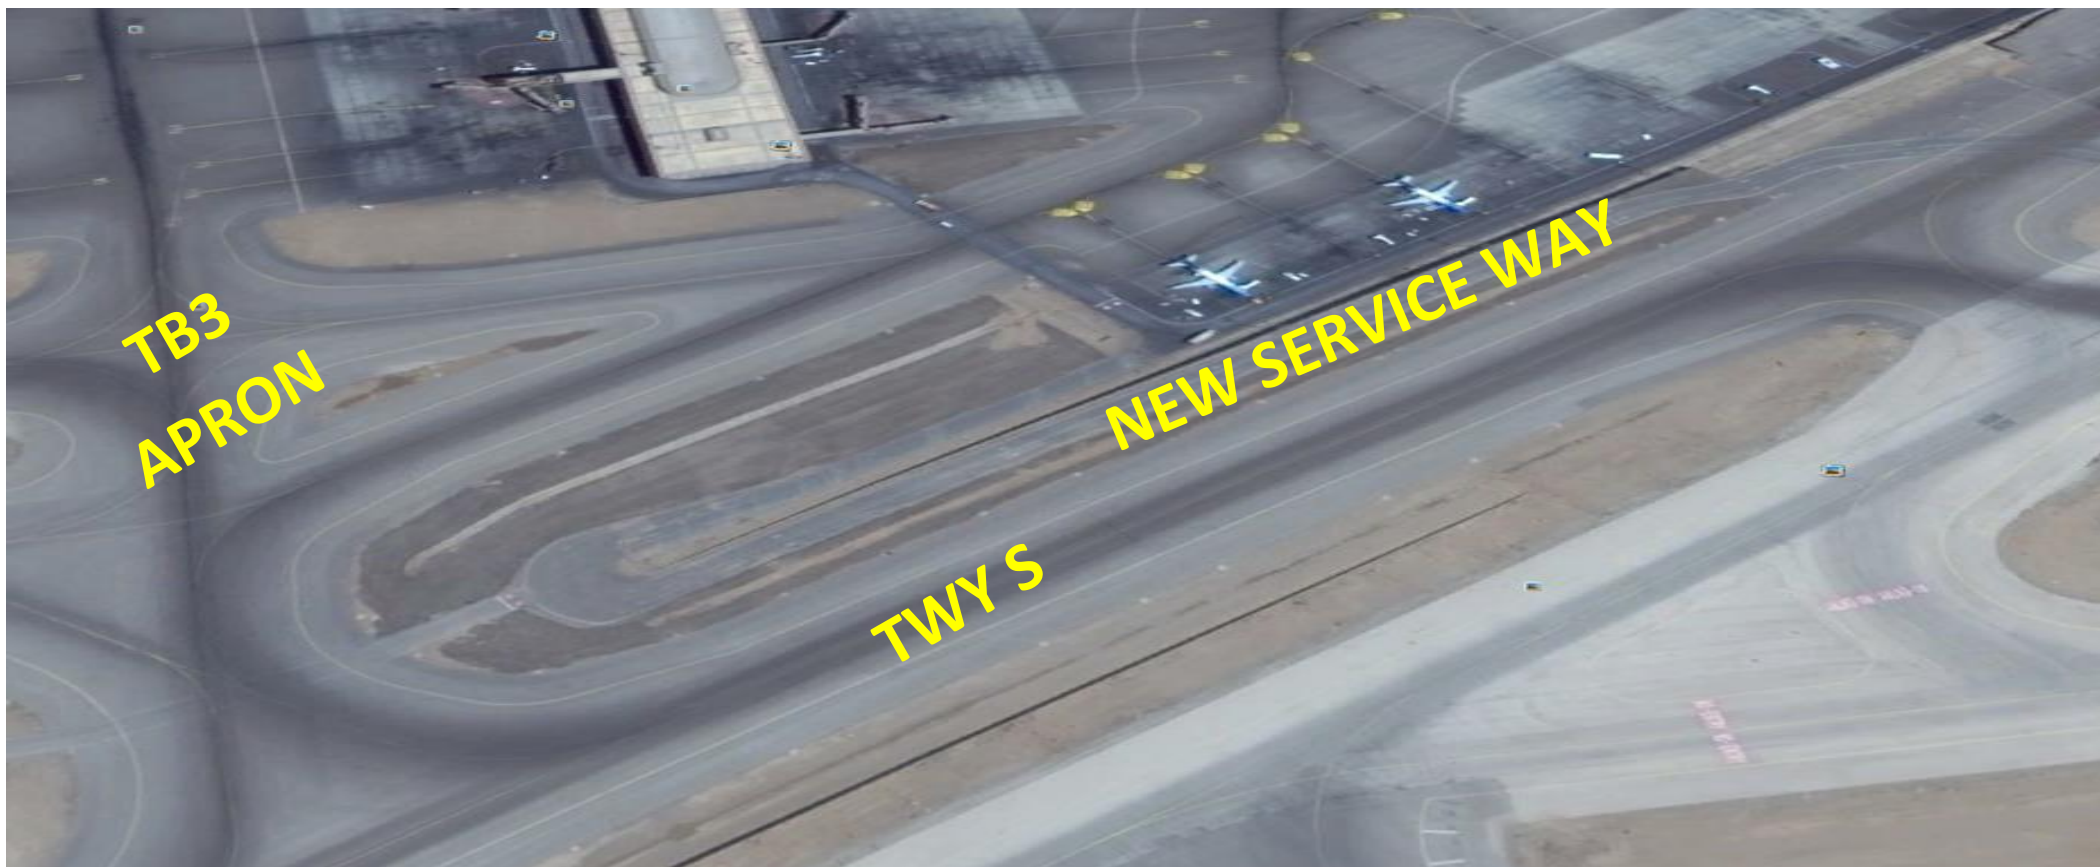
## PROJECT SITE

The site of the project is nearly located between TB1 and TB3 which blocks the service way connecting TB1 and TB3. The project team has proposed to establish a new service way extending parallel to TWY S for about 400 m.

- 1- The lateral distance between TWY S centerline and the service way edge closest to TWY S is only 44 m which does not comply with ICAO SARPs TWY to obstacle separation (ACFT code E) 47.5 m.
- 2- There is no availability to shift the service way to the other side furthest to TWY "S".
- 3- The service way width is only 8 m due to the land scape constrains.
- 4- TWY S is considered the main entrance to TB3 Apron.
- 5- 80% of ACFT movements using TB3 Apron are classified as Code E.
- 6- 60% of the Airport traffic is operated in TB3.
- 7- 50% of ACFT Ground Handling Vehicles & Equipment must use this new service way moving between TB1 & TB3, especially Catering and Fuelling Vehicles.
