Benefits to having a State Runway Safety Programme

Trinidad & Tobago Runway Safety Team

Antigua Regional Runway Safety Seminar

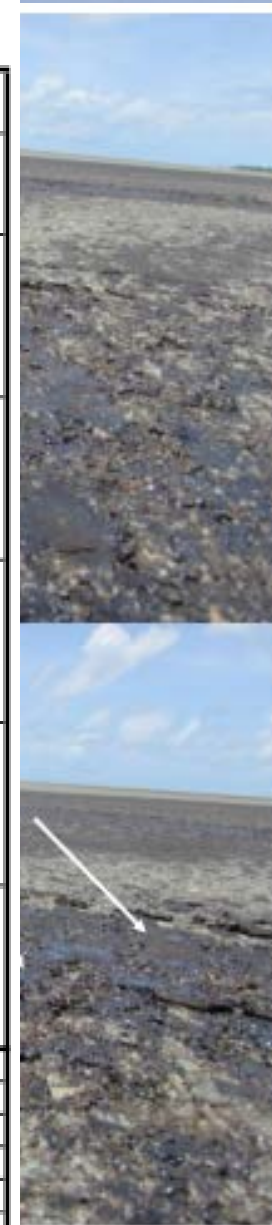
Residue from bituminous material on the runway

No	Activity	Hazard/ Hazardous Event	Possible Consequences	Assessment of risk			Current Risk Controls	Assessment of risk		
				Likelihood	Severity	Risk Level		Likelihood	Severity	Risk Level
1	Runway asphaltic surface 'bleeding' at the ANR Robinson International Airport	Aircraft encountering FOD due to deterioration of the asphaltic surface	Major Aircraft Damage	3	B	3B	-ATC Manage Traffic-use of leading lines and turning bays -Runway Pavement rehabilitation	2 2	B B	2B 2B
2		Sticky bituminous substance rising to the surface and adhering to aircraft tyres	Minor damage Inconvenience	4	D	4D	-ATC Manage Traffic-use of leading lines and turning bays -Conduct bituminous material removal process -Runway pavement rehabilitation	3 2 2	D D D	3D 2D 2D
3		Reduced friction on the runway surface due to soft bituminous residue	Runway Excursion	4	B	4B	-ATC Manage Traffic-use of leading lines and turning bays -Conduct bituminous material removal process -Runway pavement rehabilitation	3 2 2	B B B	3B 2B 2B

4		Hydroplaning in the bleeding areas following a precipitation event	Runway Excursion	4	B	4B	-ATC Manage Traffic-use of leading lines and turning bays -Conduct bituminous material removal process -Runway pavement rehabilitation	3 2 2	B B B	3B 2B 2B
5		Undulation of the runway surface	Runway Excursion	2	B	2B	-Conduct bituminous material removal process -Runway pavement rehabilitation	2 2	B B	2B 2B
Likelihood		Meaning		Value	Severity		Meaning		Value	
Frequent		Likely to occur many times [has occurred frequently]		5	Catastrophic		Equipment destroyed / Multiple deaths		A	
Occasional		Likely to occur sometimes [has occurred infrequently]		4	Hazardous		Major equipment damage / Serious injury		B	
Remote		Unlikely to occur, but possible [has occurred rarely]		3	Major		Serious incident / Injury to persons		C	
Improbable		Very unlikely to occur [not known to have occurred]		2	Minor		Minor incident / Nuisance		D

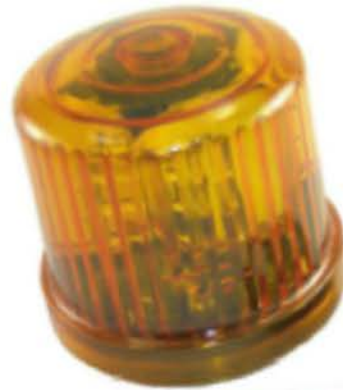
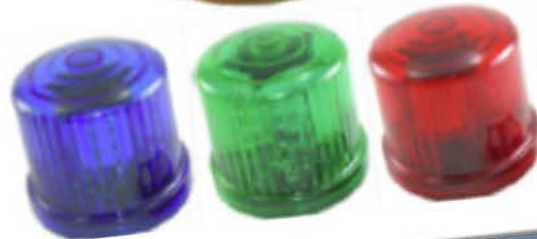
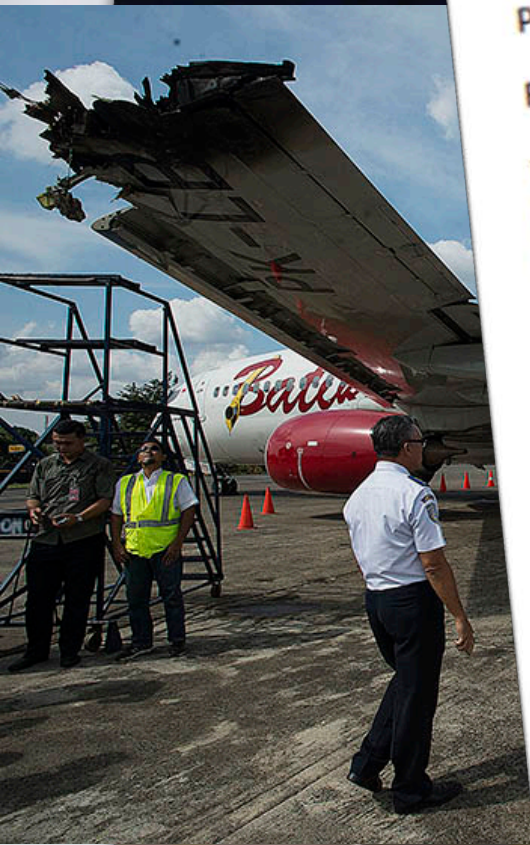
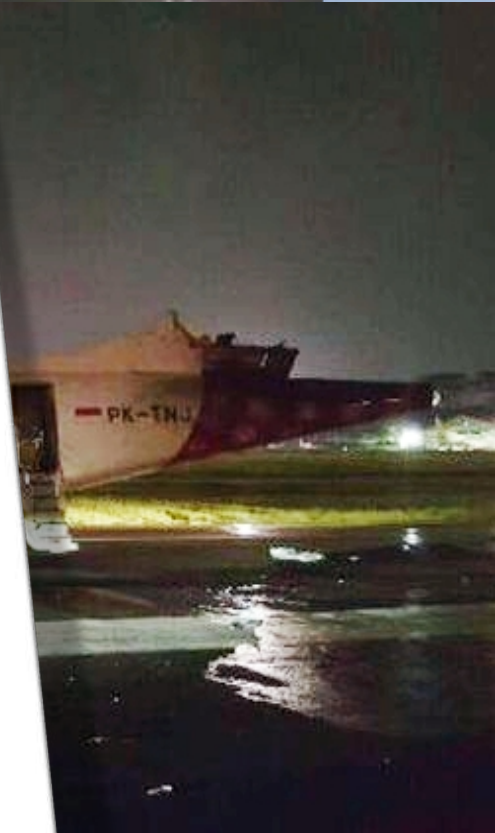
Rotating Pattern LED Beacon Light, Battery Operated, Optional AC Power, Magnet Mount

The PL-300XJ battery operated beacon is a versatile safety light suitable for a variety of warning and attention-getting applications. Equipped with two powerful magnets on the base, this beacon can be temporarily mounted on vehicles and other equipment. The rotational pattern of the 20 LED lights simulates the look of a motorized beacon without any moving parts. The rotational speed is easily adjusted with an internal screw. A built-in AC jack allows for the use of an optional plug-in power adapter. On a fresh set of batteries, this beacon can run for as many as 144 hours.
