E/CAR/NTG/8 & E/CAR/RD/6 — IP/04  
03/09/18

**Eighth Eastern Caribbean Network Technical Group (E/CAR/NTG/8) and  
Sixth Eastern Caribbean Radar Data Sharing Ad hoc Group (E/CAR/RD/6)**  
Saint George's, Grenada, 3 - 5 September 2018

**EFFECTS OF HURRICANE MARIA ON SAN JUAN, PR. MEVA**

<b>EXECUTIVE SUMMARY</b>	
This information paper describes the destruction of hurricane Maria on MEVA equipment at the San Juan CERAP, and the aftermath to restore services.	
<i>Strategic Objectives:</i>	<ul style="list-style-type: none"><li>• Air Navigation Capacity and Efficiency</li></ul>
<i>References:</i>	<ul style="list-style-type: none"><li>• Eighteenth MEVA II Technical Management Group Meeting (MEVA/TMG/18), Mexico City, Mexico, 20 to 22 February 2007</li><li>• Nineteenth MEVA II Technical Management Group Meeting (MEVA/TMG/19) 26 to 27 February 2008</li><li>• Summary of Discussion and Conclusion</li><li>• Frequentis MEVA-III Emergency Antenna Commercial Offer</li></ul>

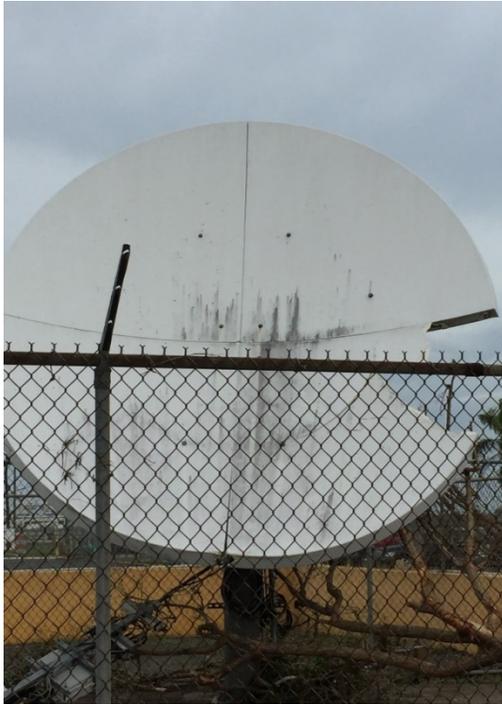
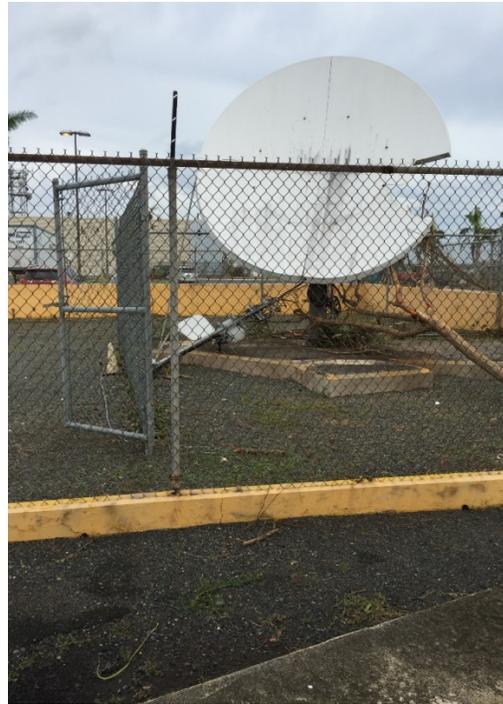
San Juan MEVA

1.1 Common operating procedures to protect the antenna from hurricane force winds is to lay it on its back to resemble a birdbath, which protects it from flying debris. Unfortunately, due to limited personnel resources and the possibility of losing communications with neighbouring islands, these procedures were not performed. Ultimately, the hurricane severely damaged the antenna beyond all possible repair and the accompanying electronic were destroyed.

2.1. Delivery of a new antenna takes approximately 90 to 180 days. Due to the urgency of the situation, we tried to restore the aging MEVA 3.8m flyaway antenna stored in Independence, MO for the past 20 years. The components were found largely oxidised and inoperable due to its long period of storage. In addition, the antenna was stored in five large crates weighting close to an estimated 4000 pounds. The weight and size of the antenna alone made for difficult transport and the necessary repairs were going to be time consuming. As a result, we quickly realized that the size and condition of the antenna made it impractical for a quick deployment.

2.2 Since the flyaway antenna was deemed impractical and inoperable a decision was made to order a new antenna from General Dynamics. Due to the urgency, the order was expedited and the new antenna was delivered in record time - three weeks. The antenna was shipped to San Juan on a military transport and later moved to the CERAP for installation. MEVA services were restored on October 19, 2017.

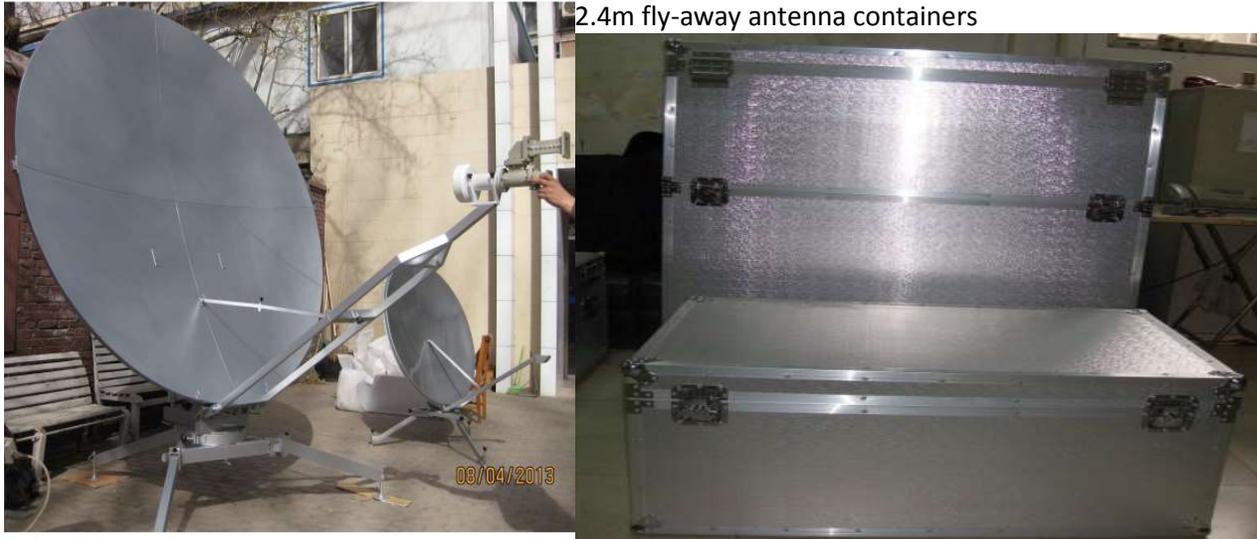
2.4m C-Band fly-away antenna

3.1 Frequentis has a proposal for a smaller, lighter antenna compatible with the current MEVA III. The proposed antenna has newer highly durable components, is more suitable to be rapidly deployed and maintained than its predecessor.
