ICAO NACC SAR Implementation Workshop (07-08 AUG 2023)

SCENARIO #1

Douglas Samp, United States Coast Guard (USCG)

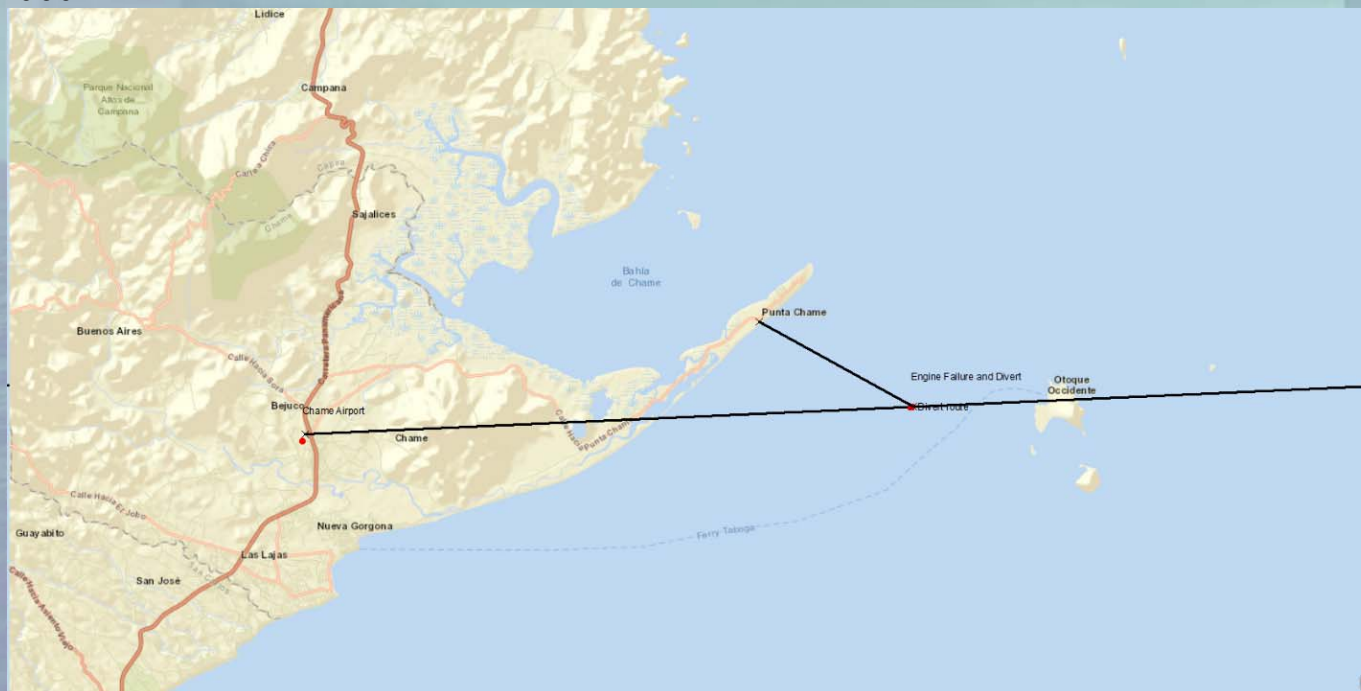
Engine Failure

At 37 miles into the voyage, the Piper experience engine failure, declared an emergency, and attempted to glide 6 miles towards Punta Chame. Panama ATC was in communications with N5535J and the aircraft was on radar.

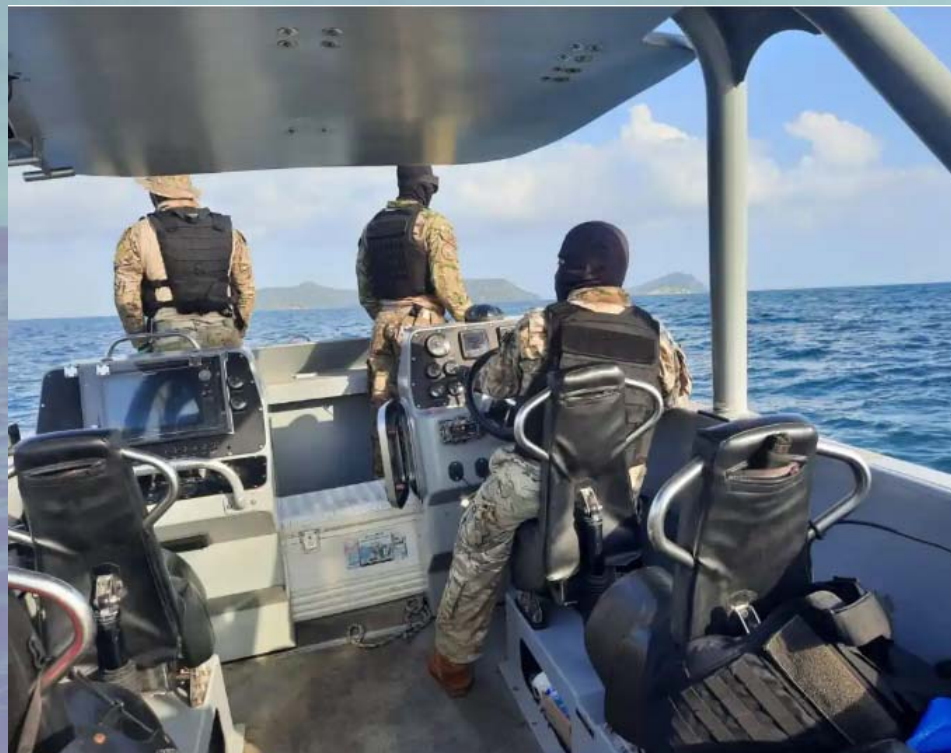
Response

Panama Defense Forces deployed two boats to the area
