Cases of SSR RF-Interference caused by Video Transmission Equipment in Unmanned Aerial Vehicle(UAV)

Presented by Yongwoo Jung
(Korea Airport Corporation, Republic of Korea
loyyd03@gmail.com(+82-01-9021-7213))

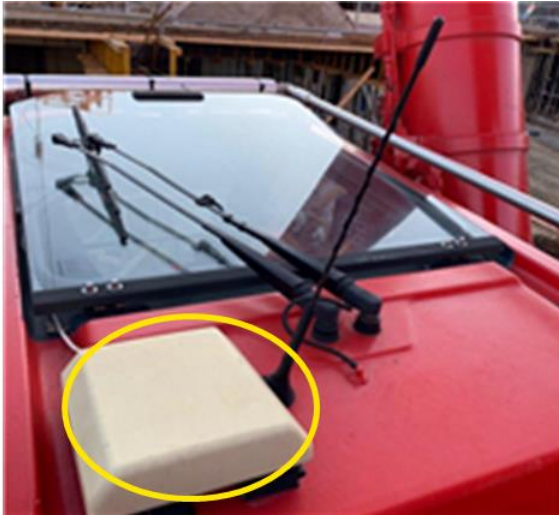
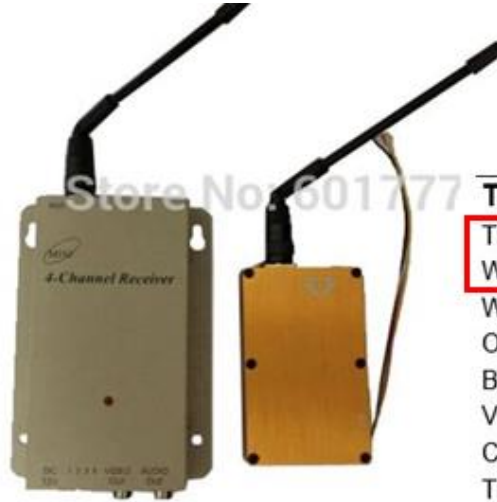
Danger of Video Transmission Equipment in UAV

Transmitter description:

Transmit Power: 5000mW

Working frequency: 1.2G (1080mhz -1120mhz -1160mhz -1200mhz)

Working voltage: DC12V

Operating Current: 900mA

Body product: 79*47*19(mm)

Video input port : Please see on picture

Channel Selection: 4-channel audio and video synchronization and adjustable

Transmitter Distance: below than 1000M in open air (300-500 meters to recommend)
