ICAO Asia/Pacific Wildlife Hazard Management Workshop  
and Seventh Meeting of the Asia/Pacific Wildlife Hazard  
Management Working Group (AP-WHM/WG/7)

**BEST PRACTICES ON WILDLIFE HAZARD MANAGEMENT AT IGI AIRPORT, DELHI**

(Presented by India)

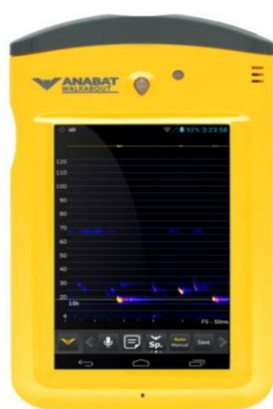
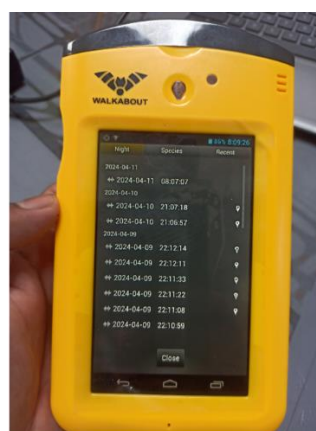
Blue color indicating the bat frequency

Recorded audios

**Image 1:** Bat detector device is used to record bat movements along with their frequency and time.

2.3.3 Bat Detector: Since most of the strikes had occurred during the night time and it is very difficult to identify the strike species through naked eye visibility. Therefore, to observe the reason, nighttime surveys were carried out along with the bat detector device (device which records the bats audio (ultrasonic) calls and with the help of software, one can identify the bat species). Through the device, 07 species of bat (05 insectivore and 02 frugivore) were identified.

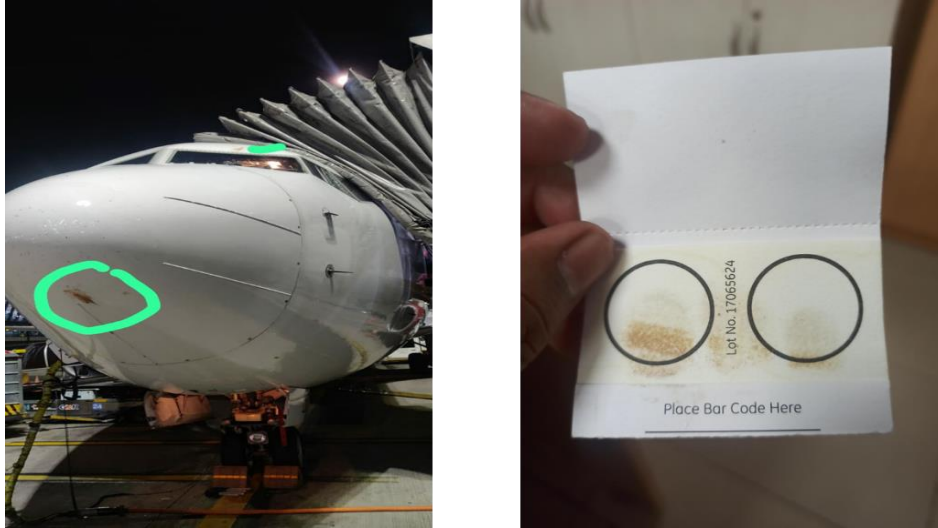
**Image 2:** Blood sample taken for DNA analysis to identify the species.

2.3.4 **DNA Analysis:** Most of the nighttime strikes, only blood stains were observed on the aircraft radome/ windshield. Therefore, DNA analysis is carried out to identify the species to robust the existing mitigation measures. In analysis results, it came to know that more than 95% of the bat strikes are of insectivore species.

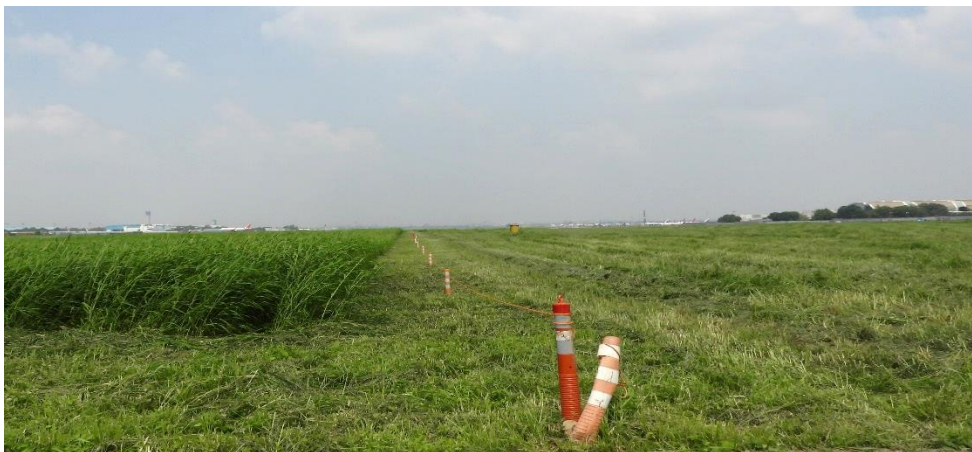
**Image 3:** Comparative image of long grass policy vs Short height policy.

2.4.1 **Change in grass height policy:** Since it was observed that most of the strikes are of insectivore bat species, and they were observed feeding on the airborne insects over the grassland. Therefore, to cut down the breeding and hiding spaces for the insects, the grass height policy was changed from 'Long' to 'Short'. Currently, a grass height policy of 6-8 inches is maintained.
