# Commercial Flight Safety Presentation

Aviation Safety and Aircraft Accident and Incident Investigation Symposium

November 2024

# American Airlines, AA383, 28th Oct 2016, Rotor Disk separation

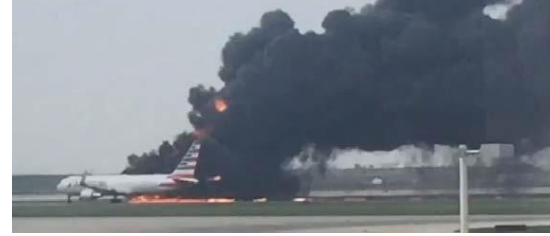
## Event Photos:

- October 28, 2016
- Operator: American Airlines; Flight # AA383
- B767-323, Registration # N345AN
- CF6-80C2B6, Engine Position #2, ESN 690-373
- Event Location: Chicago O'Hare Airport (ORD); Time: 14:32 CDT
- 161 Passengers & 9 Crew, 21 Injuries (1 Serious Injury)
- The HPT S2 disk (IN718) of the #2 engine separated during the takeoff roll. A disk fragment penetrated the wing fuel tank leading to a ground fire that damaged the wing & fuselage beyond repair. The separation was due to crack propagation from a Discrete Dirty White Spot introduced in the Inconel disk material melt process.

- Analysis of the material anomaly identified it as a '**discrete white spot**' that is associated with a step in the ingot production process.
- The material anomaly was further classified as a '**discrete dirty white spot**' due to its composition; 'discrete dirty white spots' are associated with clusters of micron-sized oxide, nitride, and/or carbonitride particulates.
- Historical production and testing results on the triple-melt process indicate that the 'discrete dirty white spot' is an **inherent infrequent characteristic of the vacuum arc remelting process**.

- **Interim Actions:**
  - Service Bulletins issued for enhanced UTI of CF6-80C2 S1 & S2 HPT disks and CF6-80A S2 HPT disks (common part number) produced prior to the year 2000
  - The FAA issued NPRM 2017-19018 on September 7, 2017, intending to AD these service bulletins
- **Final Actions:**
  - Rotor Integrity Steering Committee and JENQC (Jet Engine Nickel Quality Committee) evaluating appropriate inspection techniques
  - GE Aerospace implementing enhanced disk inspections at new make and in-service
