# Aviation Safety and Aircraft Accident and Incident Investigation Symposium

# Discussion on Completed Accident & Incident Investigation and Lessons Learned

## B737-8MAX Accident summary

- The presentation focuses on **ET302, B737-8MAX** which encountered fatal accident after takeoff from Bole International airport bound to Nairobi –Kenya;
- On 10th March 2019 at around 05:44 UTC, B737-8MAX, flight ET302 disappeared from radio and radar contact;

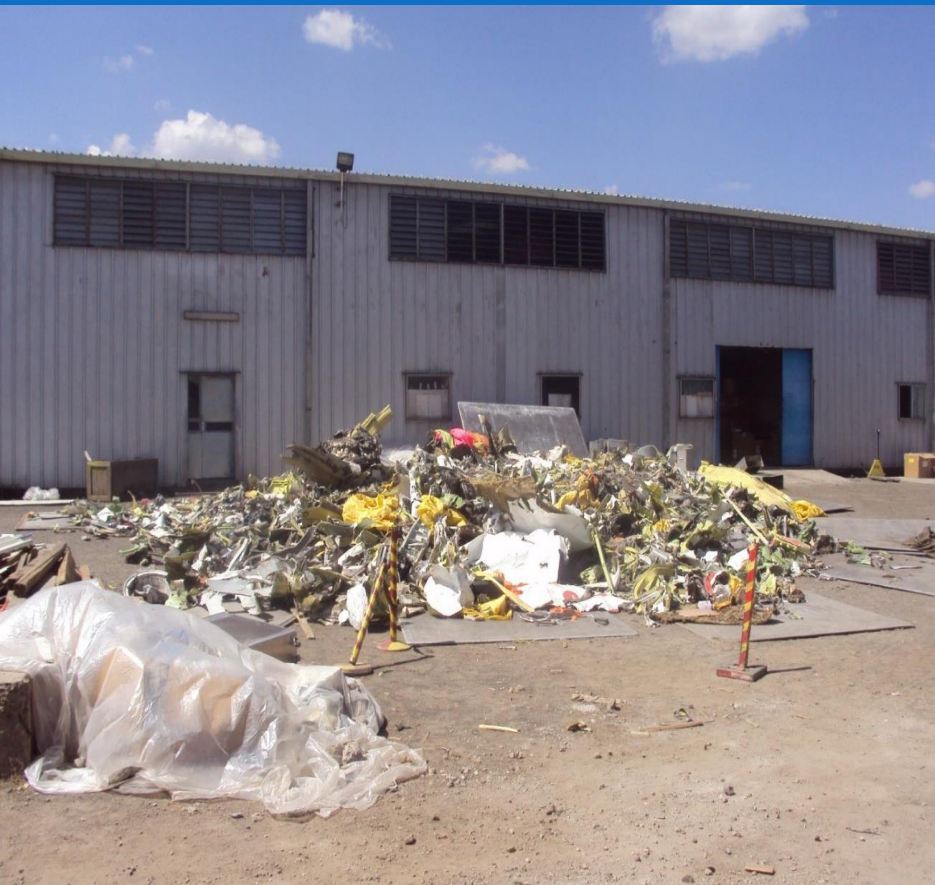
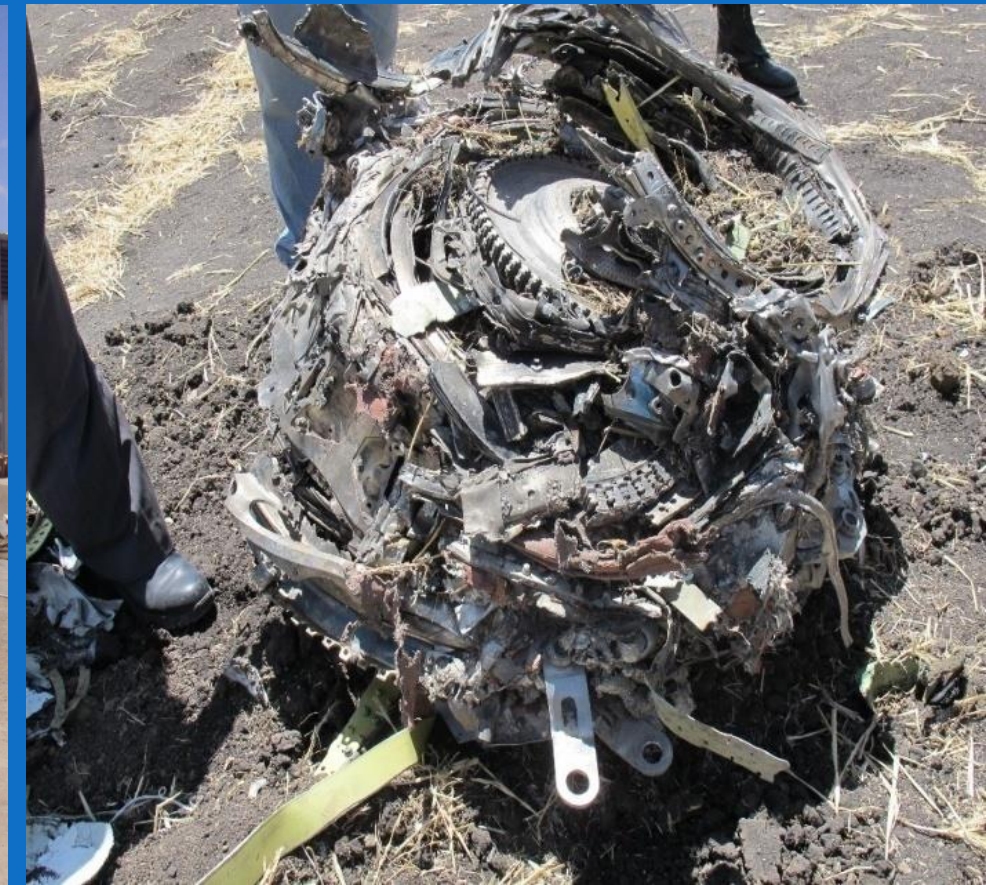
On March 20, 2019; the wreckages were collected from the sight by Ethiopia employees & transported to Addis Ababa EAIB store.

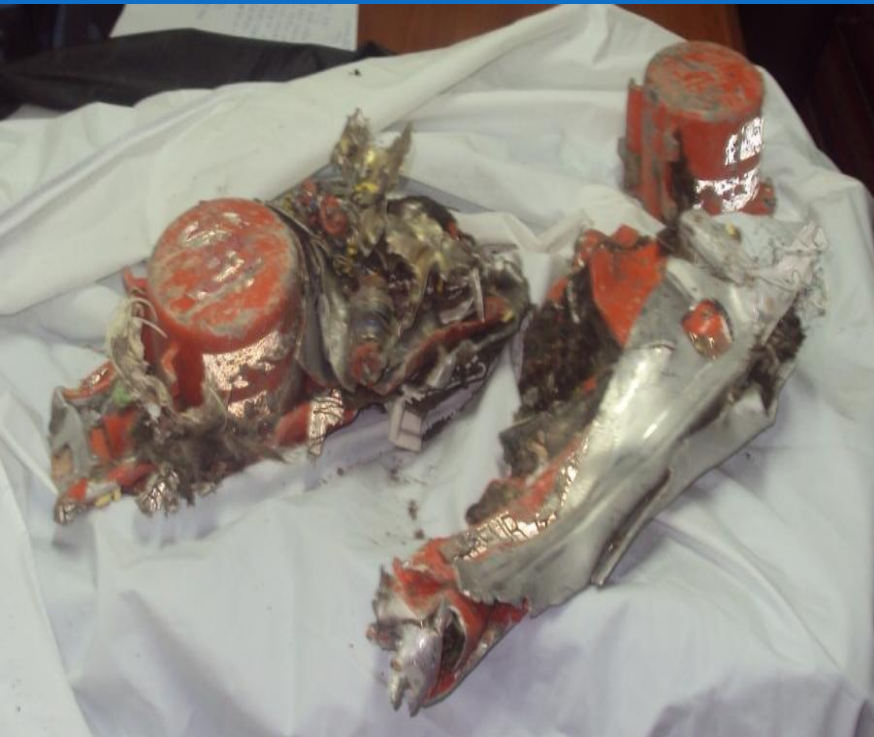
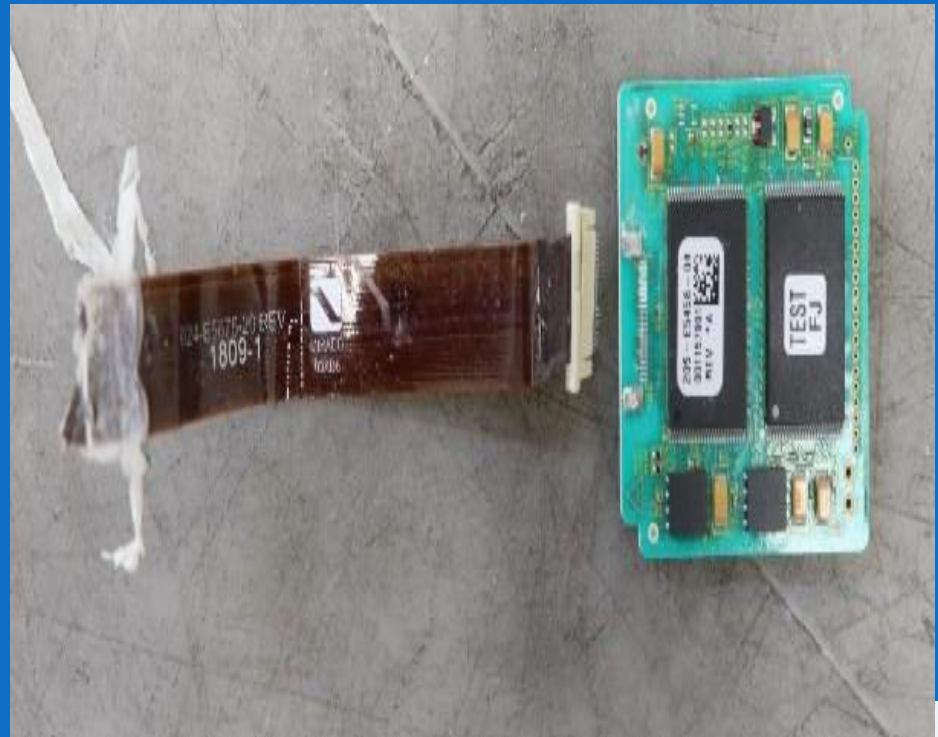
- **DFDR and CVR Recovery**

On 11 March 2019, the DFDR and CVR were recovered from the accident site by the EAIB

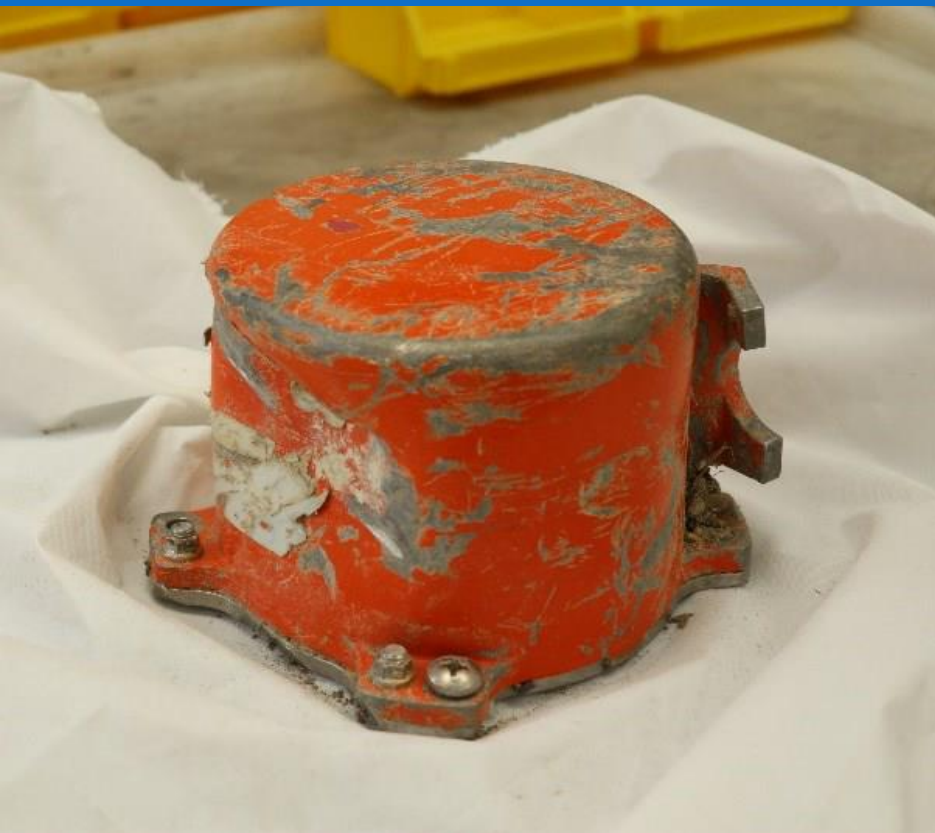
- The FDR downloaded & analyzed by **BEA & EAIB team**
- The CVR data downloaded and **transcribed by EAIB**
