MODERN TECHNOLOGIES AND METHODOLOGIES IMPROVE HELICOPTER ACCIDENT INVESTIGATION

The Vision 1000 cockpit image and data recorder was developed as standard equipment in Airbus Helicopters helicopters but outside the regulatory requirements, resulting in simplified certification and much lower costs.

By Dr. Thomas Gogel and Seth Buttner, Airbus Helicopters; and Dr. Marcus Bauer, MSimulation

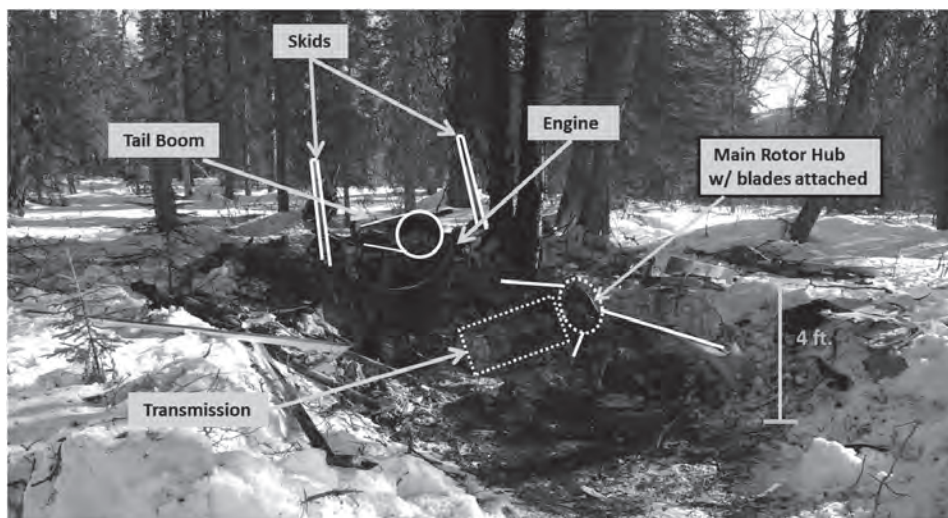
Figure 2. Accident site and location of wreckage and Vision 1000.

However, the helicopter’s Vision 1000 unit was recovered from the rubble at the accident scene (see Figure 2). The unit had been mounted on the cockpit ceiling centered between the two forward seats, but became separated from the aircraft structure during the impact event and found lying among the wreckage debris. Although the unit exhibited impact damage on the exterior case and power connector, the crash-hardened memory module and removable card were still intact and undamaged.

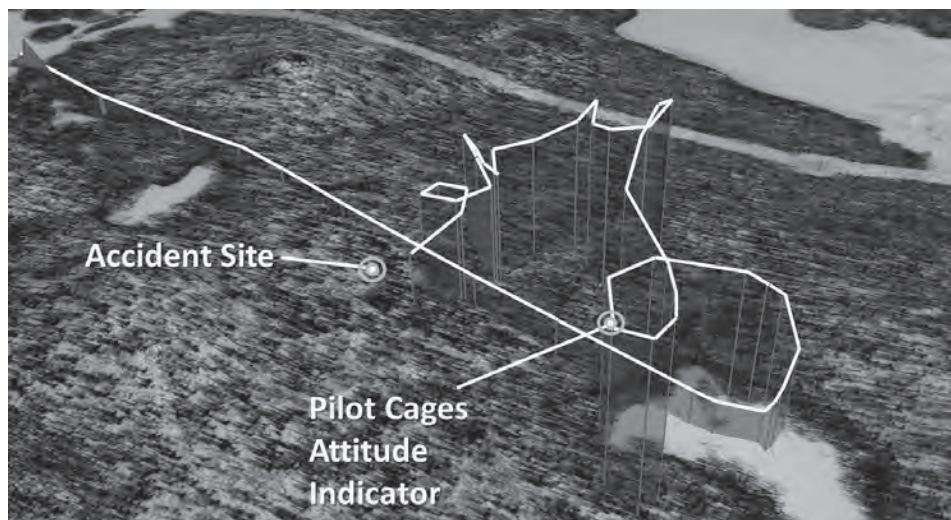
Figure 3. End of the flight path; pilot cages gyro and accident site.

With just the track information from Vision 1000 overlaid with a mapping software, like Appareo's AS-Flight Analysis or even Google Earth, the investigation team was able to retrace the flight (see Figure 3). The first leg was a straight and level flight path at a fixed altitude (~1,200 feet MSL) from Anchorage to the staging area for the TFO pickup and again a direct leg to the frozen lake near the rescue location. However, when the mishap flight departed the frozen lake in a southwest direction, it was noted that its flight path track was at a much lower altitude (~700 feet MSL), apparently tracking a nap-of-the-earth profile.

The inclement weather may have explained the 90-degree left turn to the east and then realignment back to the south when the pilot saw a power line pole directly out in front of him. Determining the cause of the sporadic noncoordinated maneuvers at the end of the flight was a focus of the investigation. The parametric data from the digital gyro information of the Appareo unit was correlated with the aircraft's analog instrument readings that were obtained from the captured image information to further understand the mishap sequence (see Figure 3, page 21).

The actions of the pilot as seen in the image information revealed the "why" and "what" that contributed to the ultimate peril of the flight. At approximately 2318, just after the helicopter flight path was seen to slow down and almost began to hover in the clearing of trees, the helicopter began to drift up and turn back and to the left, as the pilot reached out and caged the attitude indicator gyro during the flight. Caging an attitude indicator sets its display to a level flight attitude (0 degrees pitch and 0 degrees roll). This action is intended to be performed only when an aircraft is in a level flight attitude, such as on the ground or in straight-and-level, unaccelerated flight. After this event, the helicopter entered a series of erratic turns, climbs, and descents.

The parametric data confirmed the pilot's action of caging the attitude indicator gyro that was seen in the recorded images. Without the imagery and parametric data obtained from the Appareo unit, we would never have known this pilot action and would have lost critical information on the contributing factors leading to the accident

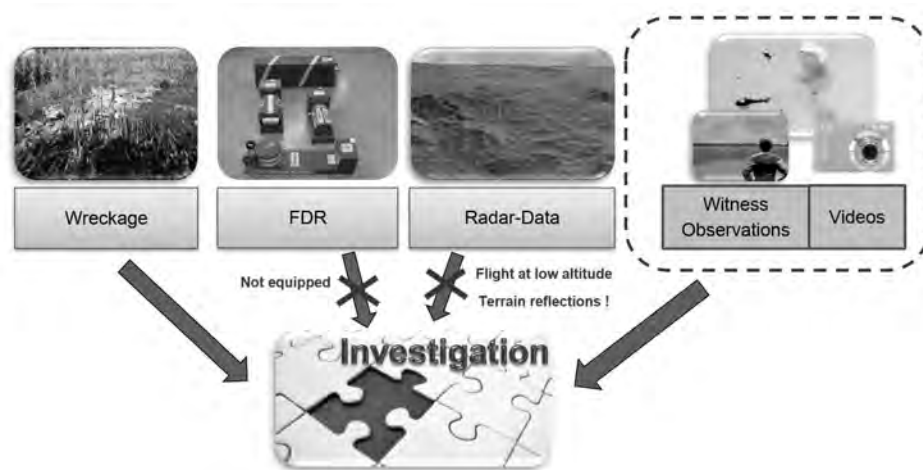
Figure 4. Overview of available information for accident reconstruction.

The method iwi® was developed in 2009 to make use of available witness information for accident reconstruction with reduced time and costs, especially for accidents with limited information available (missing radar data due to low flight altitude and/or FDR data not available) as shown in Figure. 4

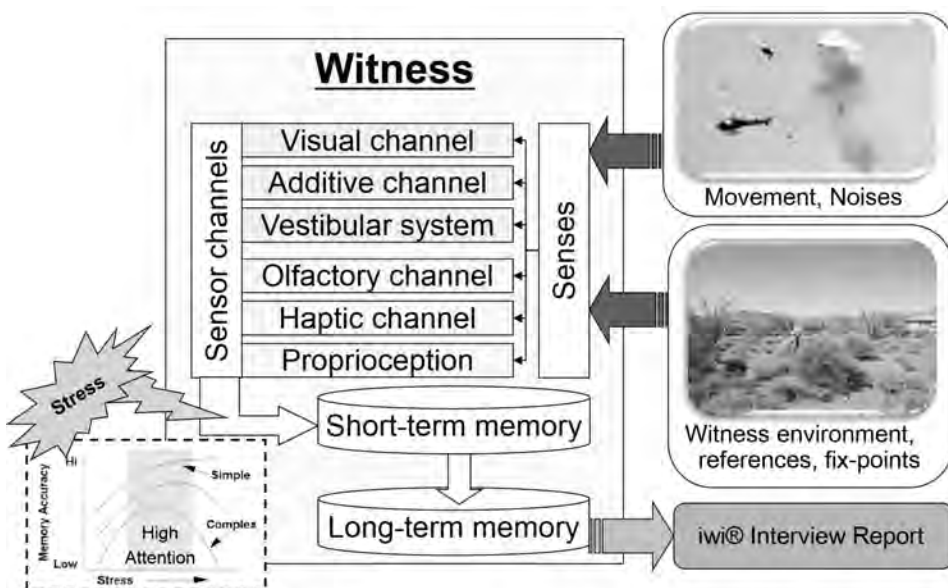
Figure 5. Witness awareness, memory, and the influence of stress on memory accuracy.

The quality and accuracy of a witness statement depends on the stimulation of a witness memory, the complexity of the observation, and the level of stress that occurred to the person during the situation. Figure 5 shows the overview of the main senses of a human and information of an aircraft observation. An eyewitness uses surrounding objects/reference objects to recall the observed aircraft positions and movements.

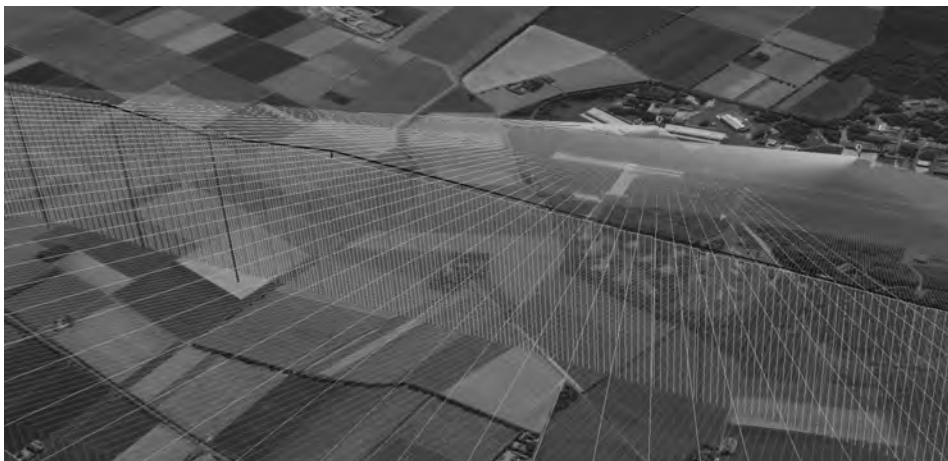
Figure 6. Reconstructed flight path (black line), lines of sight (grey lines), and radar data (grey path).

A final reconstruction (see Figure 6, page 23), is calculated based on Newton's iterative method, and the total residuum declares the maximum error of the reconstructed flight path.

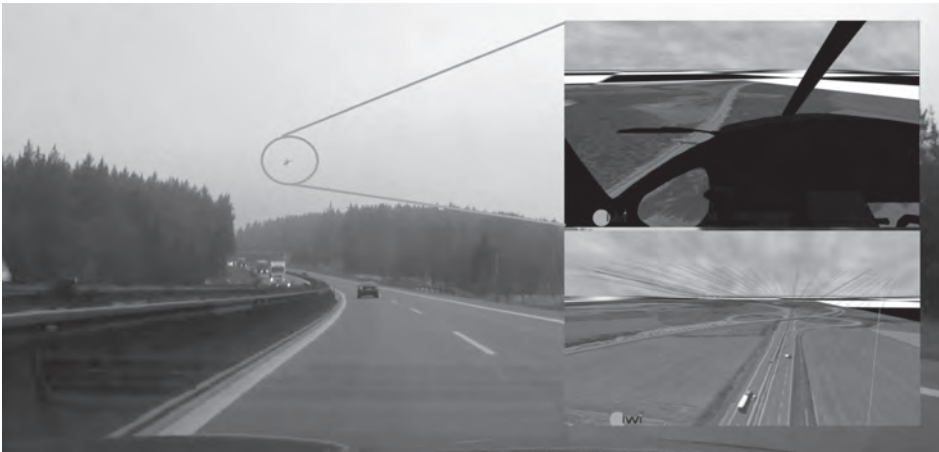
Figure 7. Car camera view with imported lines of sight (lower right), reconstructed helicopter path, and pilot's perspective (upper right).

this information based on camera lens information and the locations of visible reference objects as shown in Figure 7, an example showing the capabilities of iwi® to reconstruct a moving object based on moving witnesses.
