RASG-PA Runway Excursion Prevention Seminar

Mitigation Measures – Gol Airlines Experience
10.OCT.14

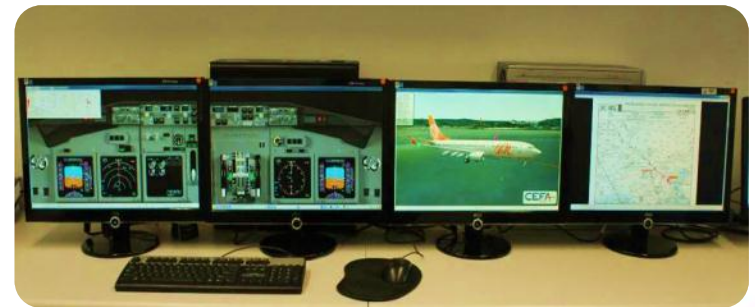
- Valuable tool to reproduce flights generating 3D images from the flight parameters analyzed at the FOQA Program;
- 4 screens to visualize flight parameters, controls and air charts;
- Provides different prospects of the flight, in order to demonstrate a specific event to a pilot.

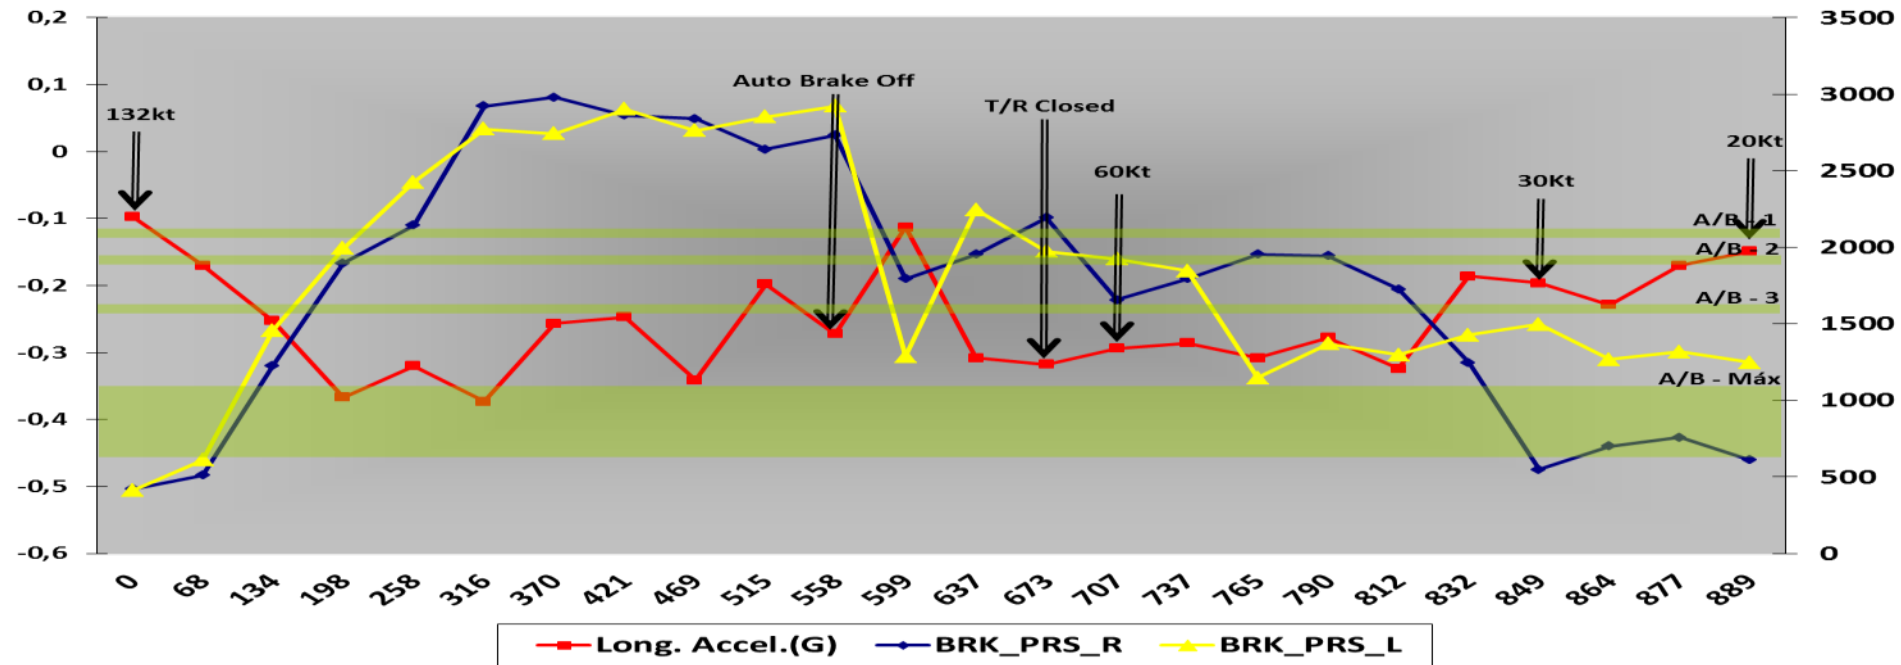
ANÁLISE FRENAGEM VOO 1 - B800SFP GW 62.04(t)

METAR: METAR SBBE 020000Z 02004KT 9999 FEW015 SCT080 26/24 Q1010=

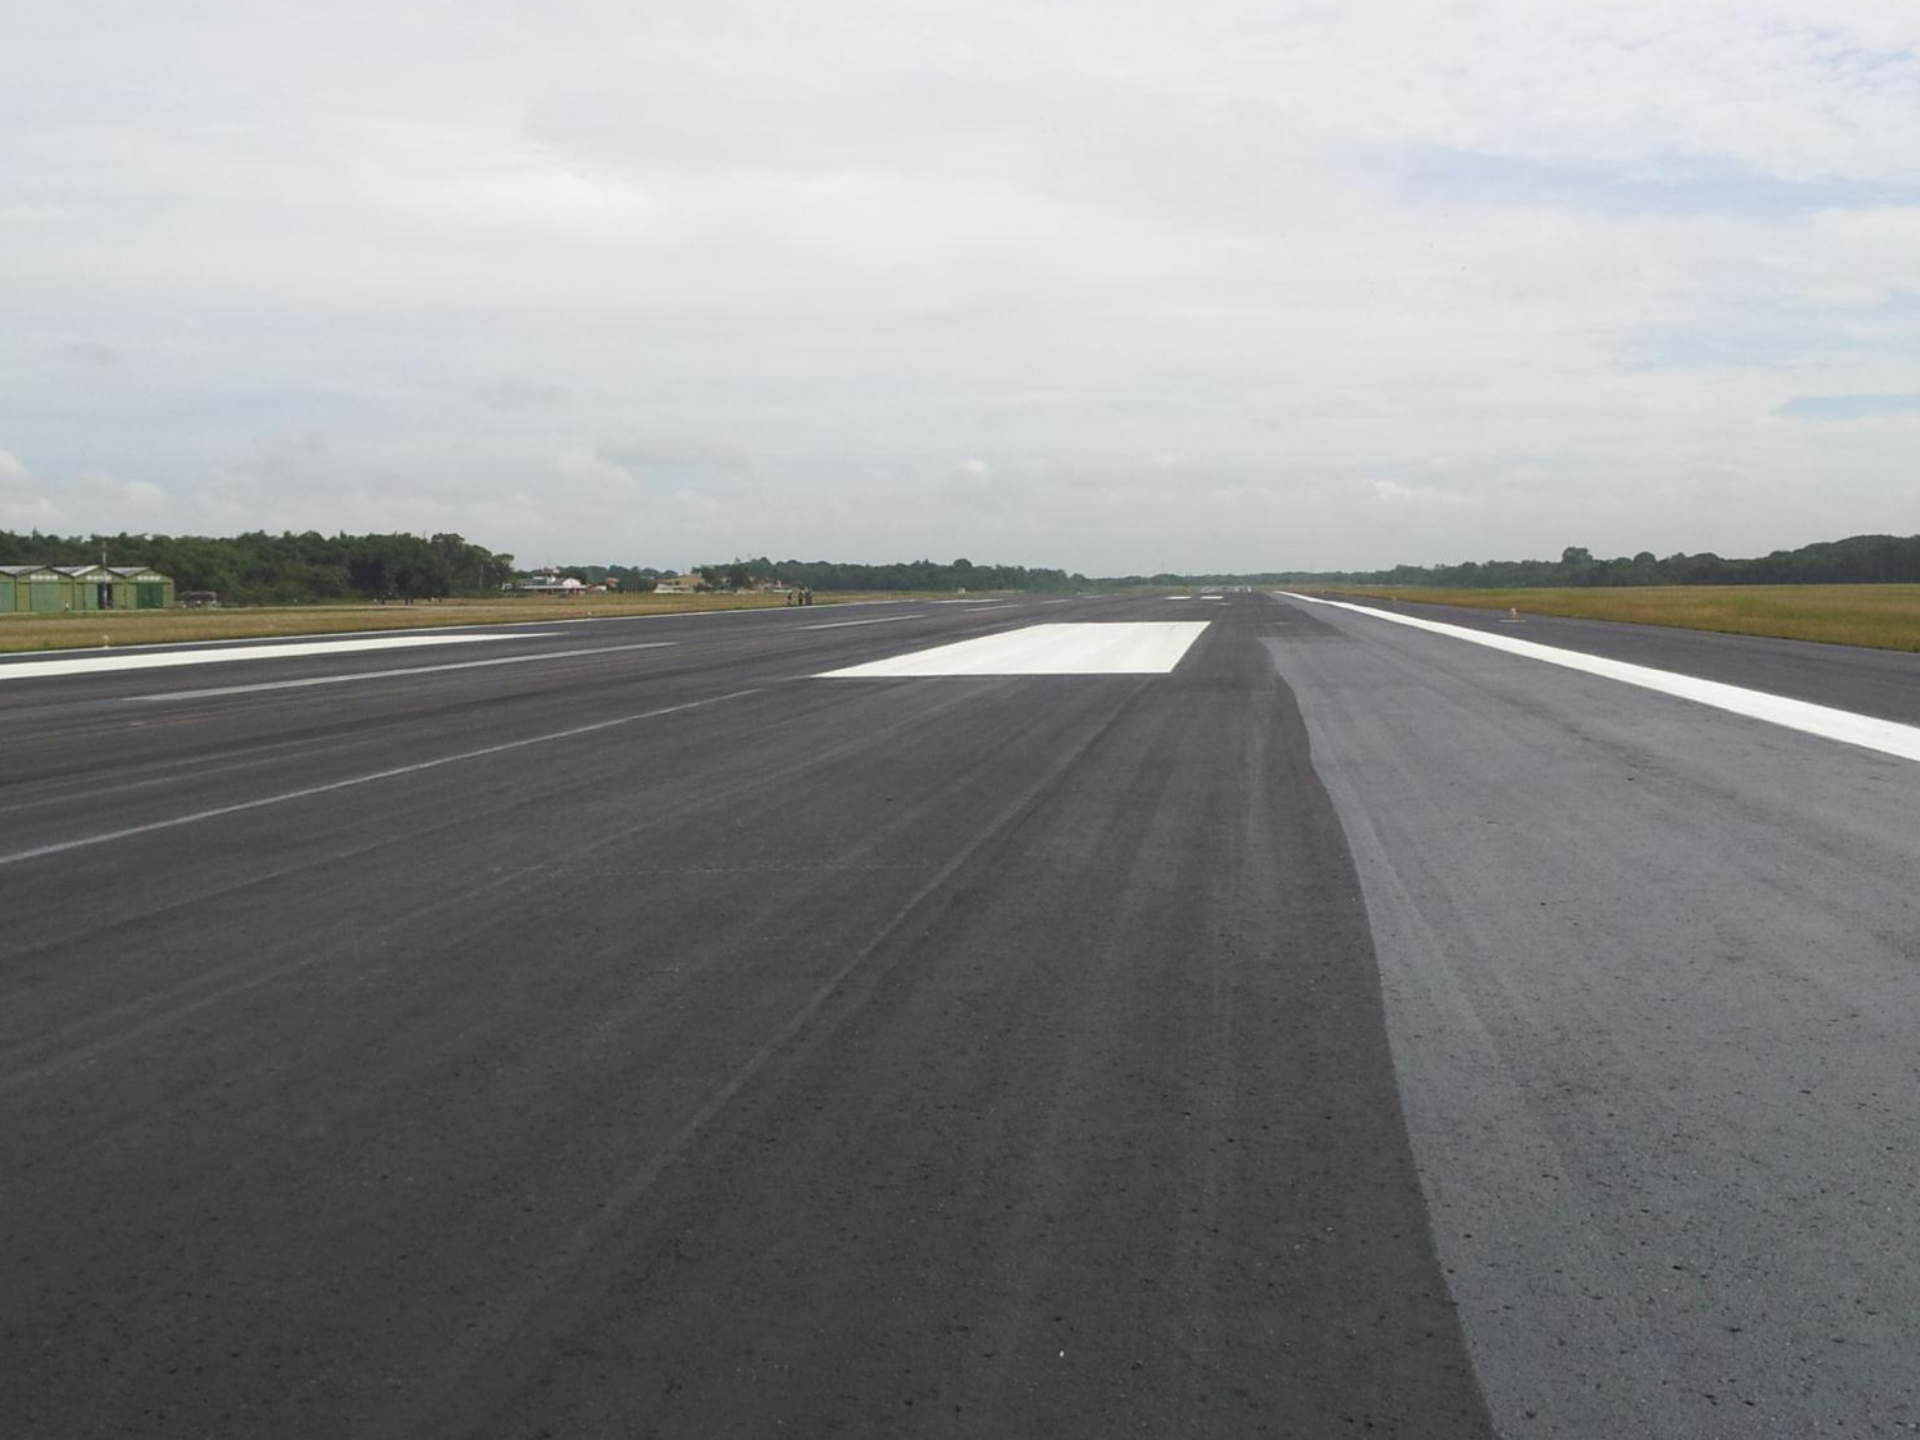
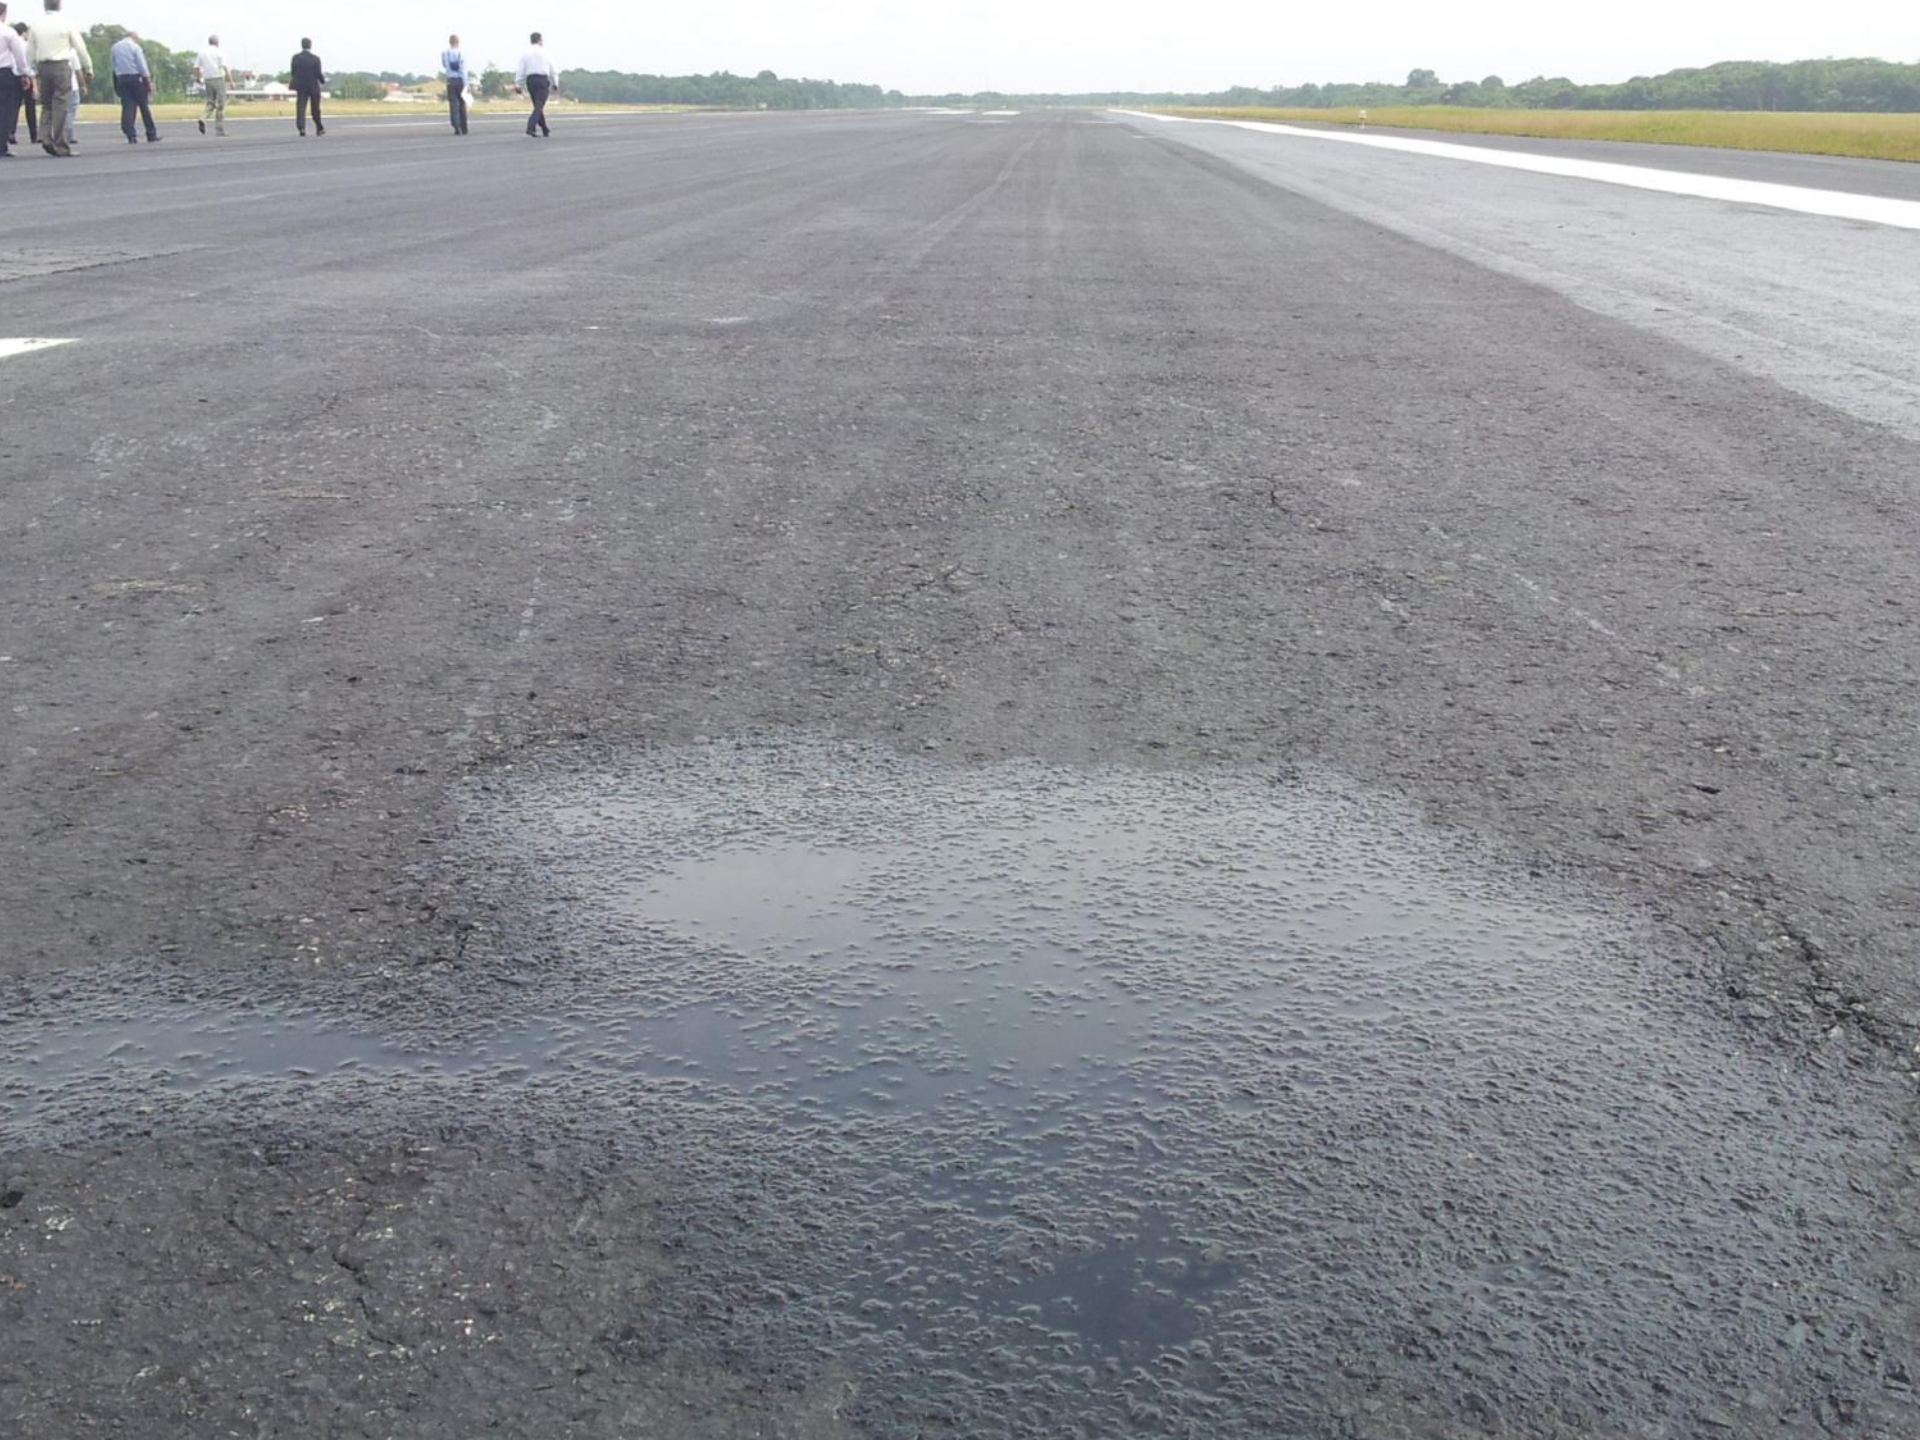
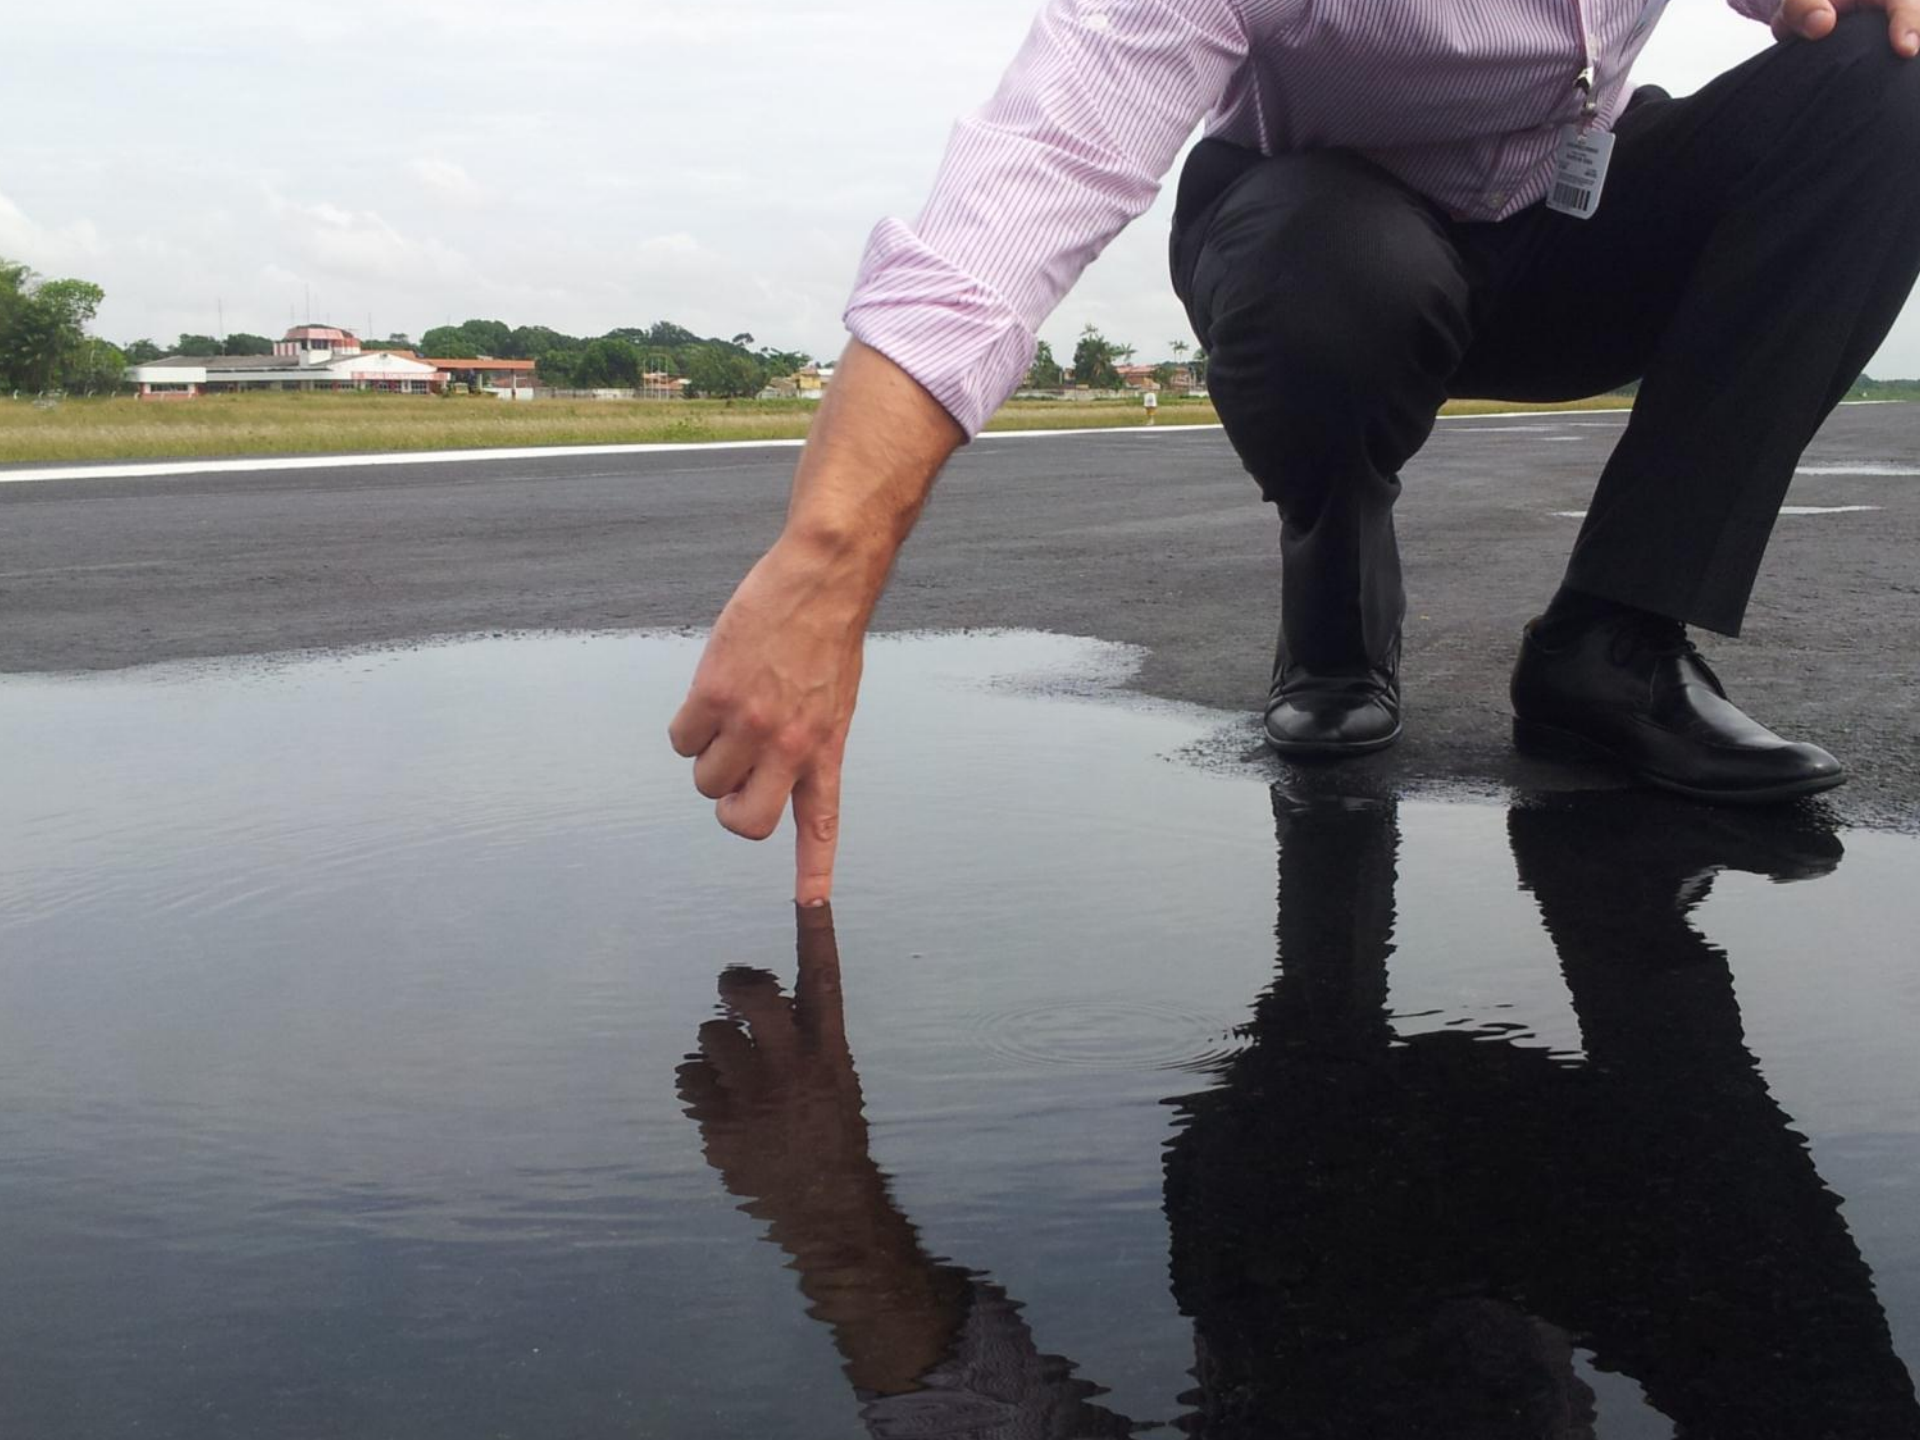
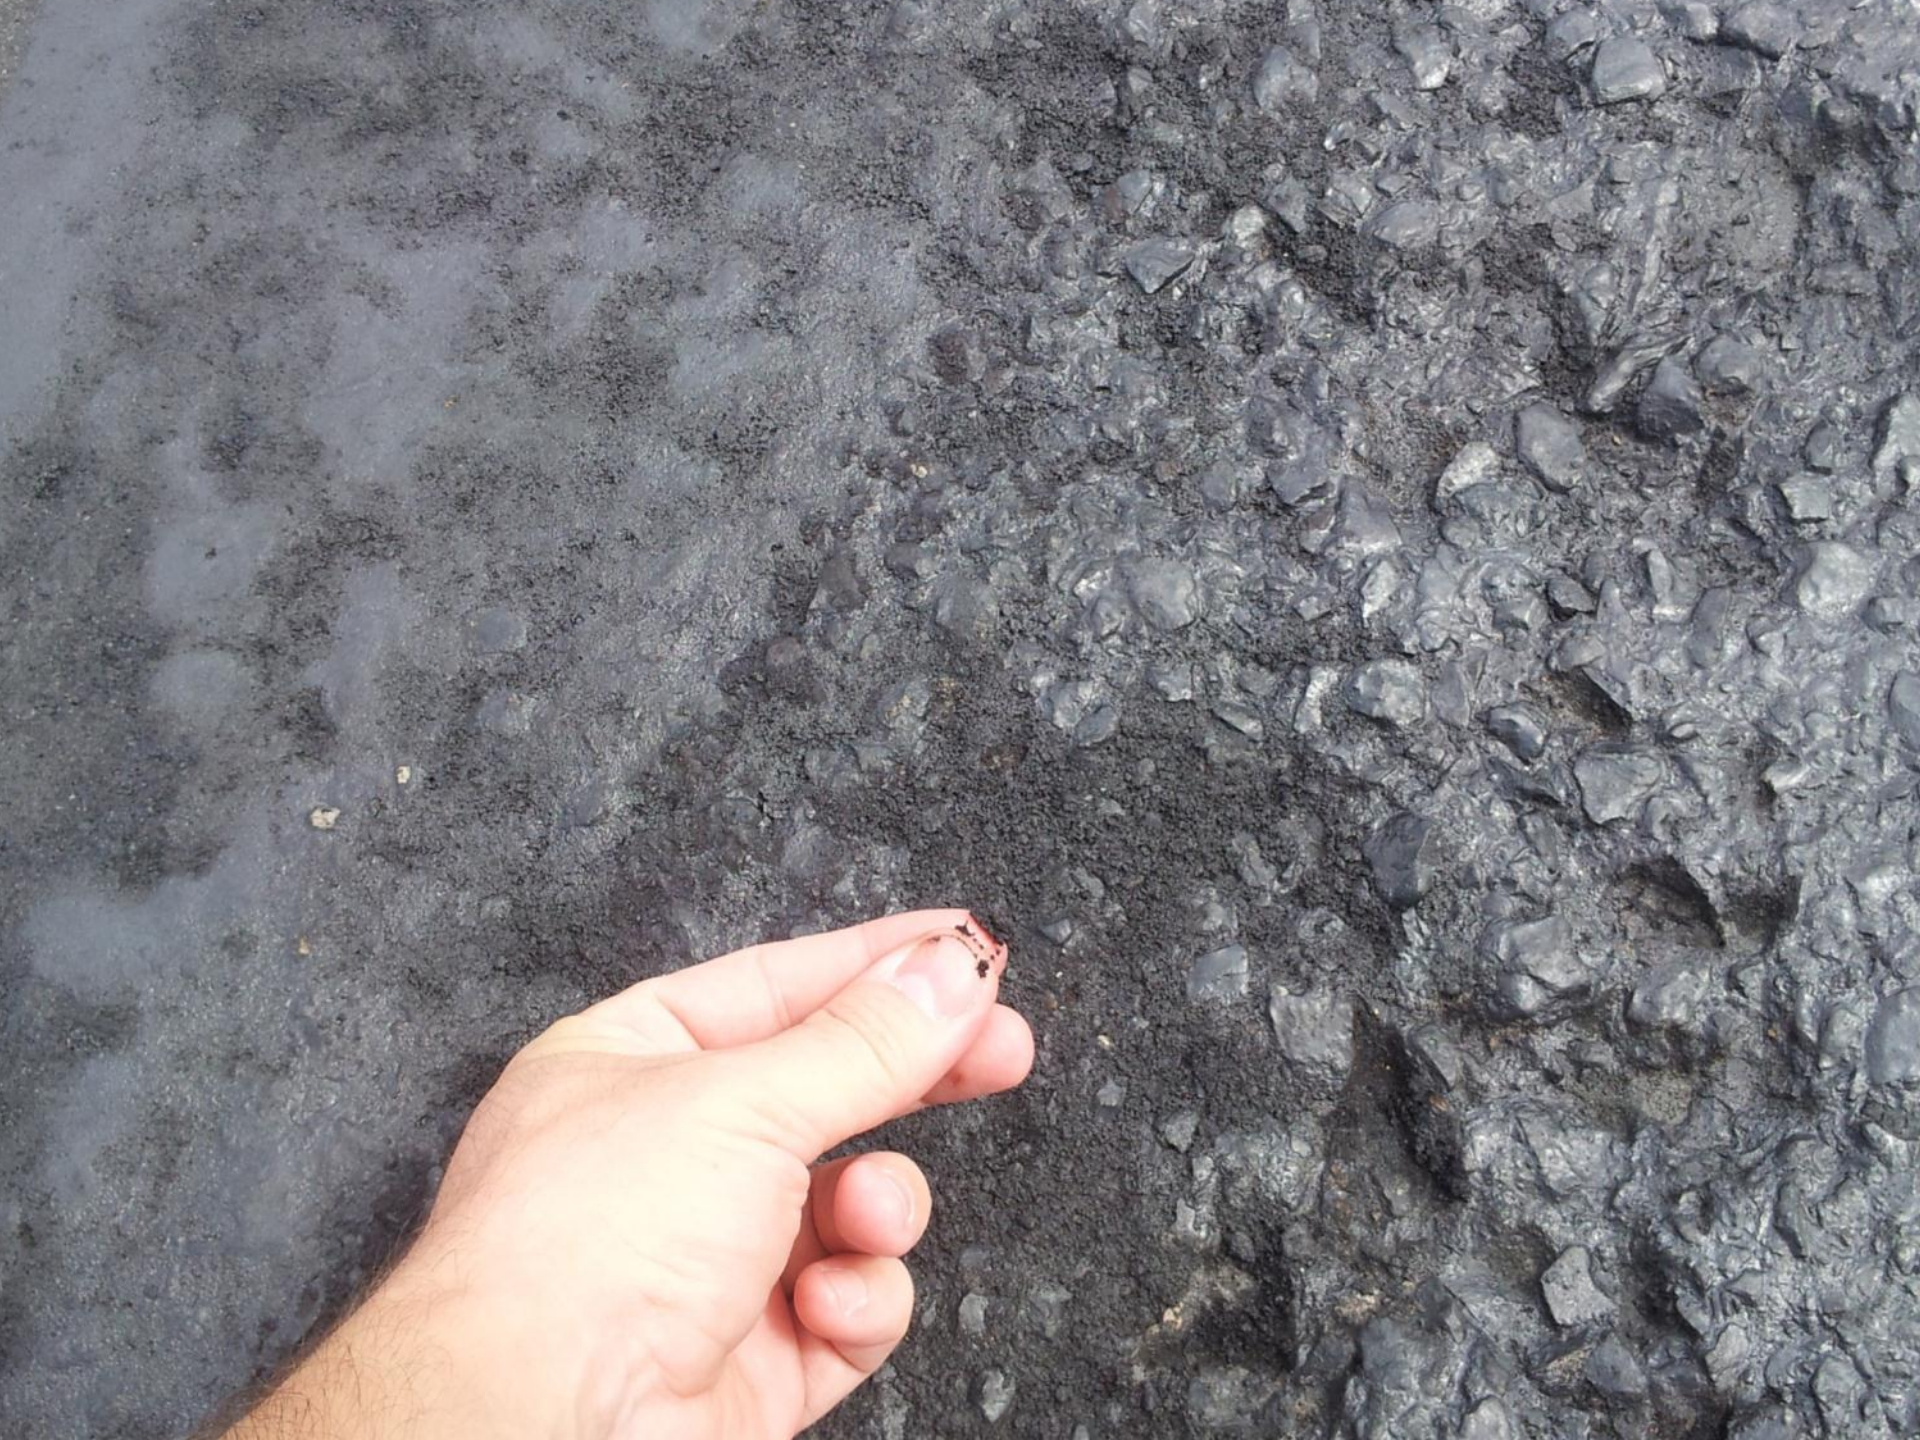
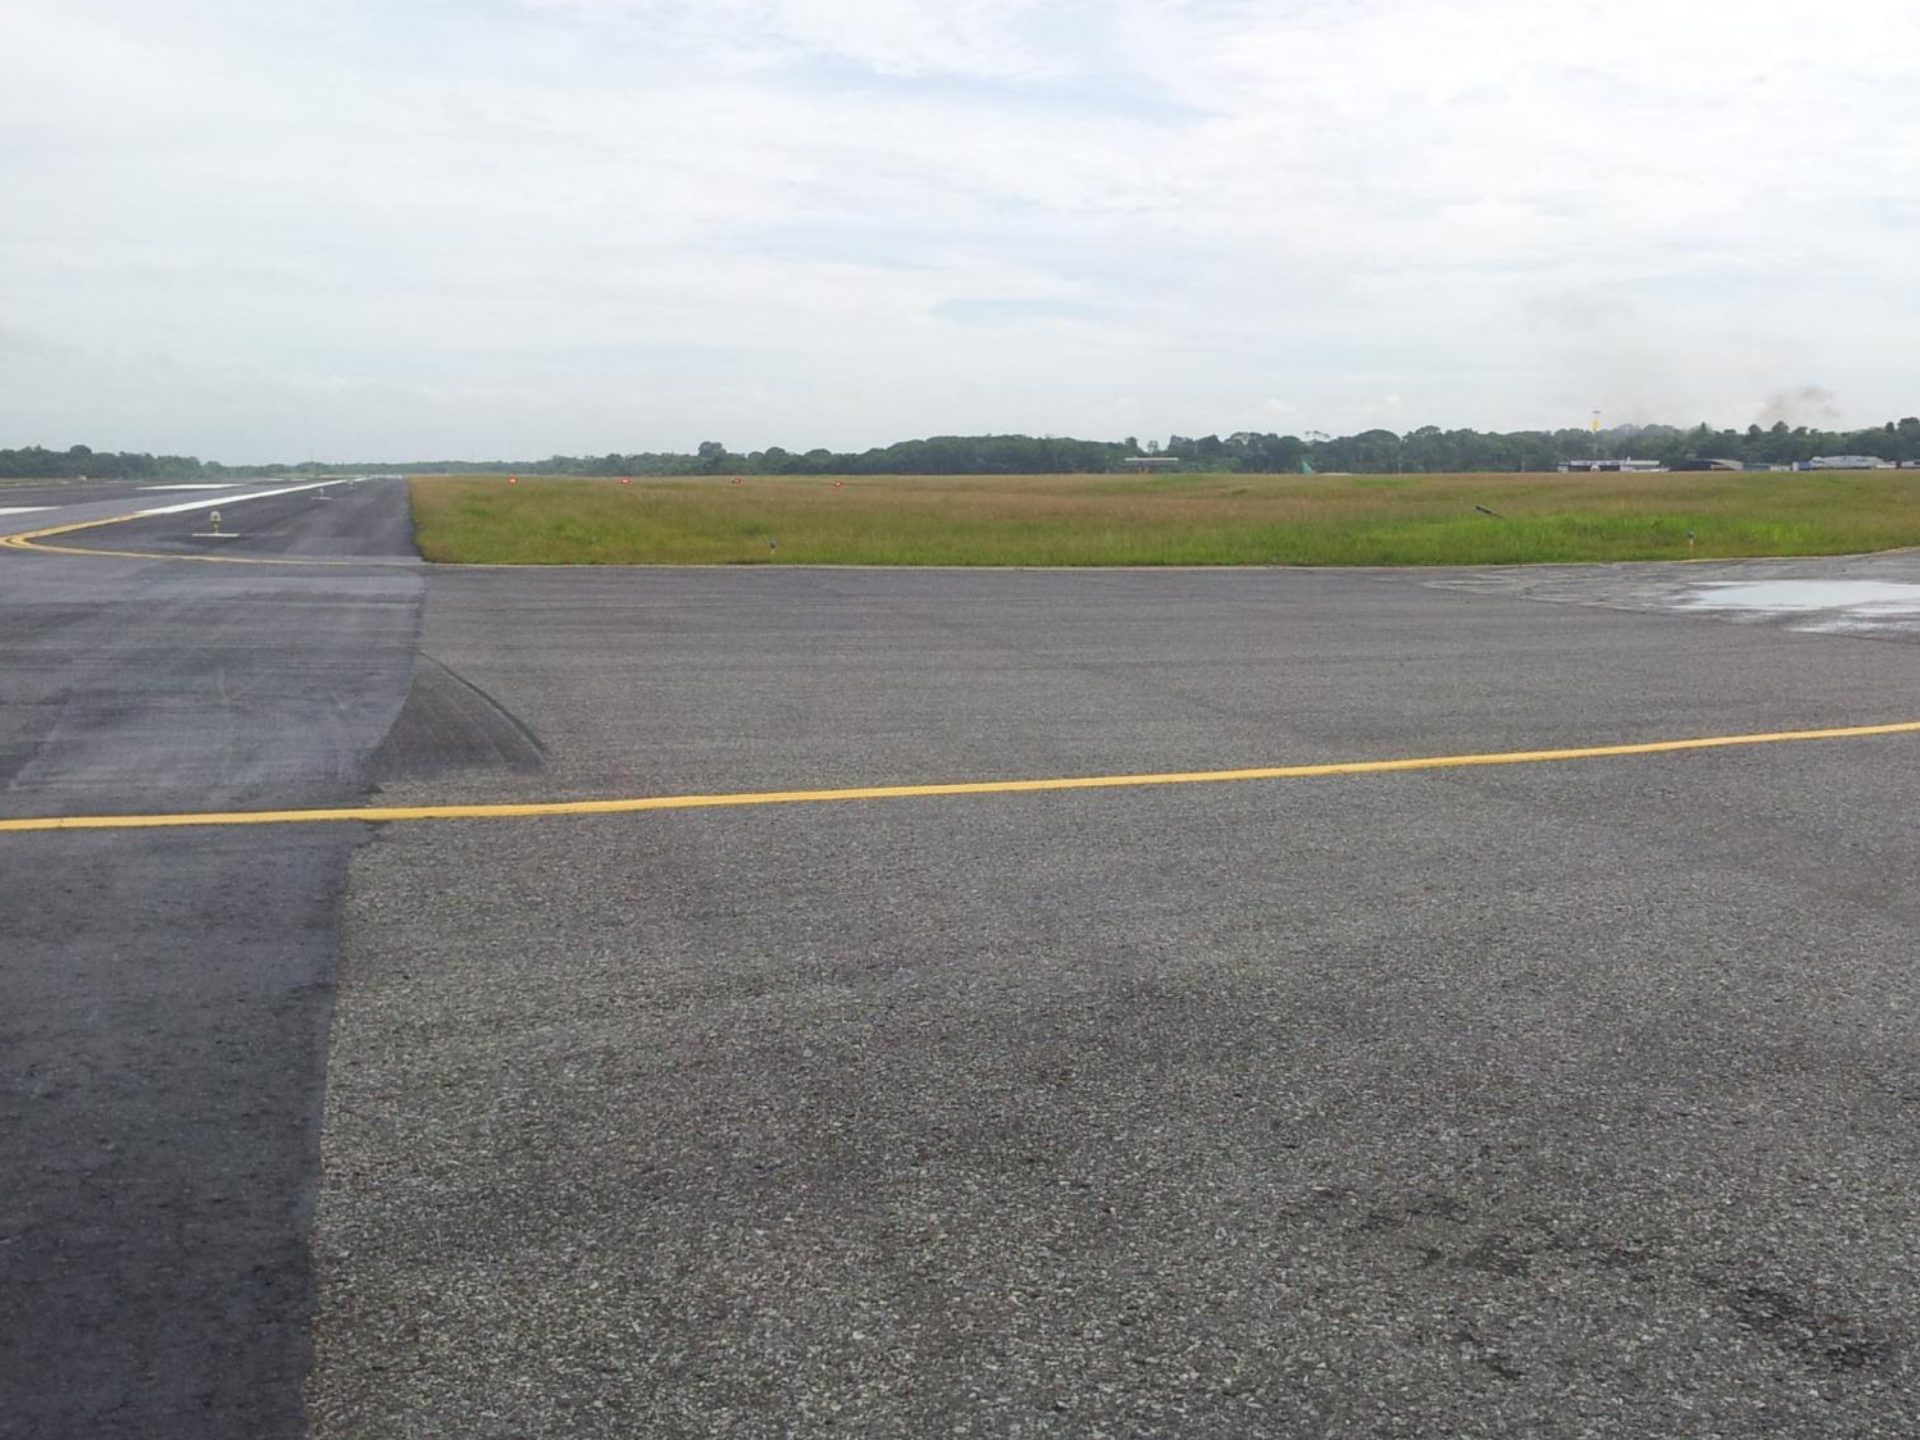
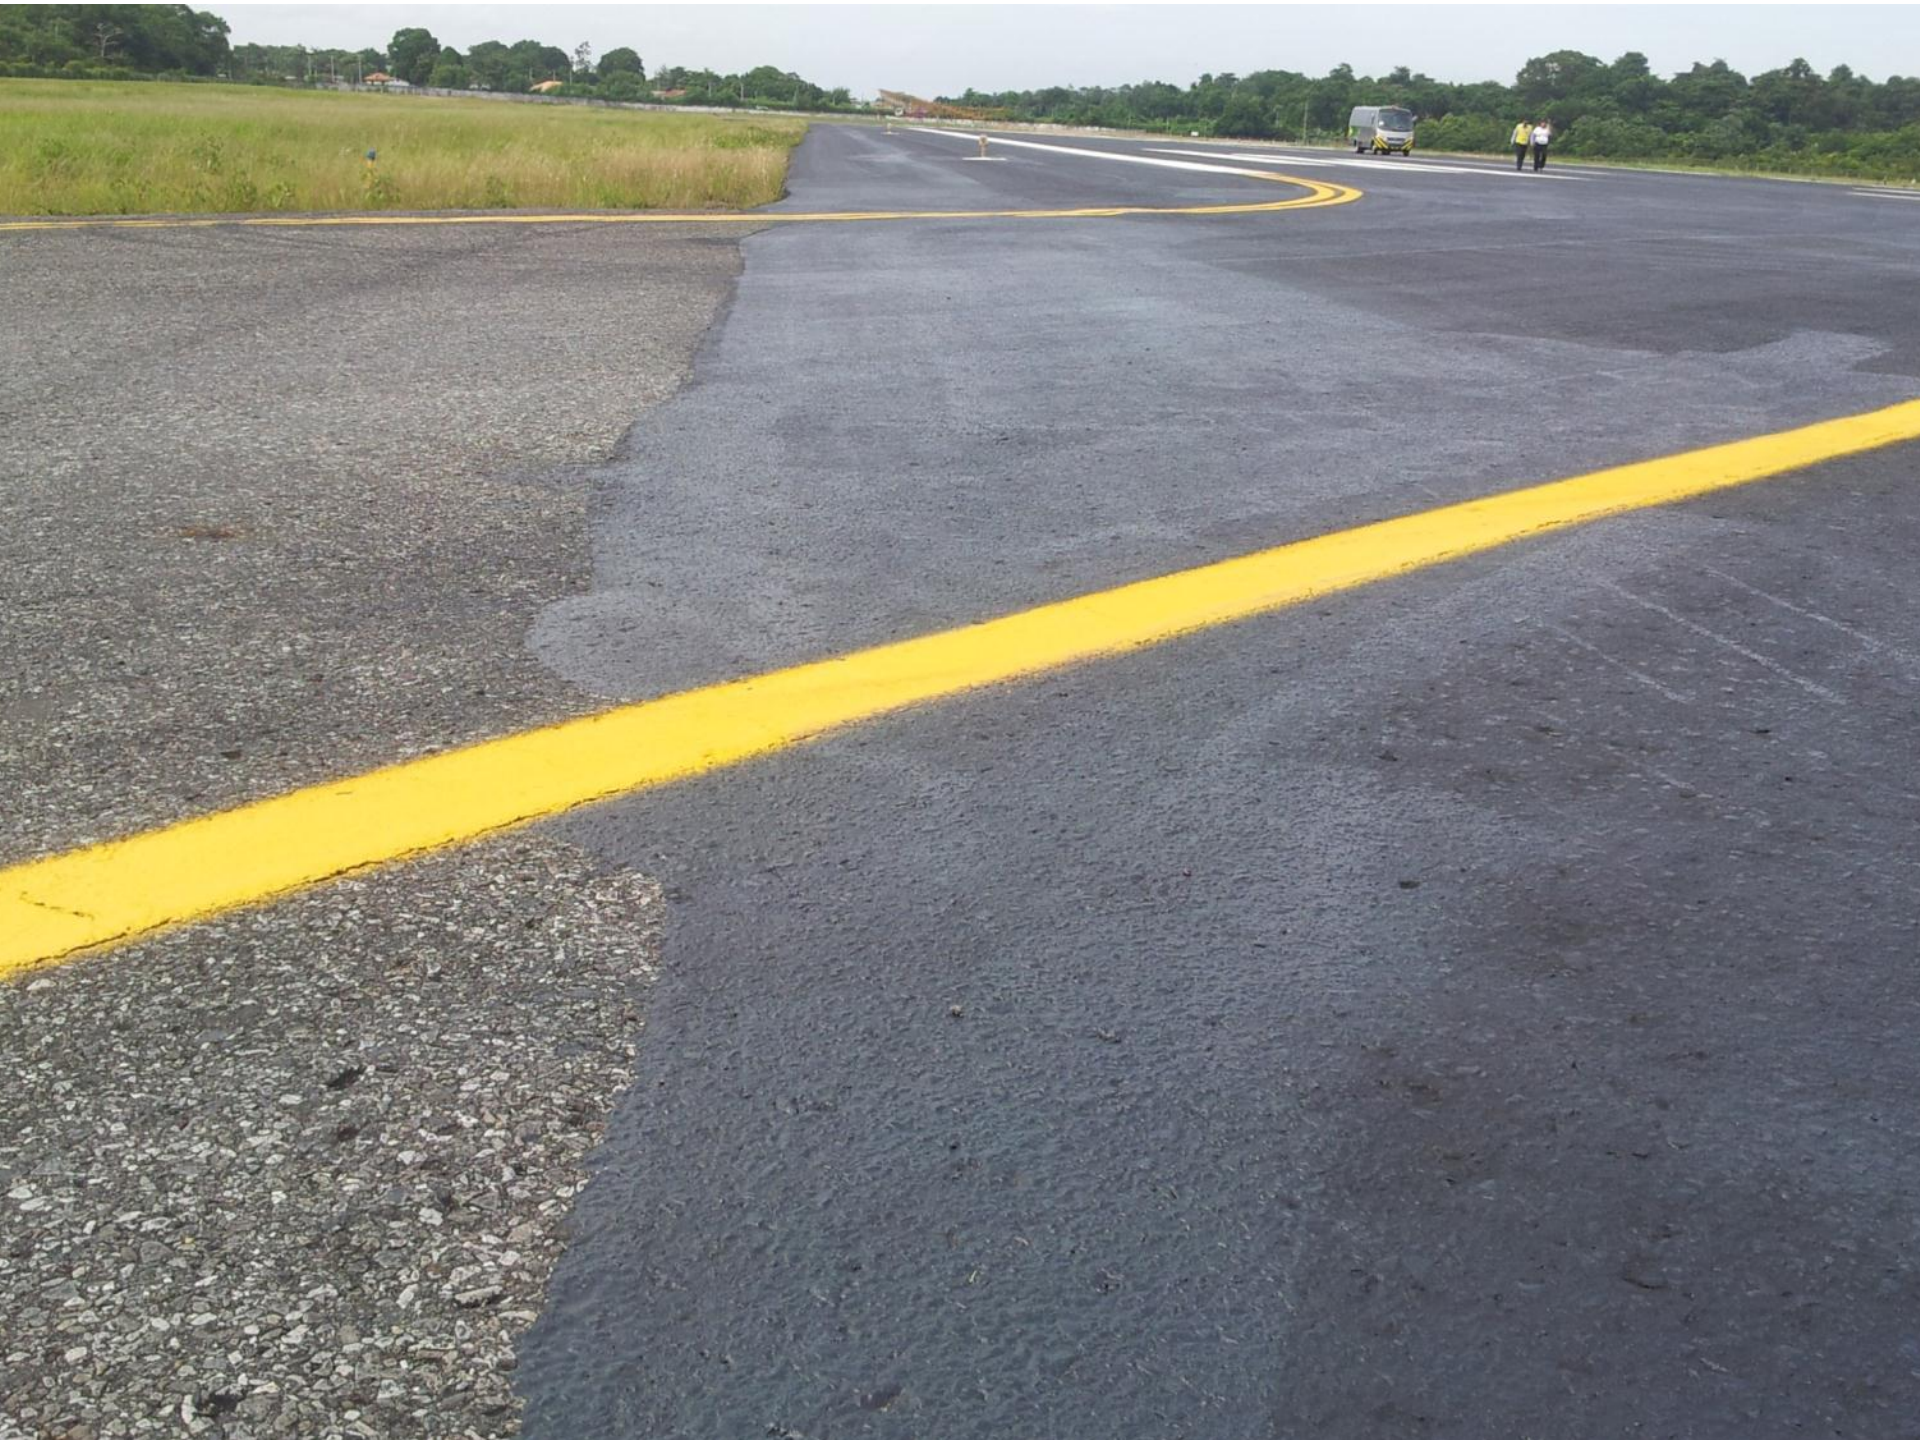
- Hazard Identification:
 - Sudden ASR increase reporting Rwy slippery when wet
 - Other airlines reporting same hazard
 - FDM Analysis
 - OCC Pilots Questionnaire
 - On site inspection

- Risk Assessment Approach:
 - Risk of veer-off
- Initial Mitigation Strategies:
 - Safety Alert
 - Autobrake setting determination
 - Restricted operations when wet
- Cooperative Mitigation:
 - Meeting with airport authority high management
 - Identification of specific spots requiring maintenance
 - Complete PDC removal

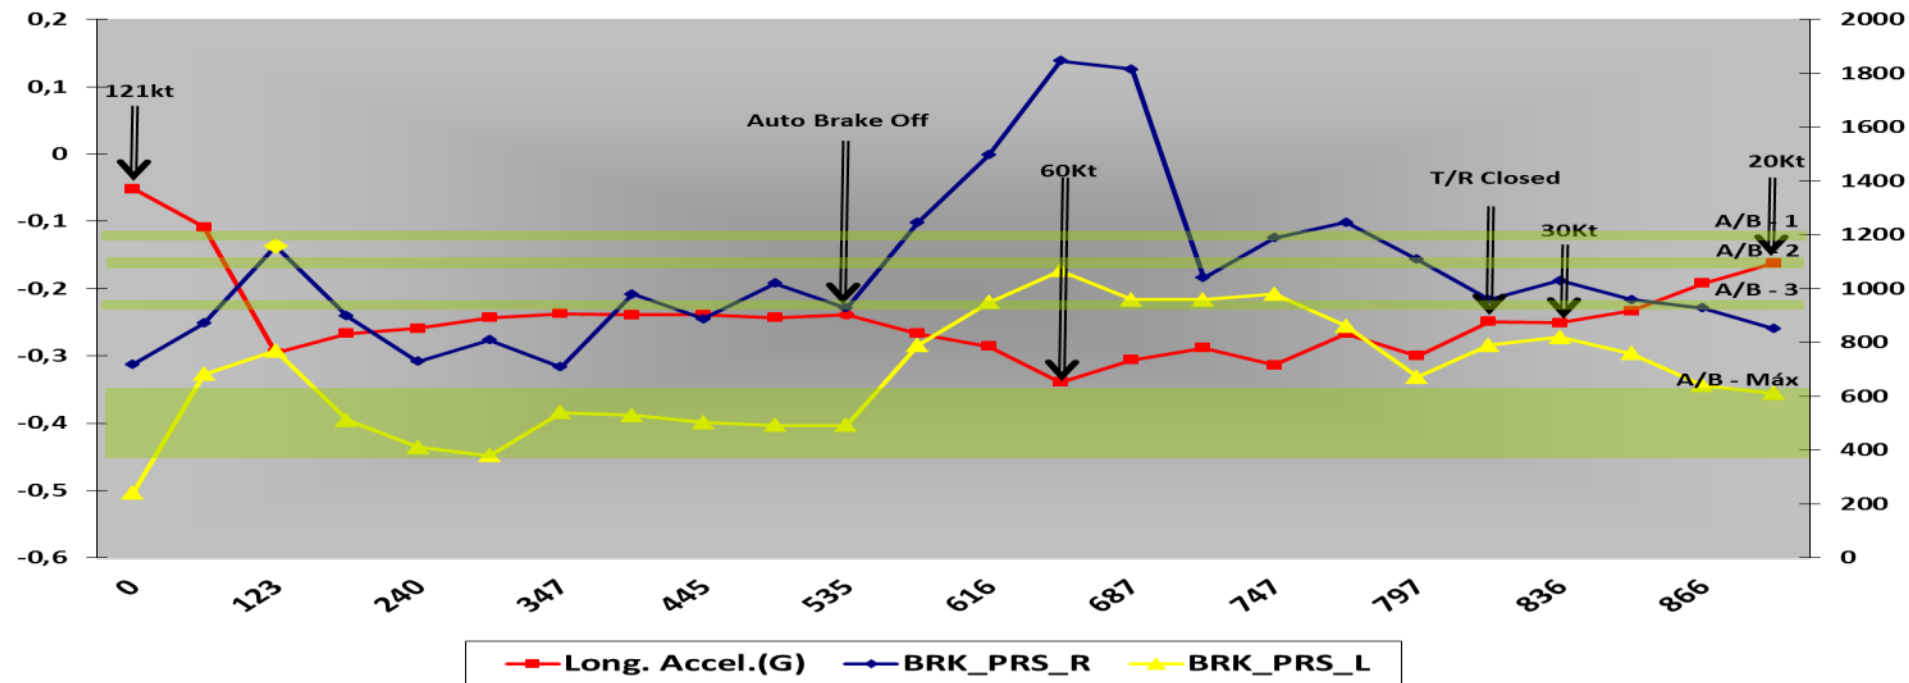
ANÁLISE FRENAGEM VOO 2 - B700 GW 53.35(t)

METAR: SBBE 081817Z 01008KT 9999 -TSRA BKN020 FEW025CB BKN100 25/22 Q1009
RERA
