Airports Safety & Standards

Prepared for: Review Committee of GREPECAS (PPRC/3)
Mexico City, Mexico

Date: July 20-24, 2015

Runway Excursions

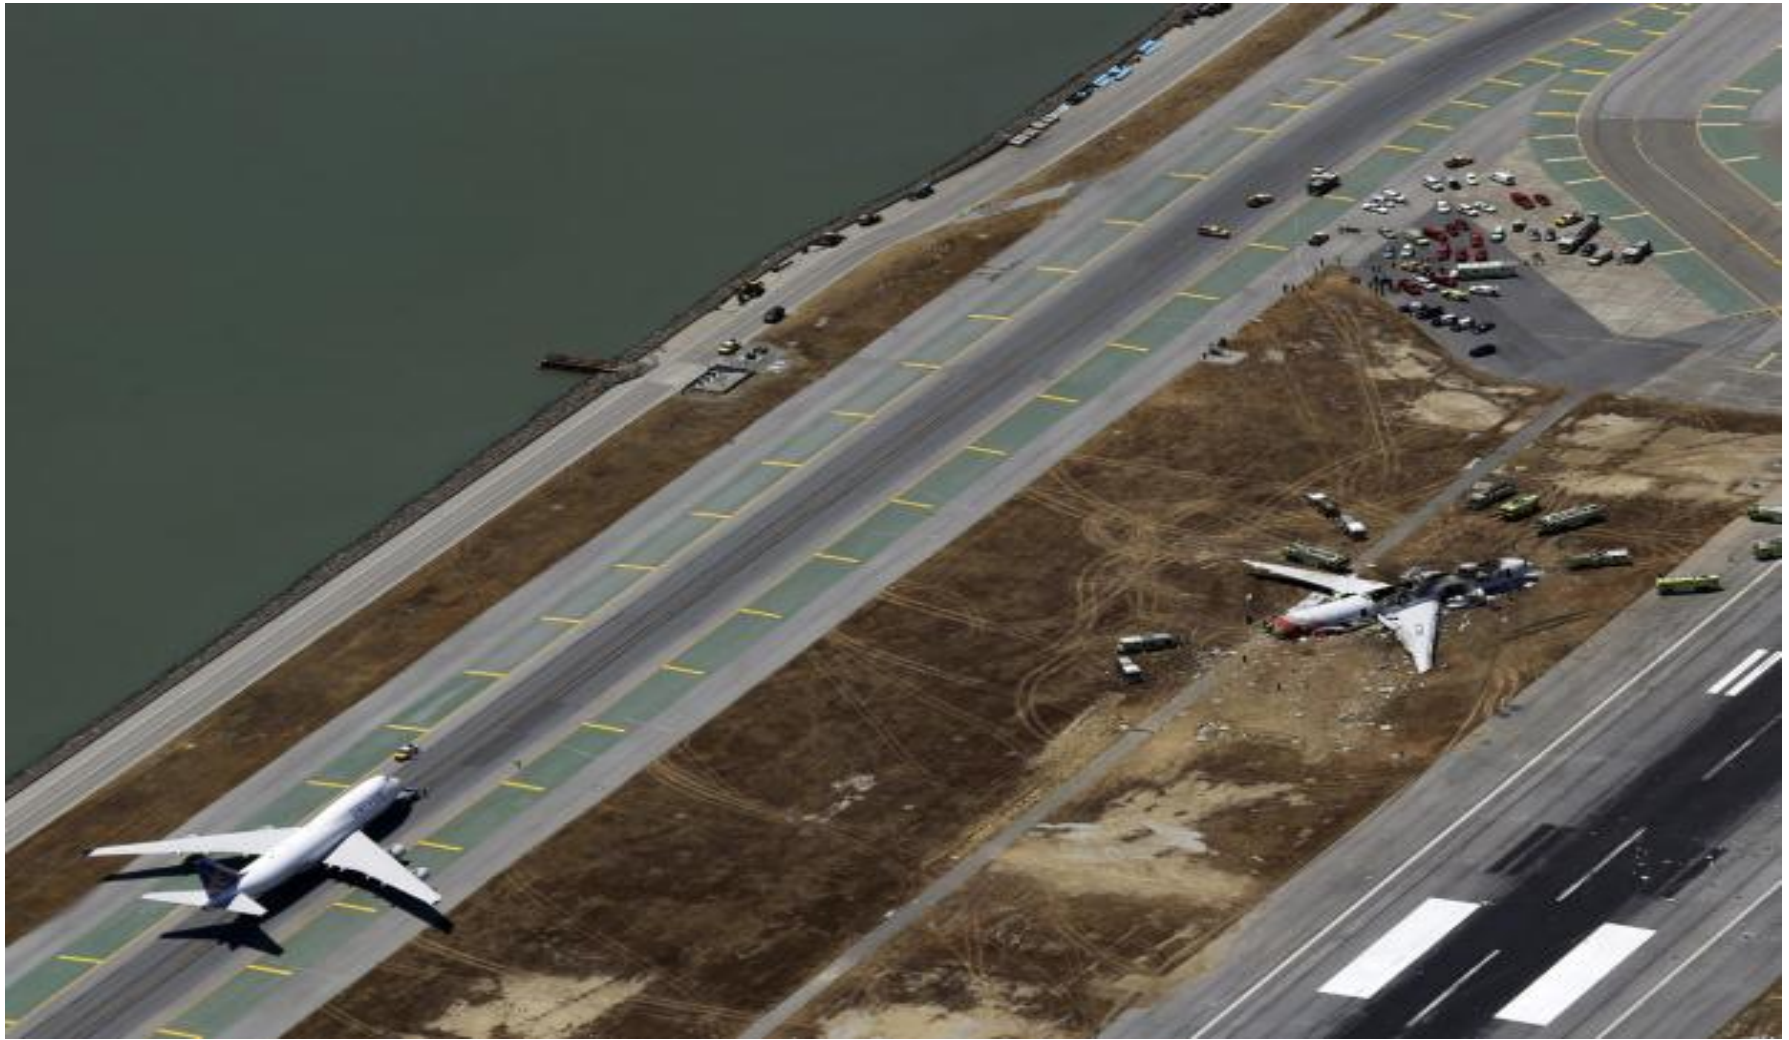
Runway Excursions - Latest SFO Incident

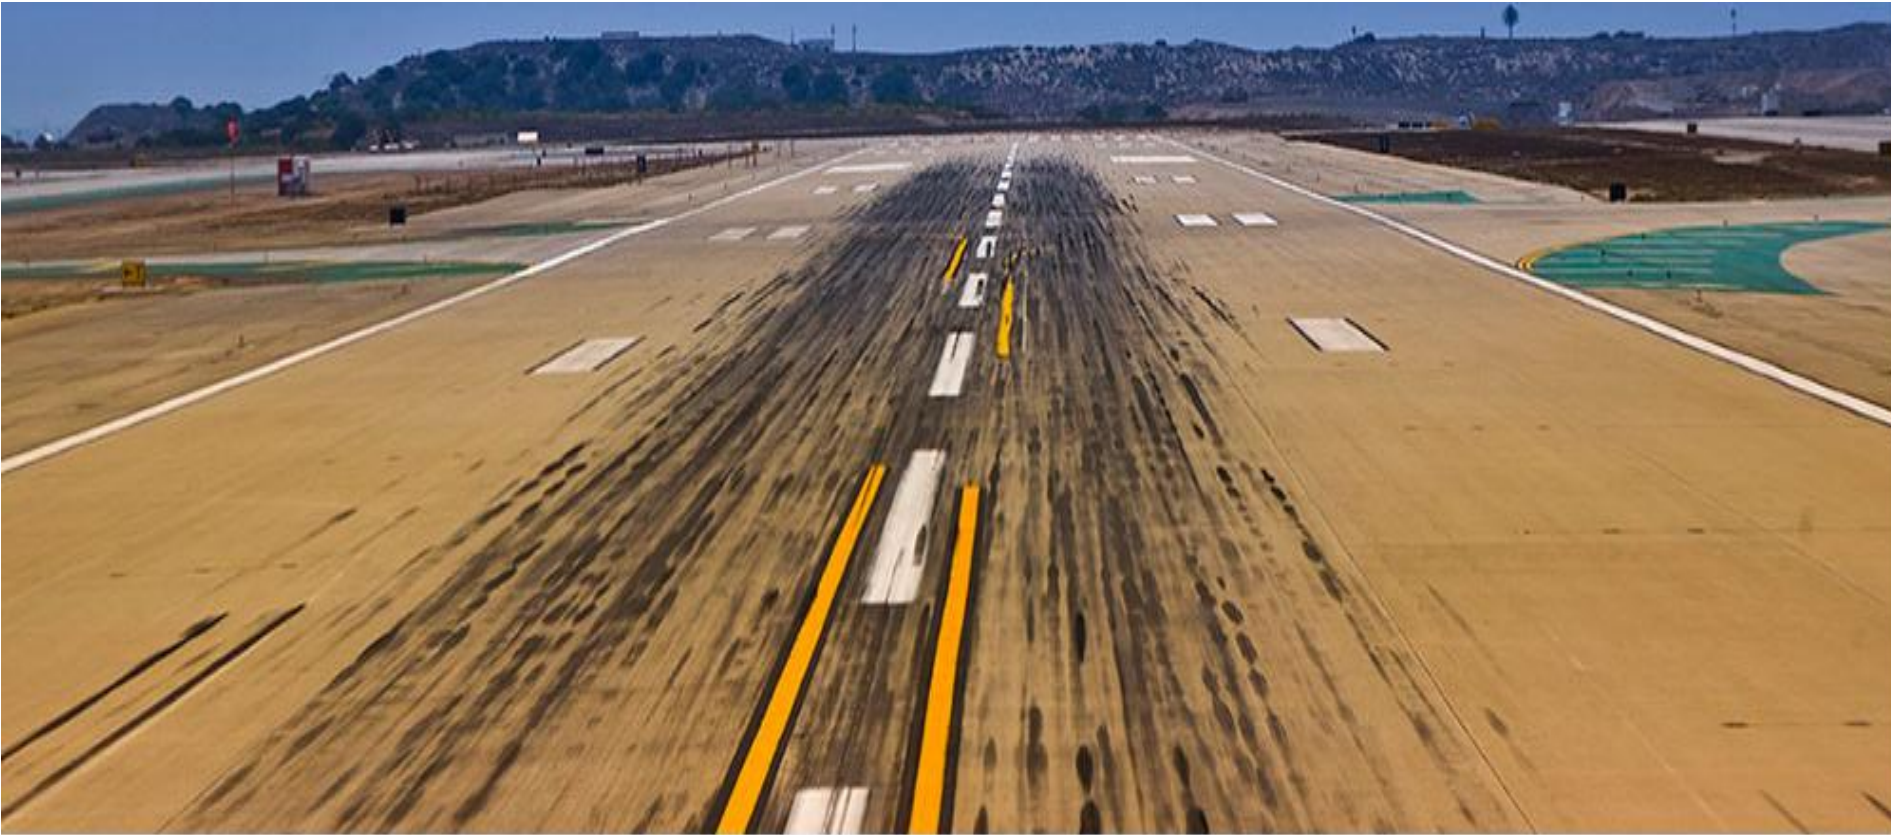
Contributing Factor Gradual Rubber Accumulation

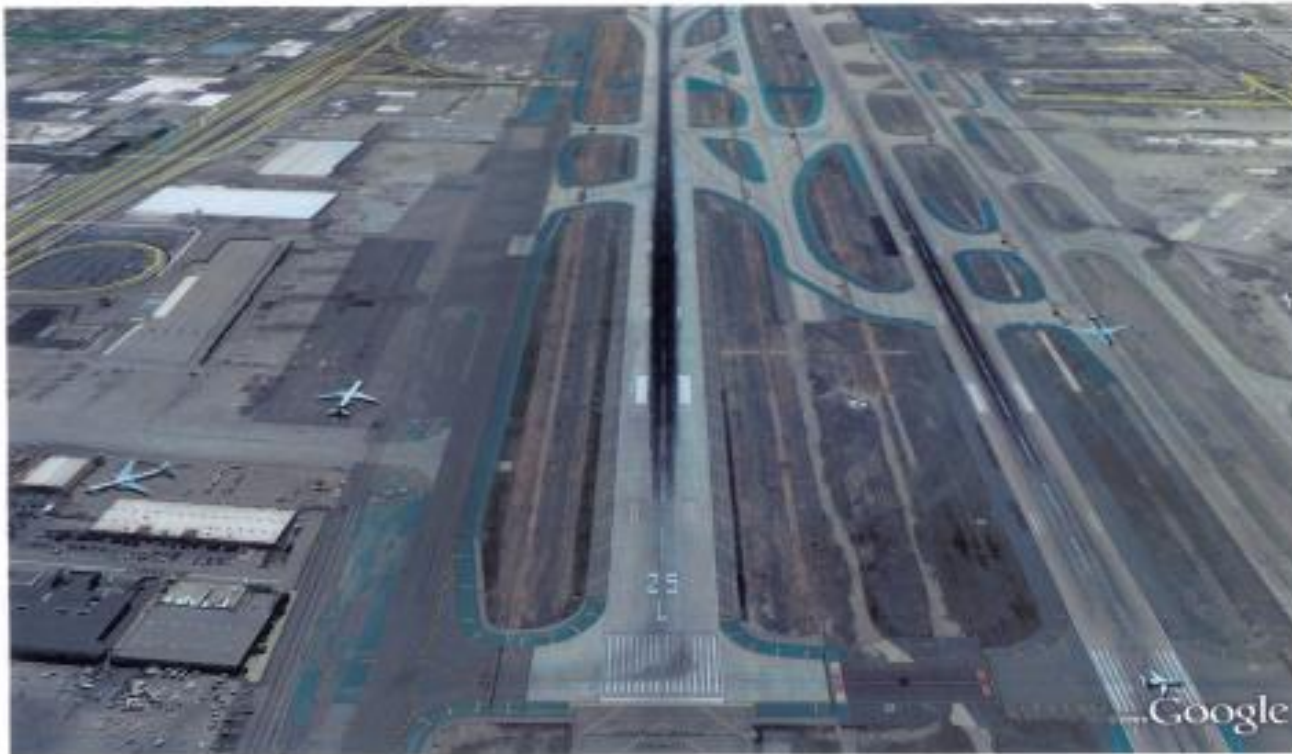
Heavy Rubber Build-Up

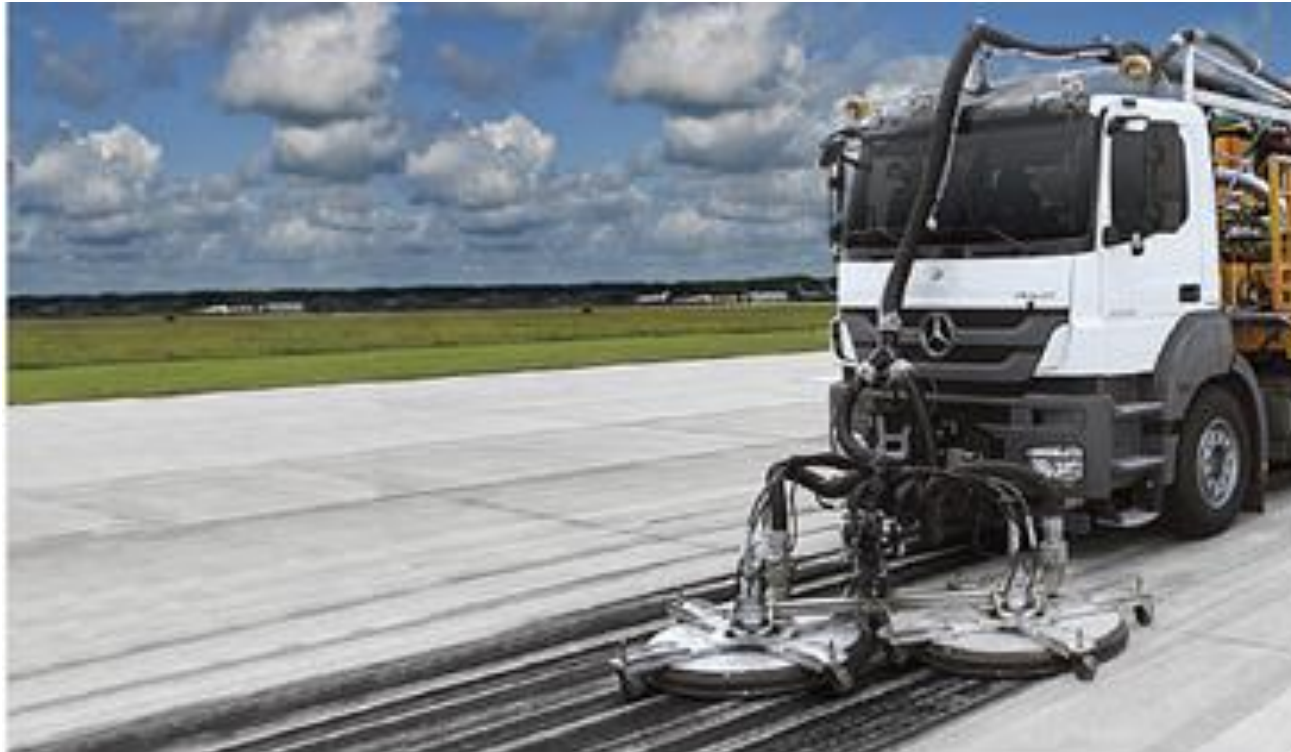
Rubber Removal from Runway Surface

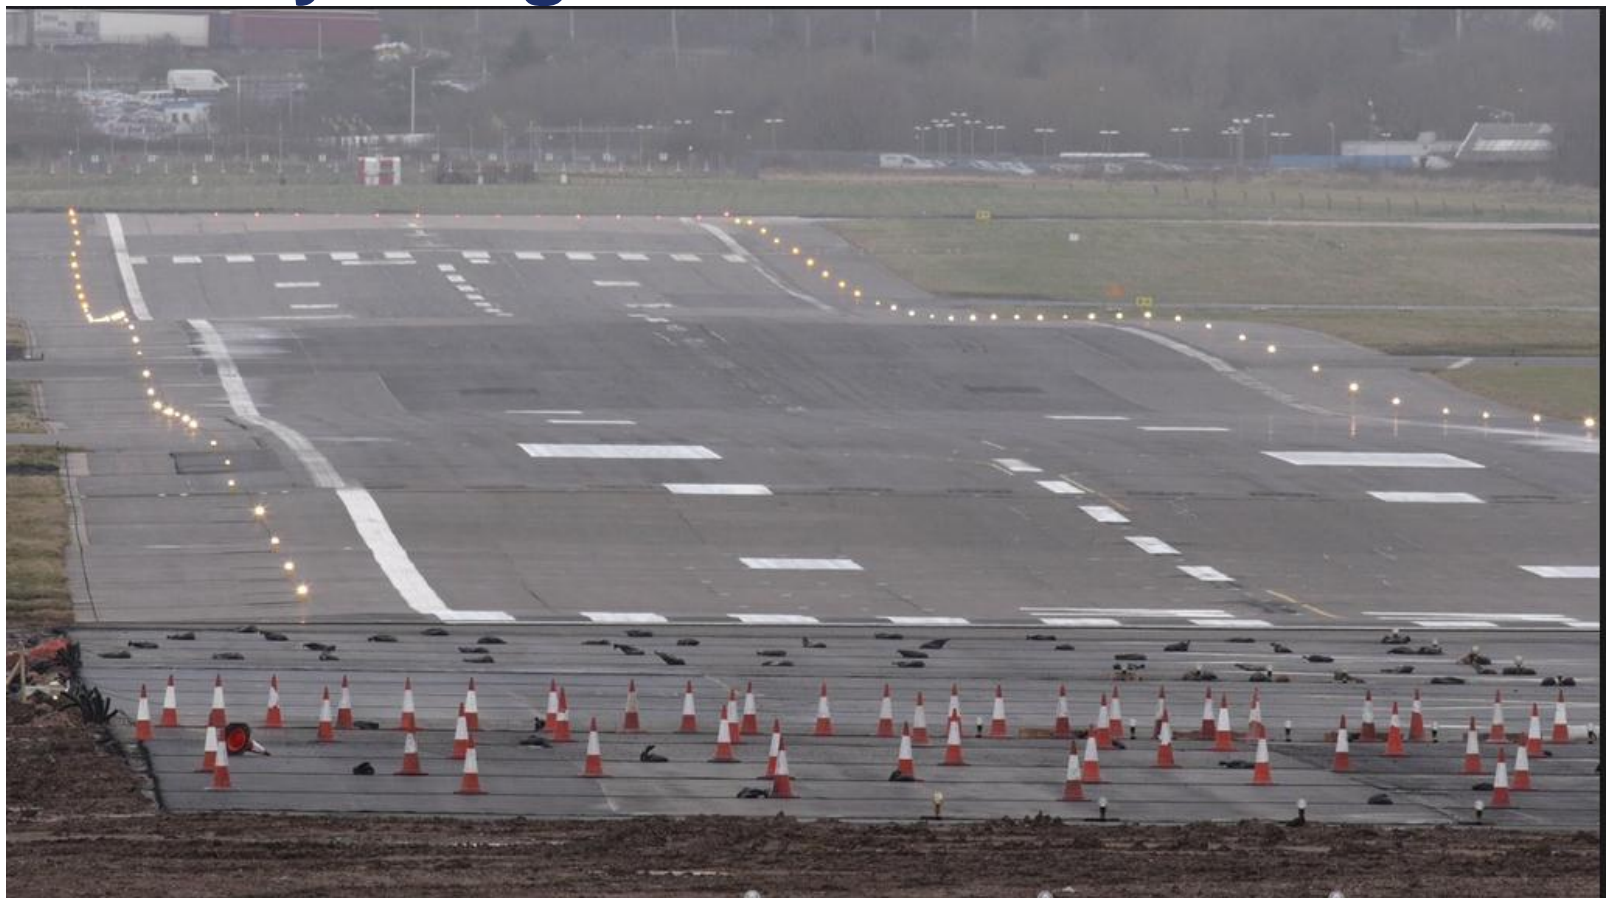
Contributing Factor: Excessive Runway Longitudinal Grade

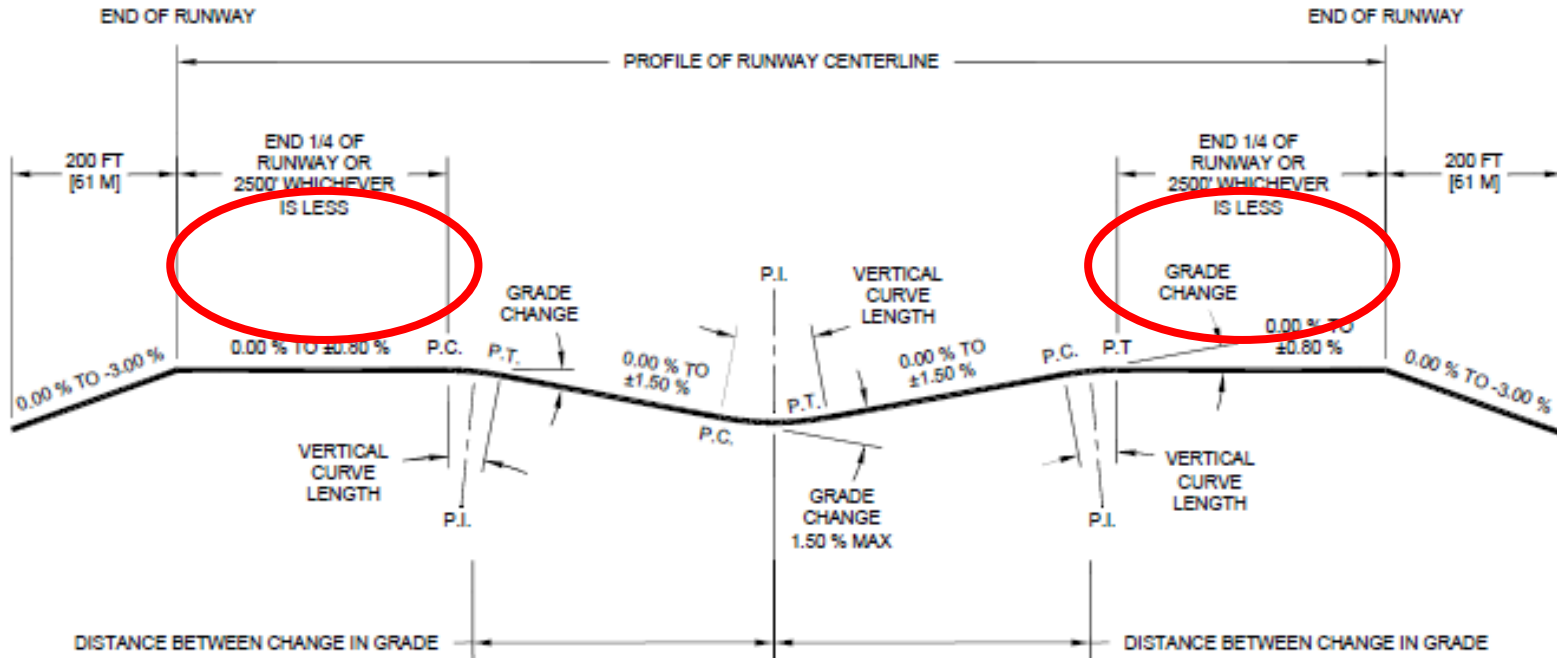
Solution: Criteria for Runway Longitudinal Grades

First and Last Runway

Quarter or 2500 feet – whichever is less

FAA Aircraft Approach Category C, D, E

FAA Airport Design Advisory Circular AC 150/5300-13

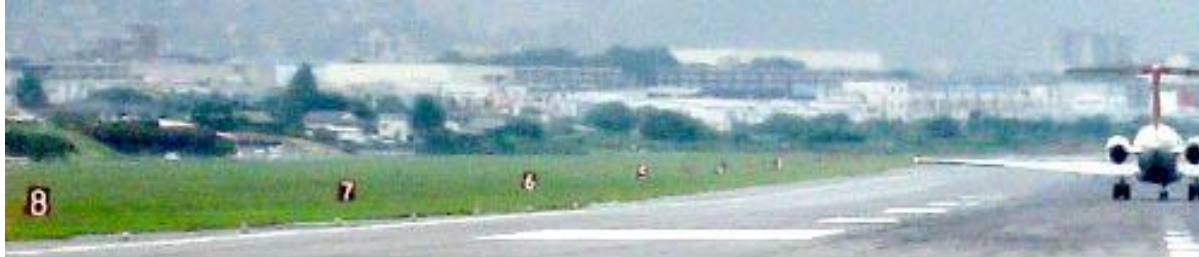
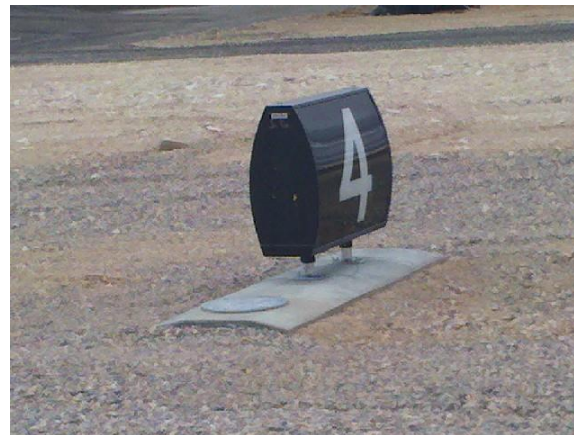
Solution: Distance Remaining Signs

- FAA AC 150/5340-18
- Not found in Annex 14 Vol 1

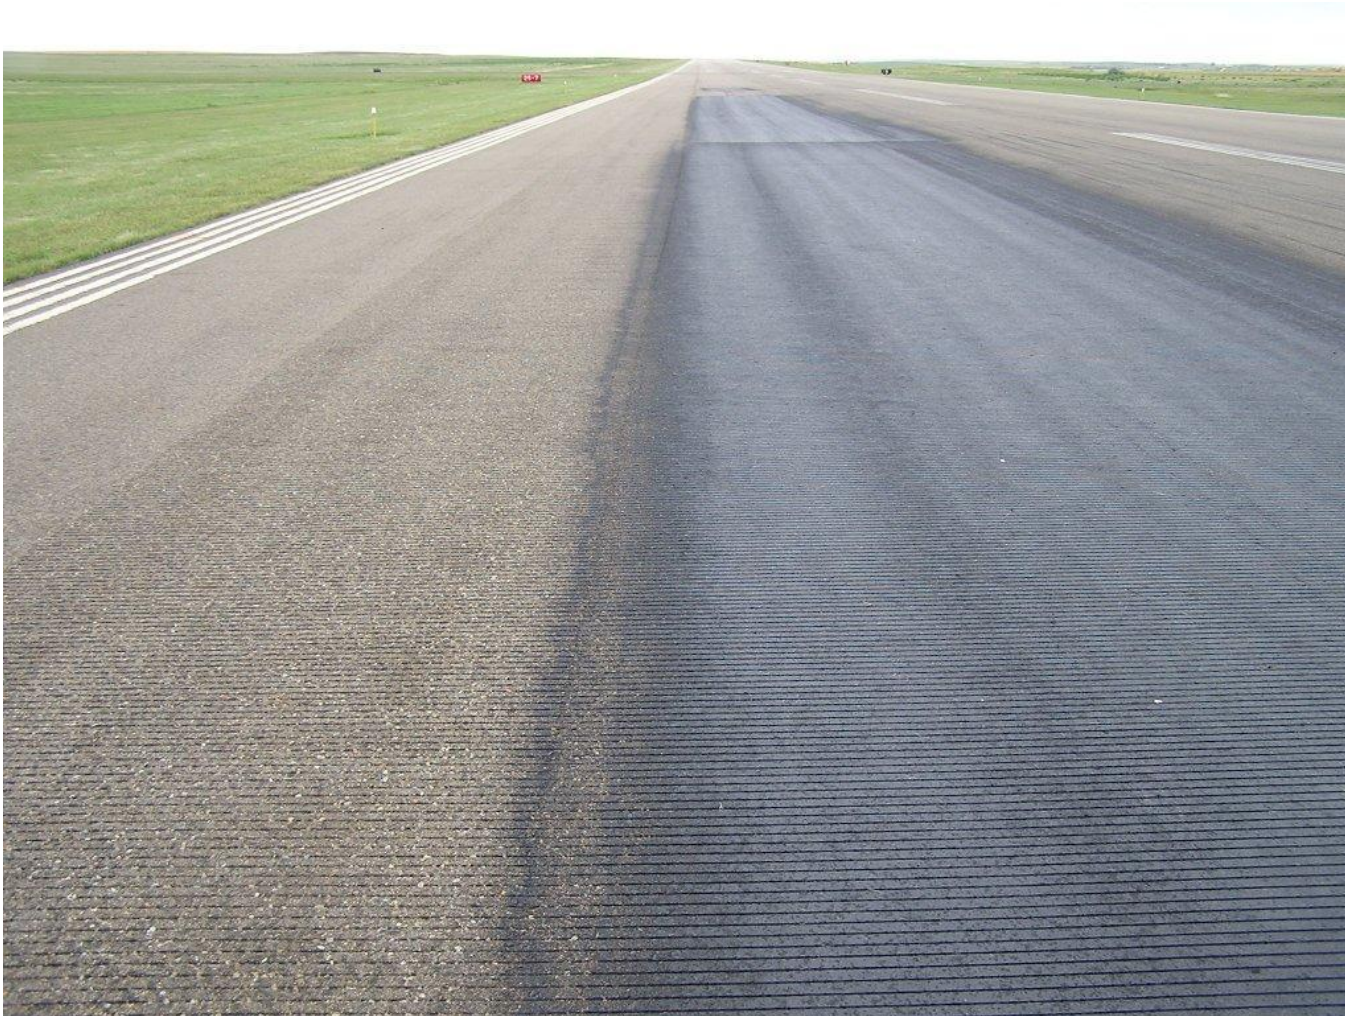
Solution: Runway Grooving

- The FAA's Technical Center includes a Runway Pavement Testing Facility.
- AC-150/5320-12

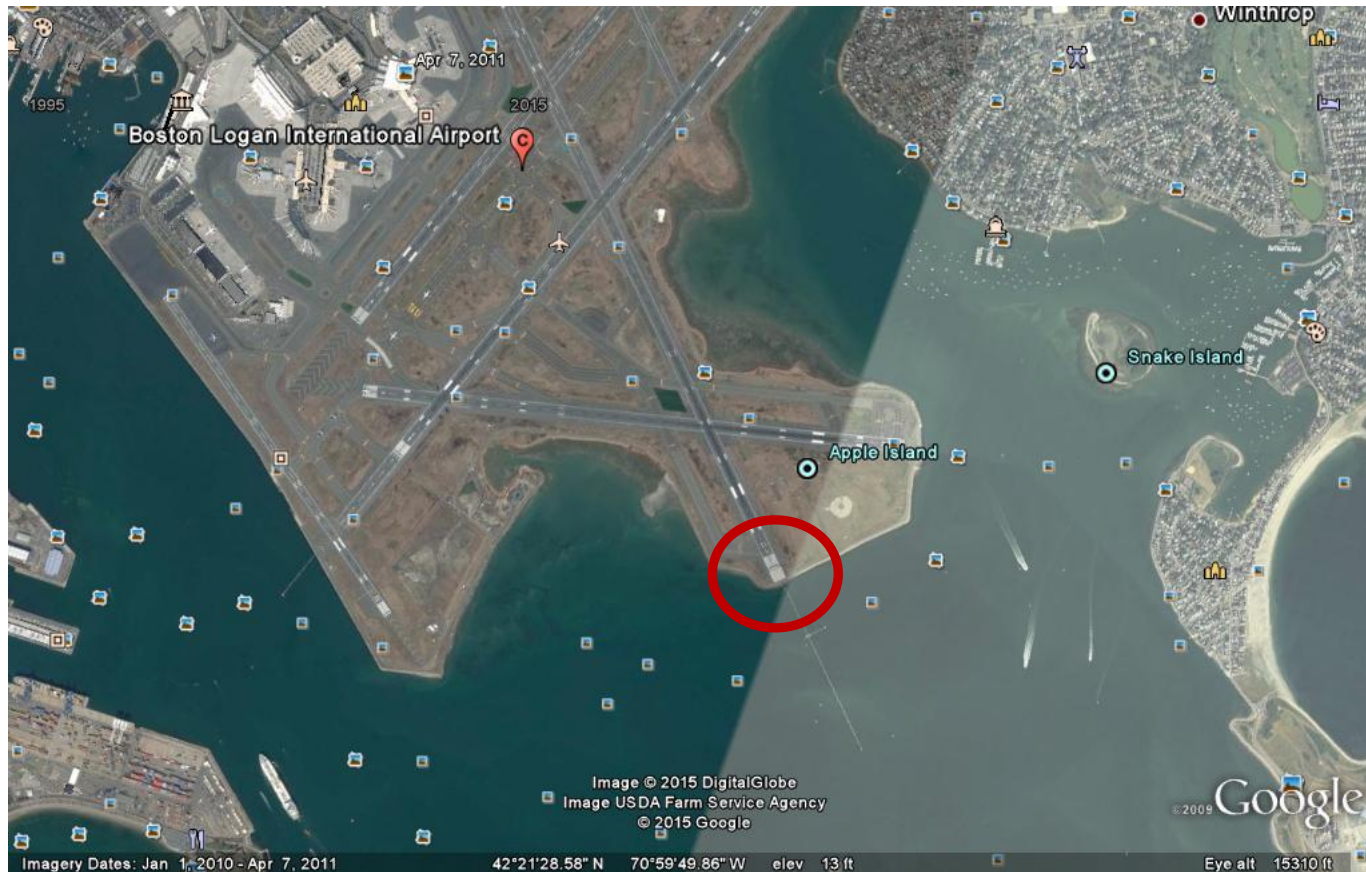
Contributing Factor: Insufficient Runway End Safety Area

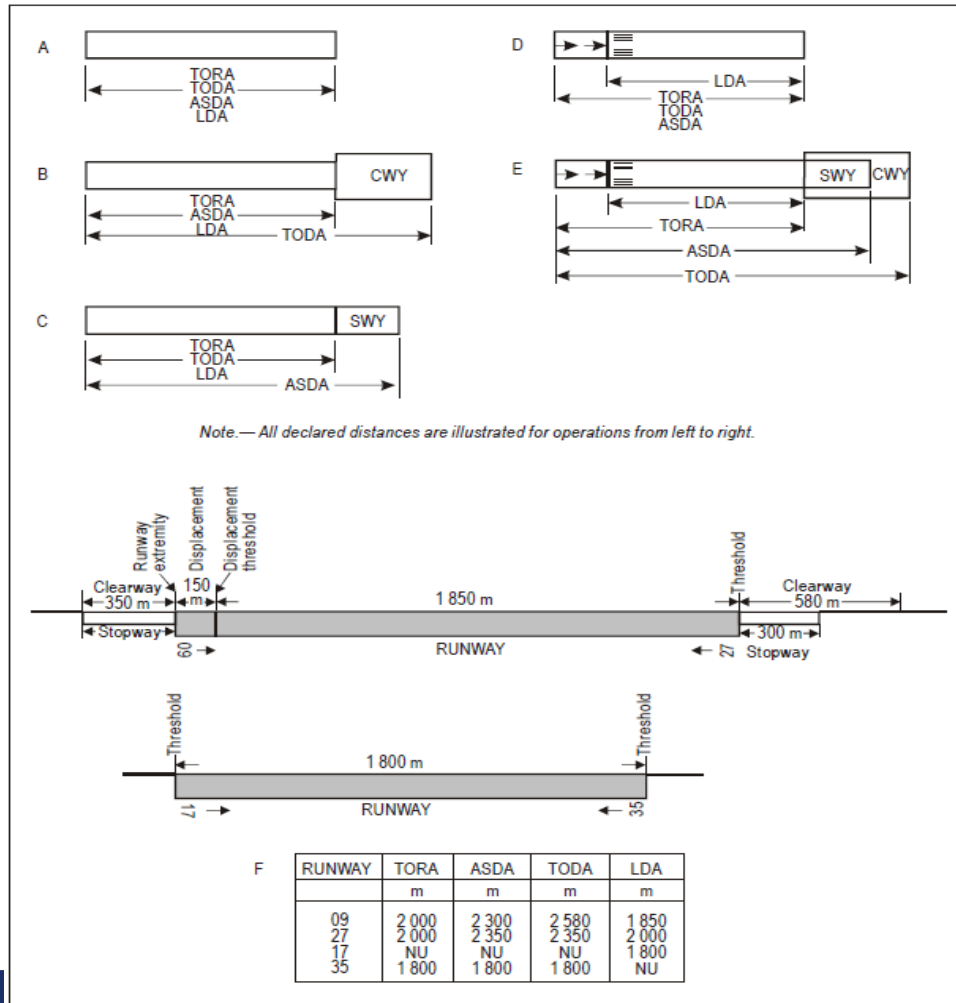
Solution: Application of Declared Distances

- Adjust Lengths of:
 - LDA
 - ASDA
- Annex 14 Vol I

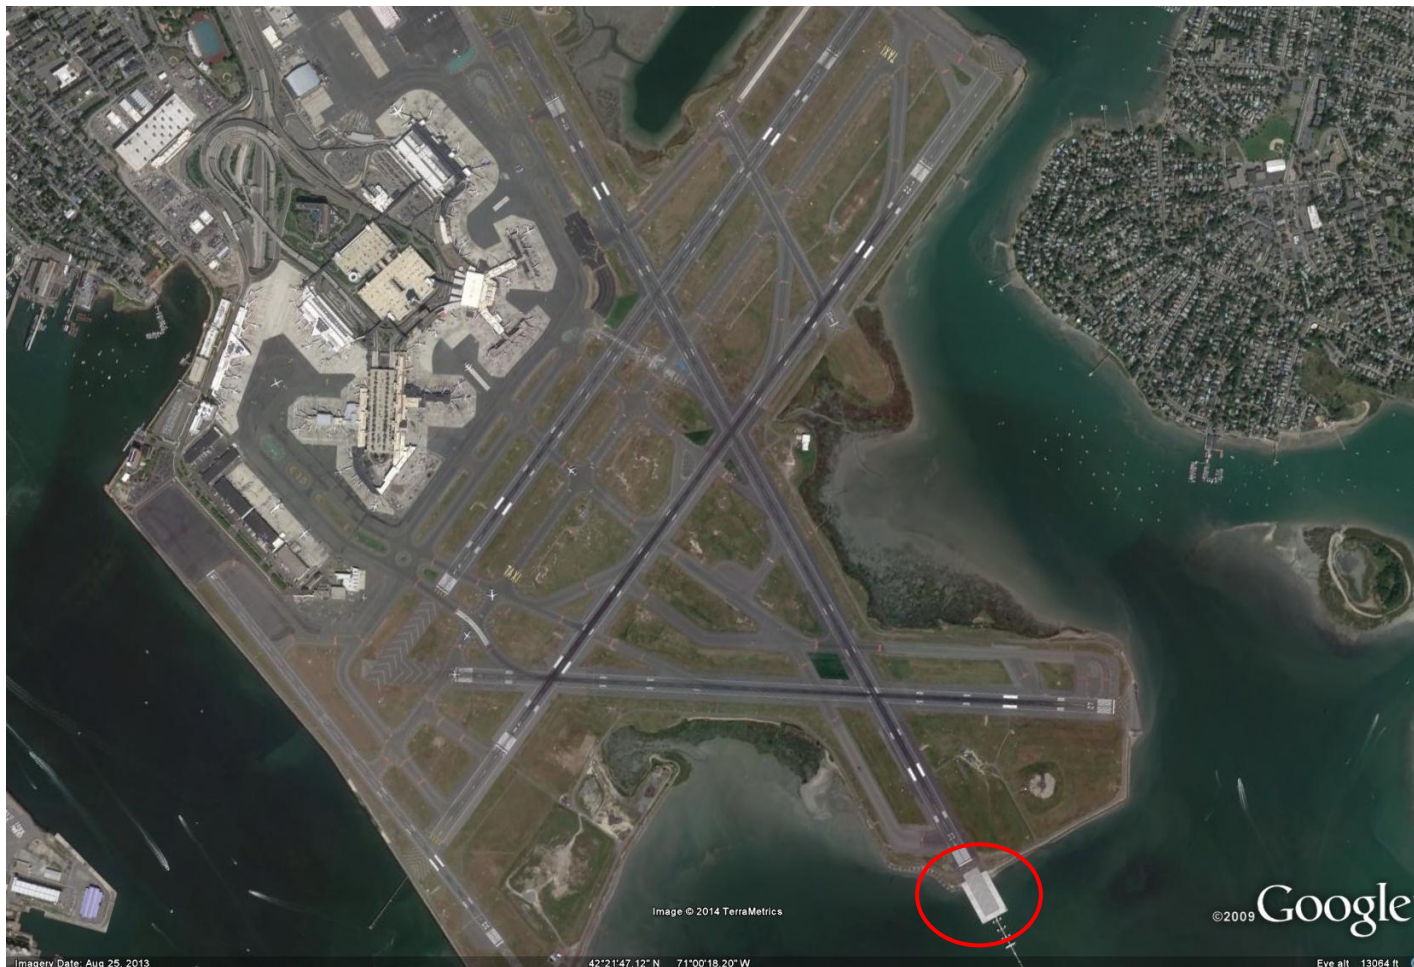
Solution: Install Arrestor Bed System Boston EMAS Installation

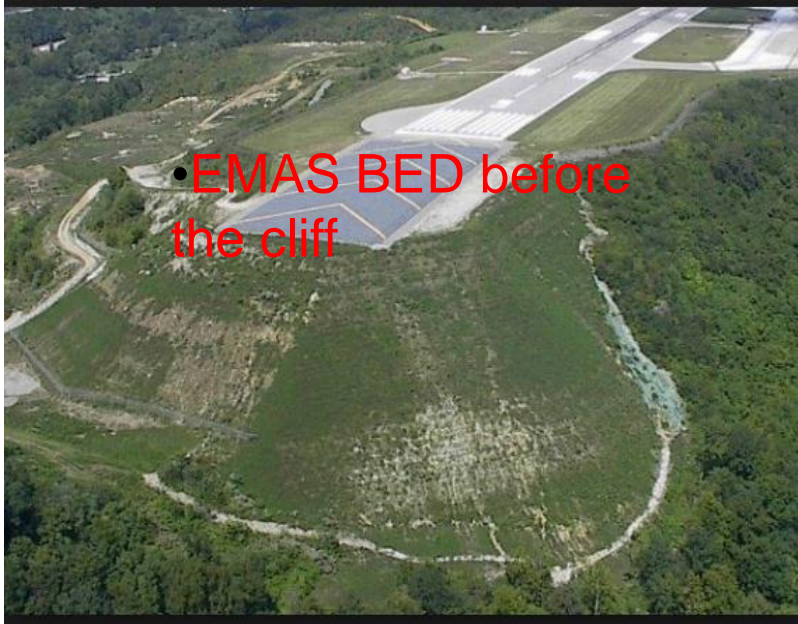
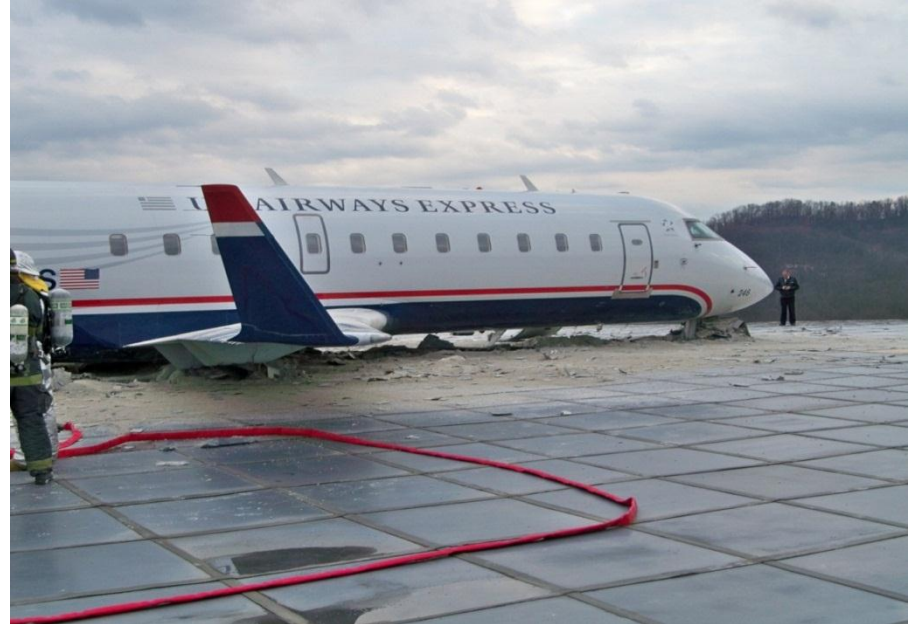
Solution: Successful Capture by Arrestor Bed Systems
