*SINGAPORE & COSCAP
CABIN SAFETY SEMINAR
19-21 NOV, 2013*

Emergency evacuation on ANA 692 at Takamatsu Airport

Akemi Inukai
Manager, Cabin Attendant Administration,
Inflight Service, All Nippon Airways CO., LTD.

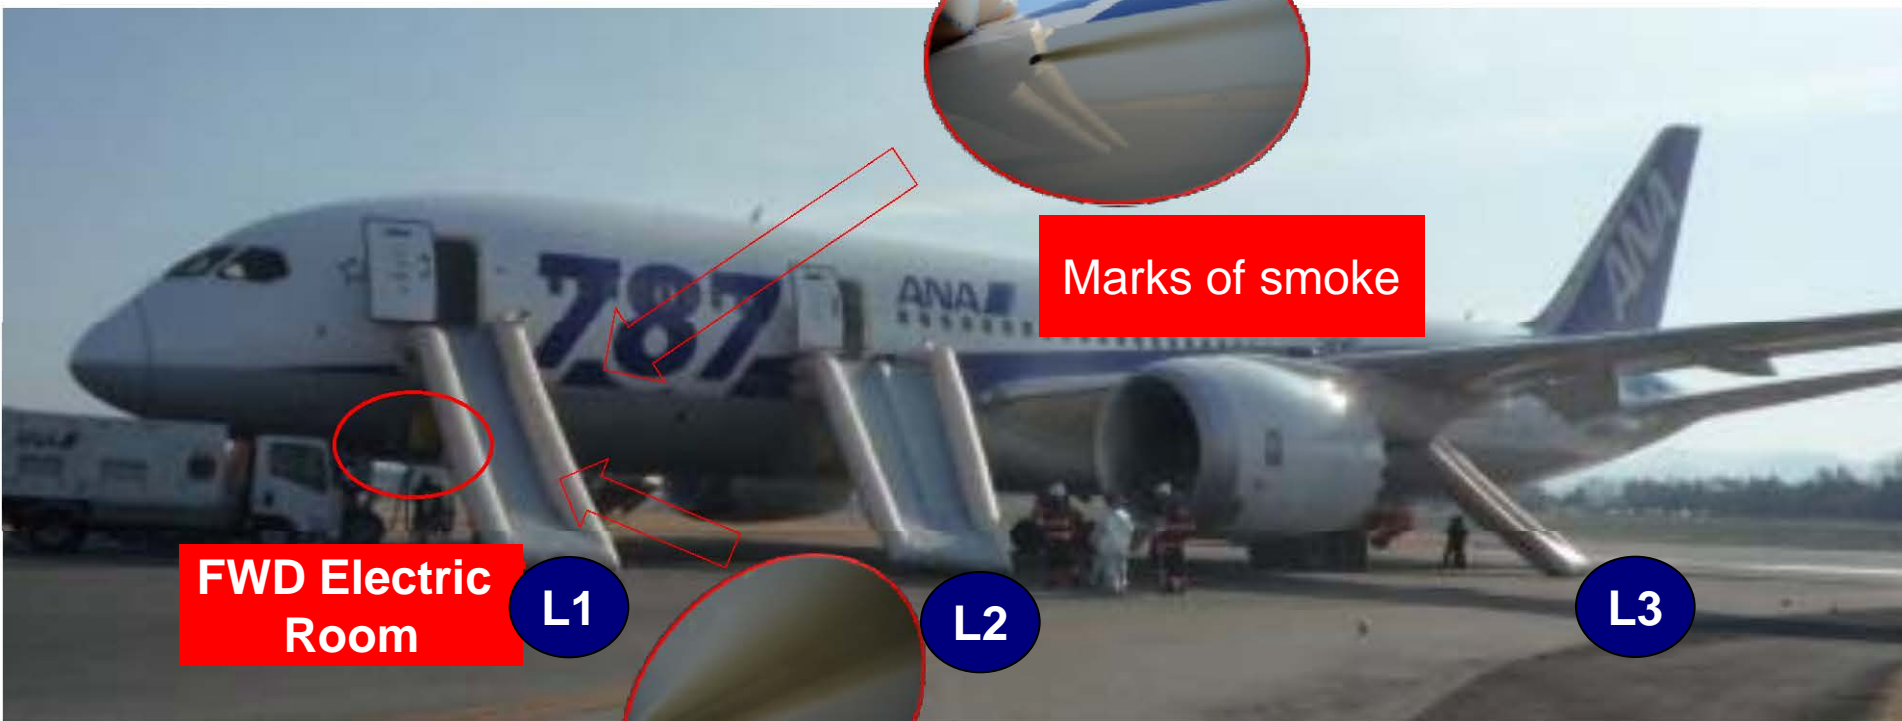
FWD Electric Room

Marks of smoke

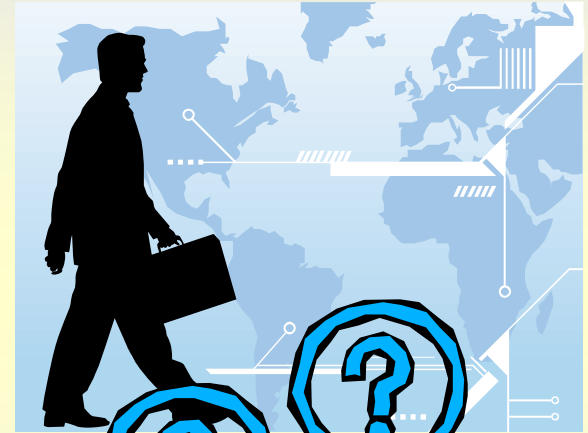
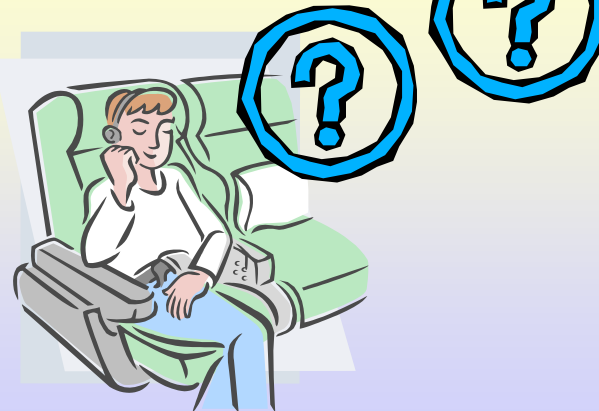
<Passenger Attributes>

- Most of the passengers : businessmen
/No infants

- PANIC or Non-Panic?

- Baggage

- Sliding condition

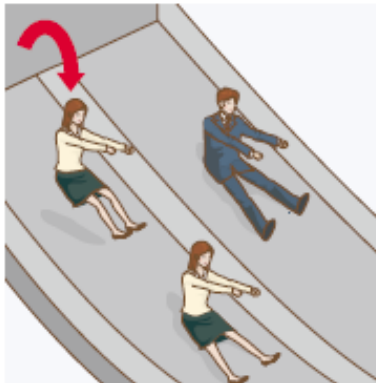
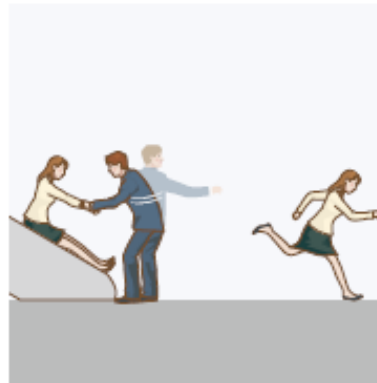
Safety Instruction Card B787-8

⚠ 脱出時の注意 | For Evacuation

飛行機が完全に停止してから乗務員の指示に従い脱出してください。
Remain Seated until the Aircraft Comes to a Complete Stop and Follow the Instructions of the Crew Members for Evacuation.
