ACCIDENT B737-300 PK-MDE MANOKWARI – PAPUA INDONESIA

By:
Fridman Ervianto
Cabin Safety Inspector

13 April 2010

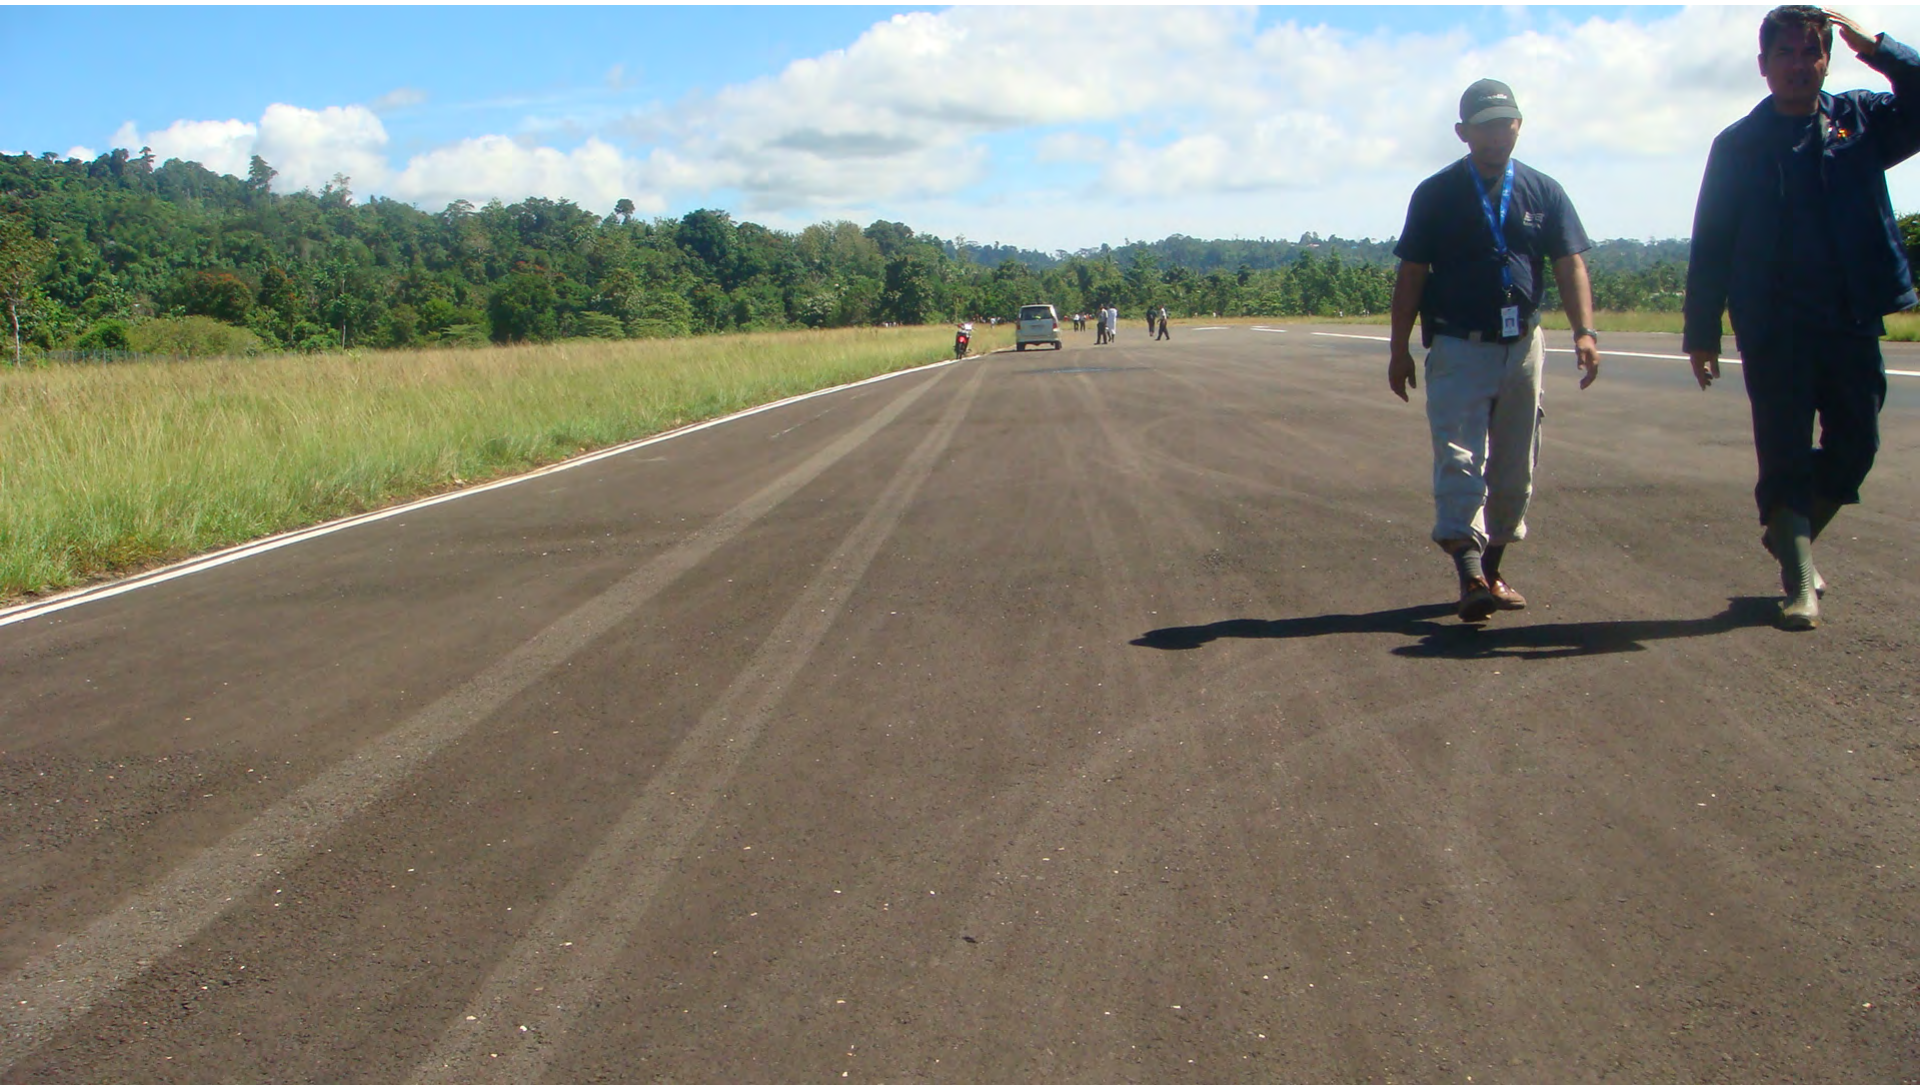
The aircraft overran the end of the runway and came to a complete stop about 205 meters beyond end of the runway in a narrow river.

Aircraft track after over run the runway

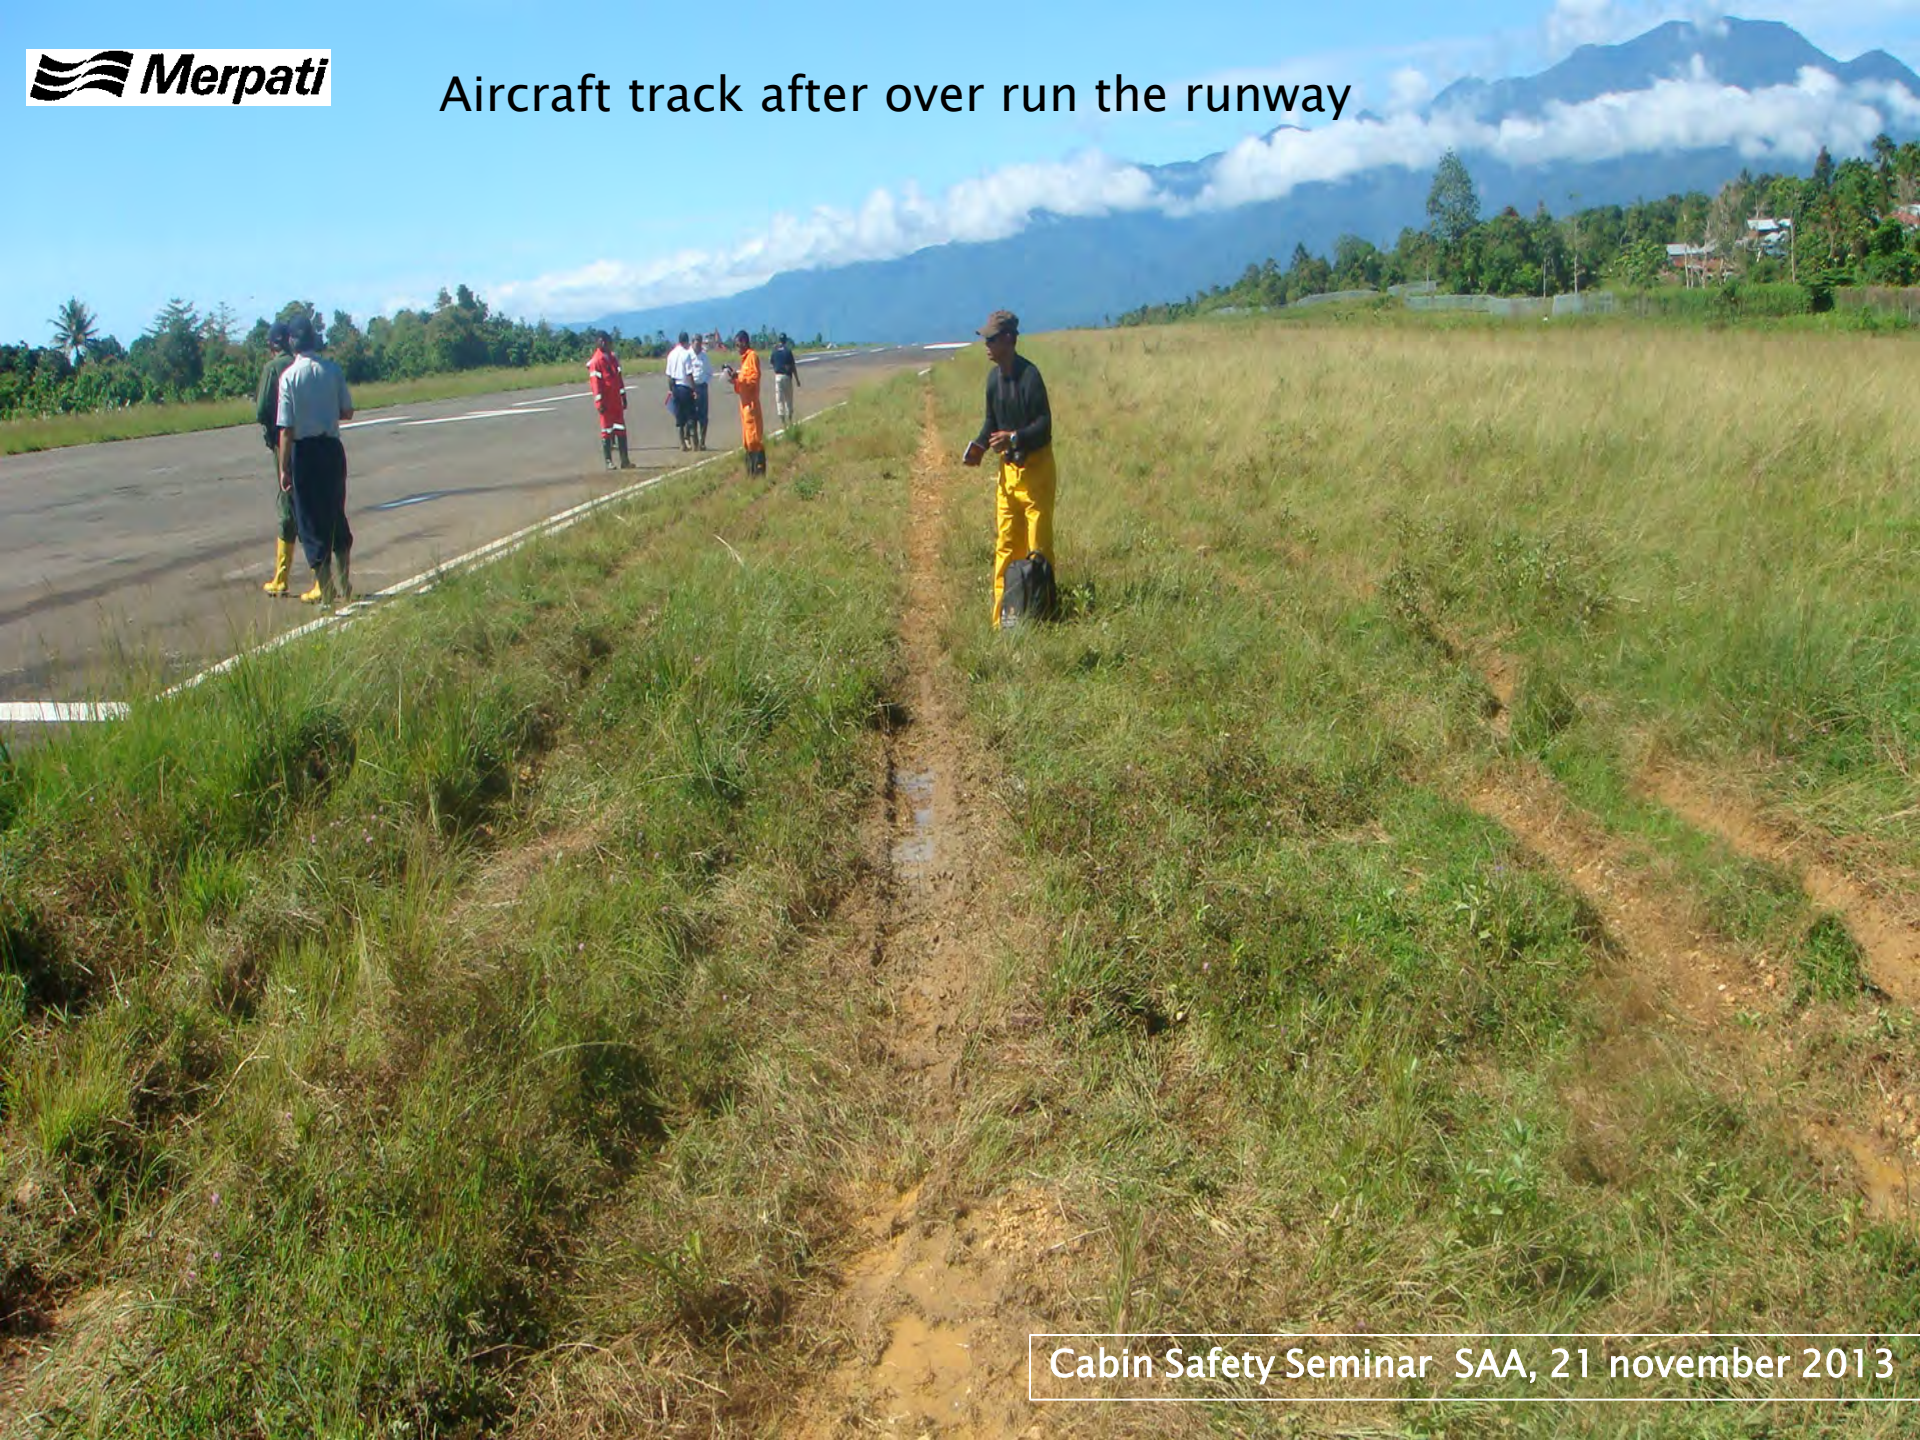
Aircraft stopped on a narrow river

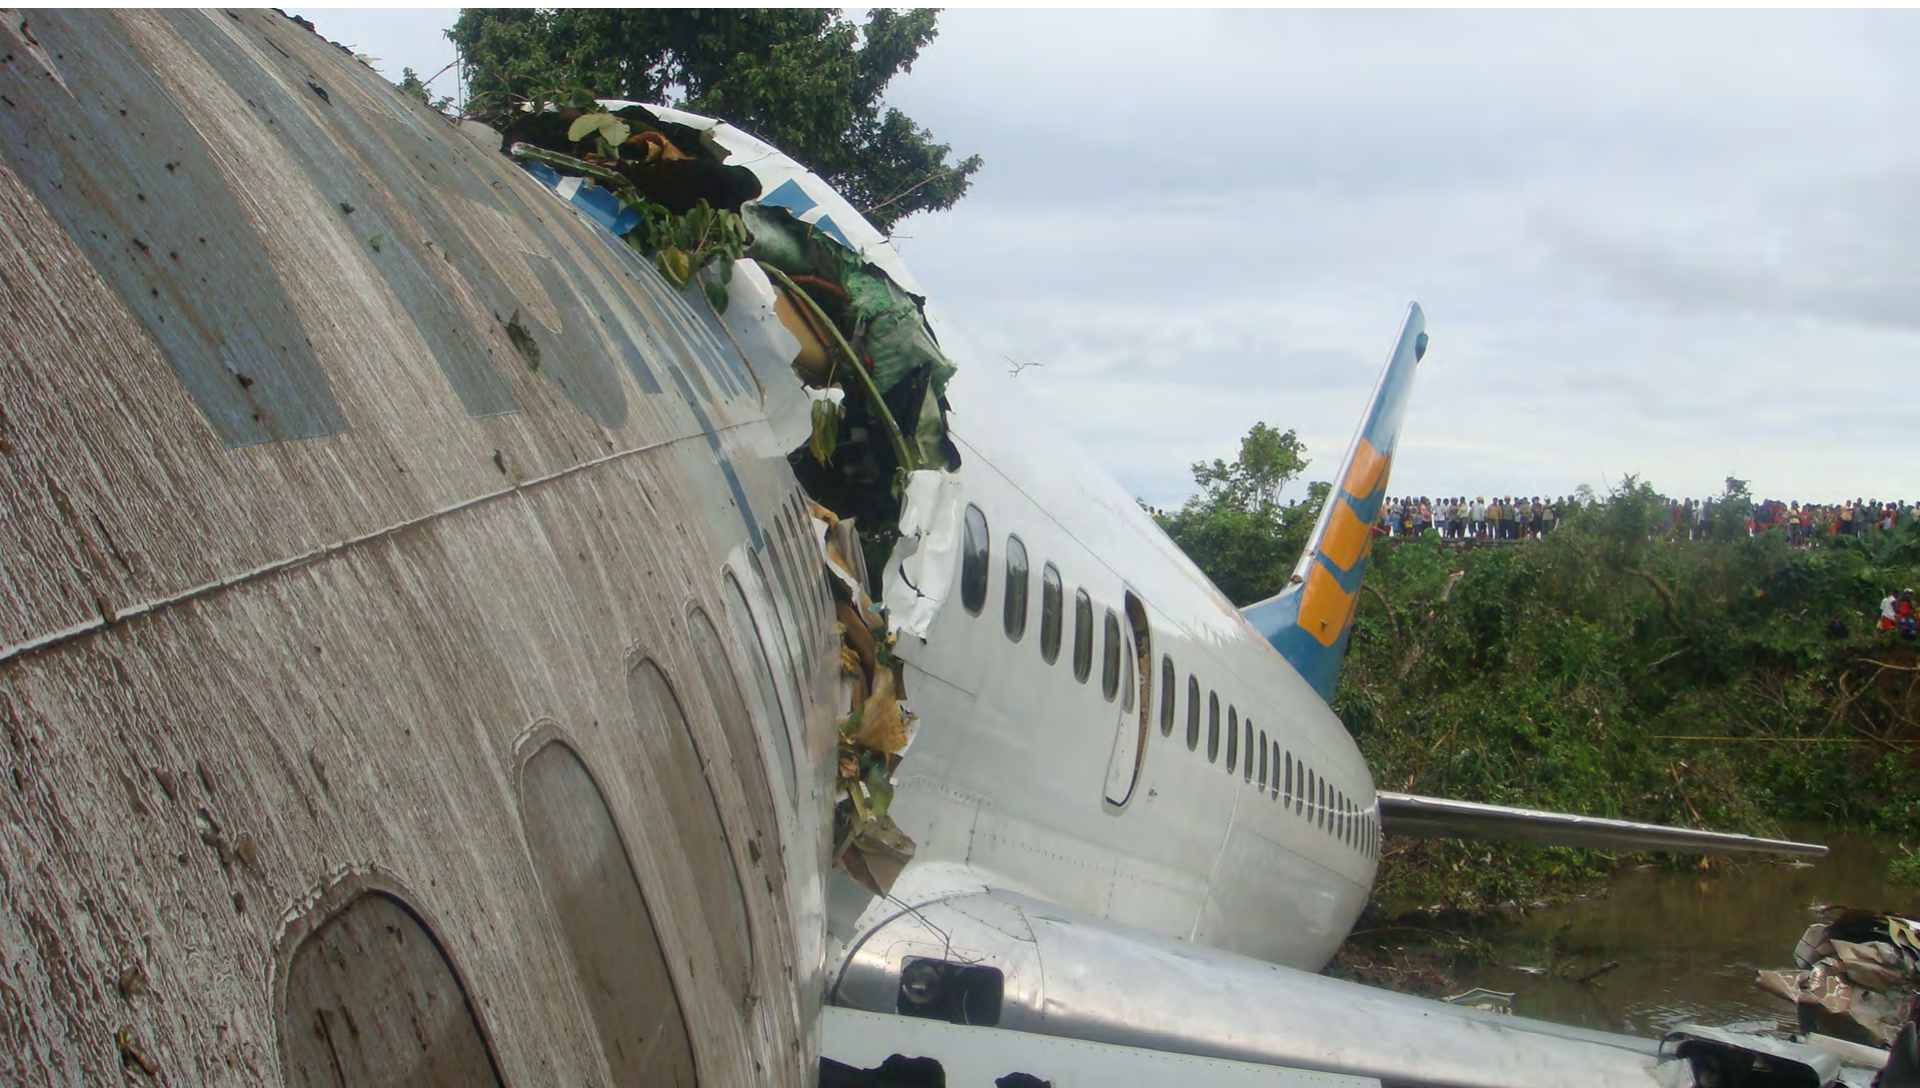
Speed indicator shown 70 knots when a/c stop

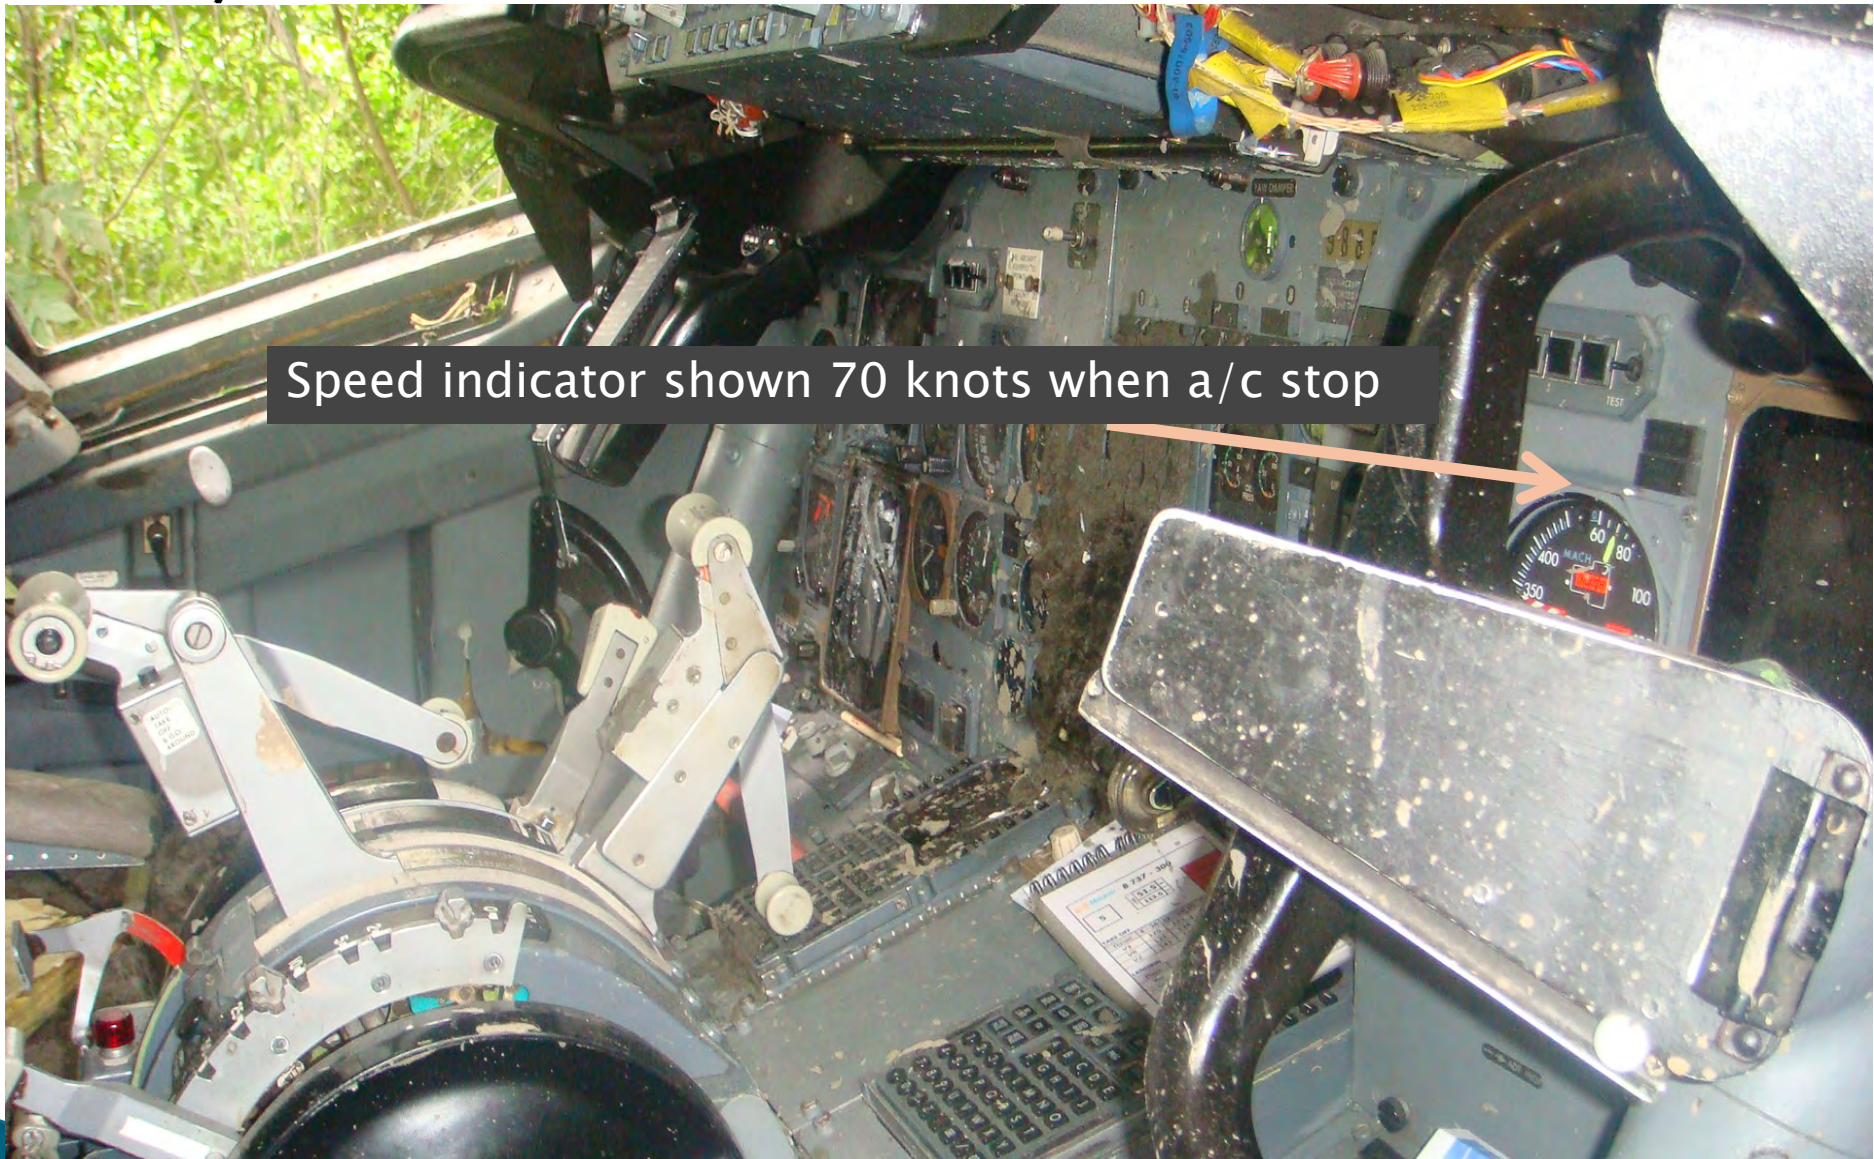
Cockpit From Outside

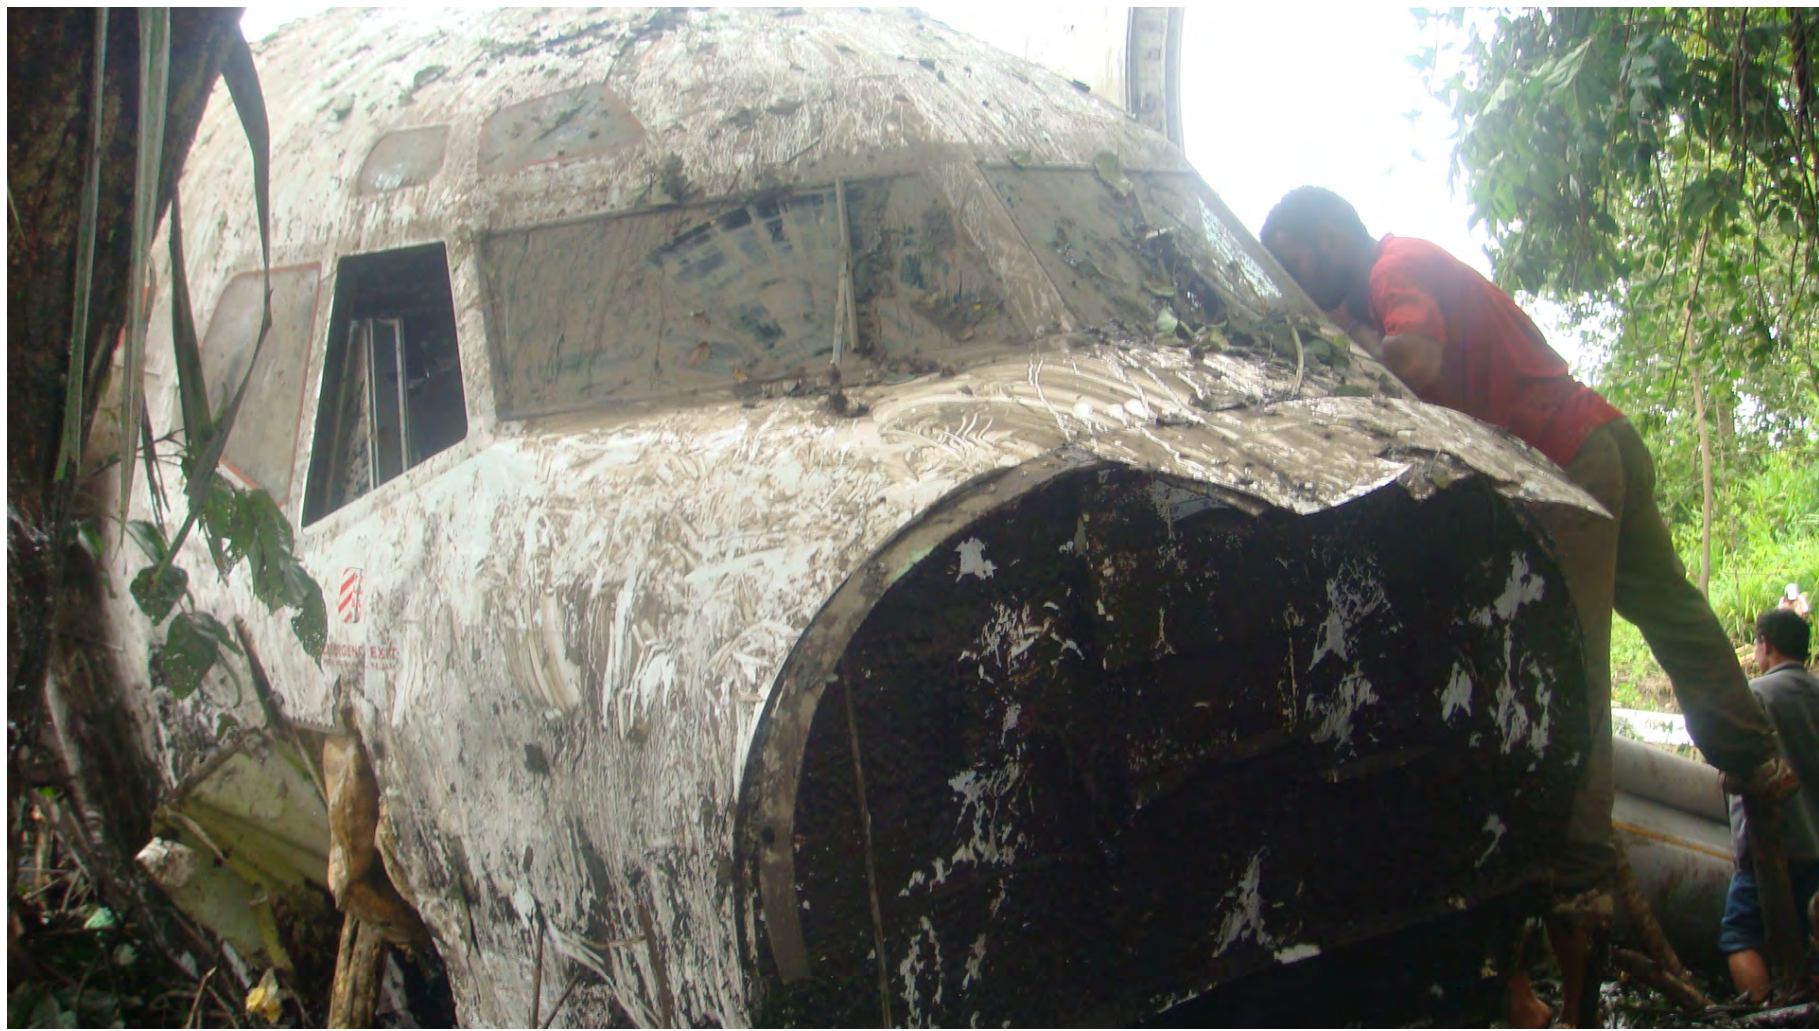
Forward Cabin Picture

- ▶ 1R Door blocked because the forward galley was collapse down.
- ▶ She went to the centre cabin to assist evacuation passengers by grasp the wiring on the ceiling.
- ▶ She found the baby on the floor against the partition and gave the baby to the mechanic
- ▶ After evacuation completed, she left the aircraft through 3L door.

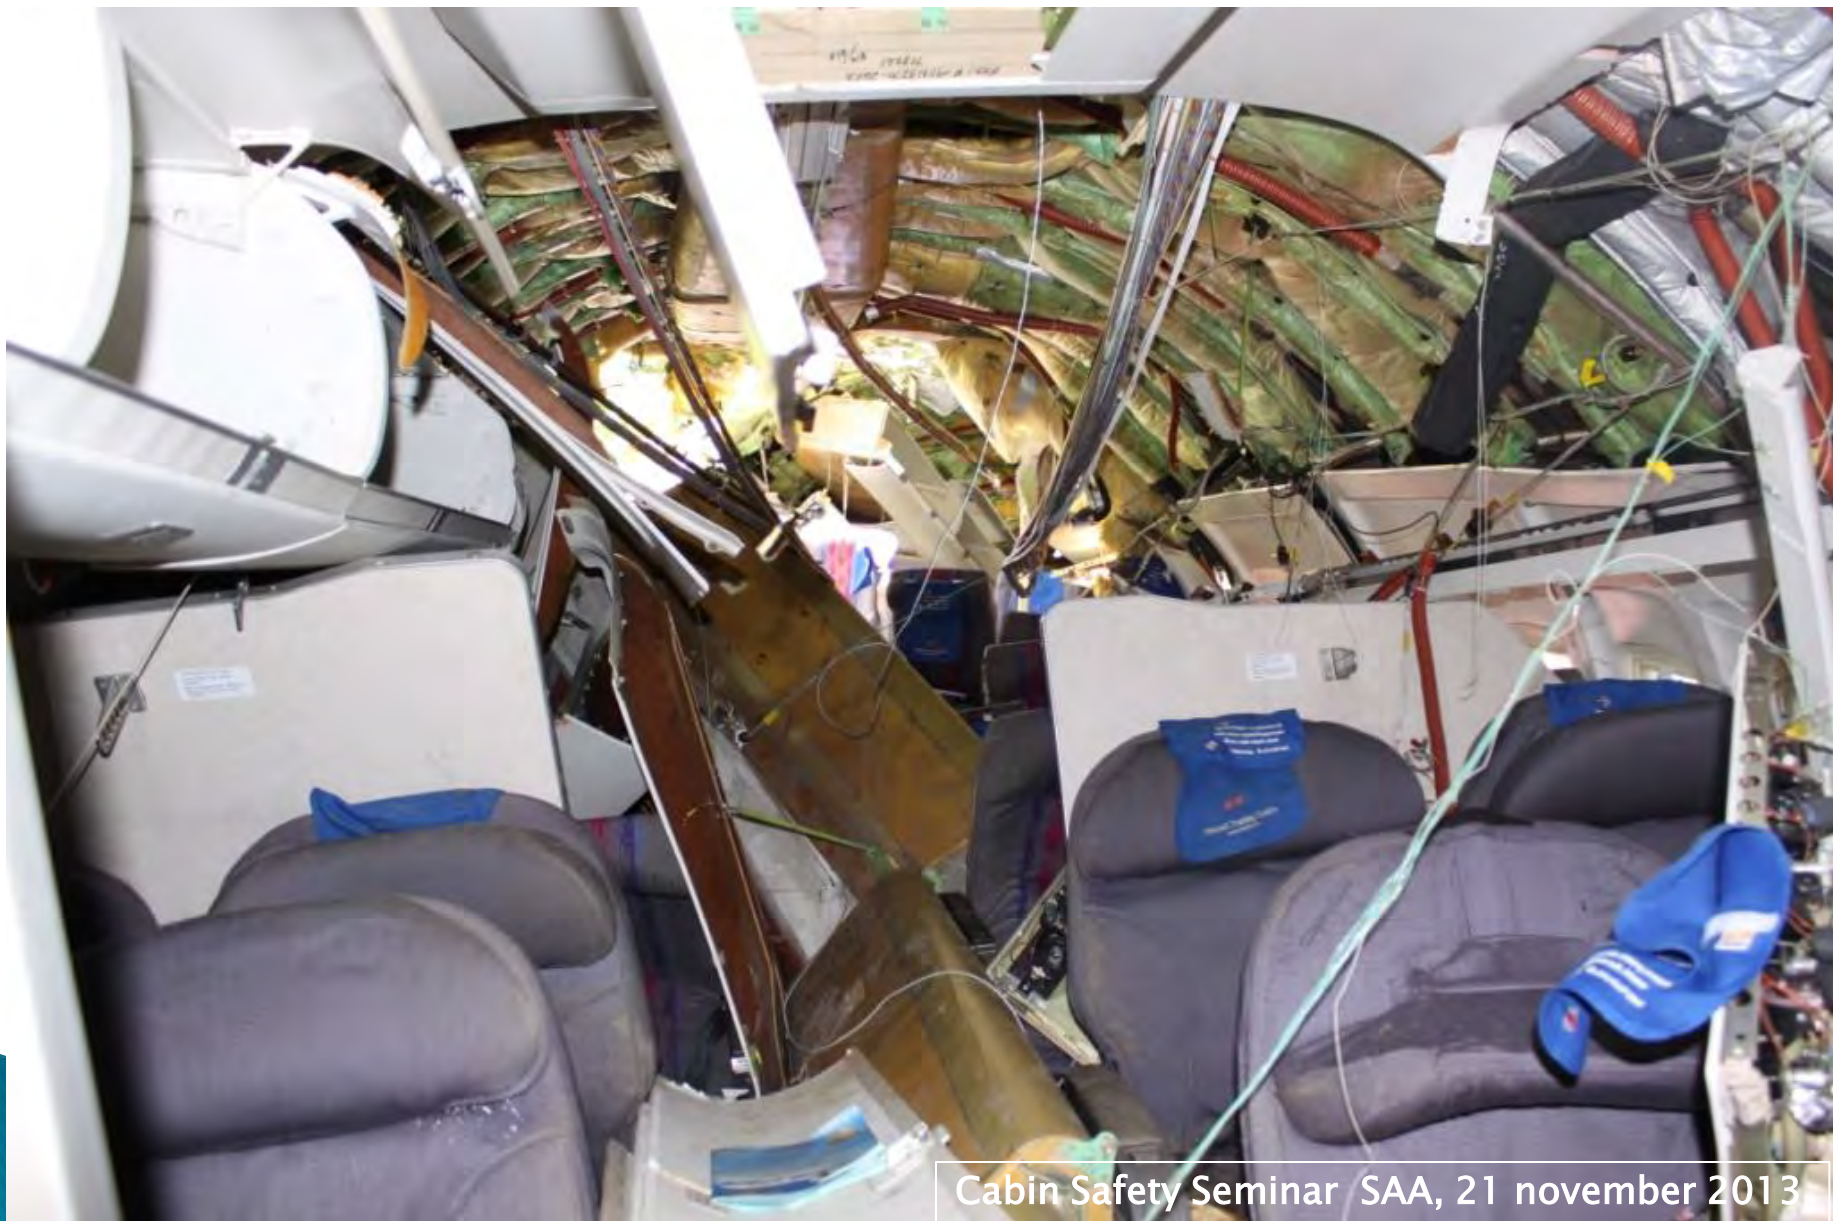
Aft Cabin Picture
