3D Laser Scanning Deployment for A330 Veer Off Runway in Myanmar

Steven Teo
Senior Investigator
AAIB Singapore

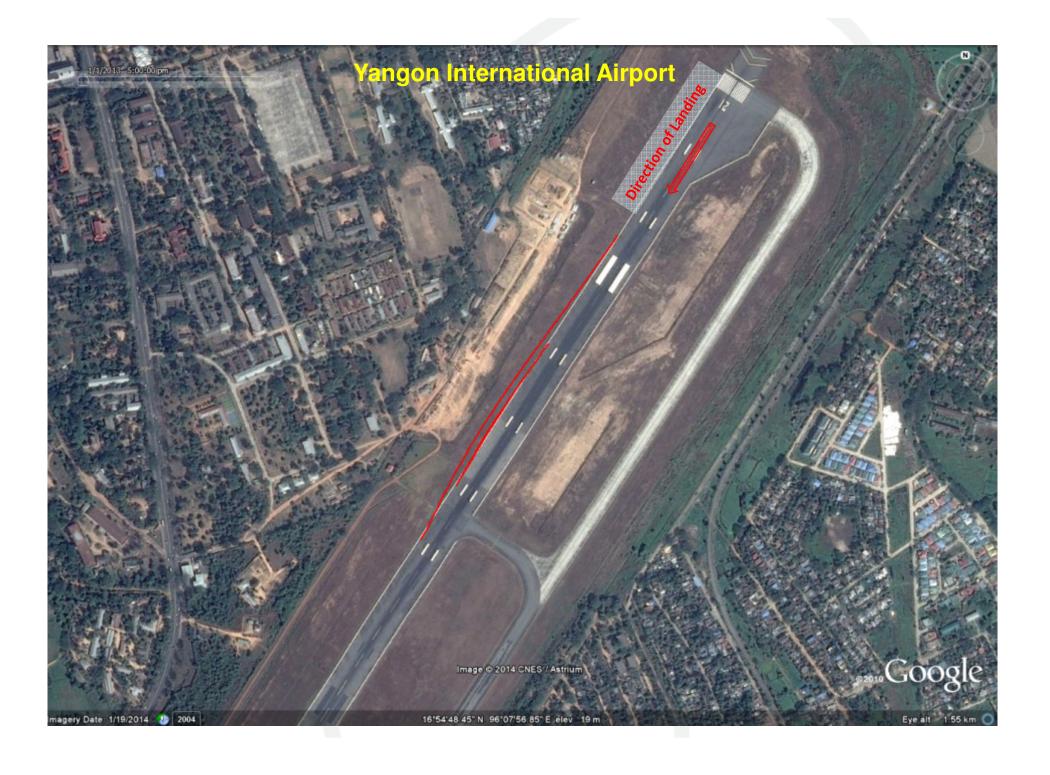
- History of flight
 - 21 May 2014 at about 0243 UTC, an A330
 Singapore to Yangon
 - landing in heavy rain and strong cross wind
 - drifted to the right and veered off the runway.
 - The crew brought the aircraft back on the runway.
 - Some hydraulic systems were damaged, tyres deflated and mud found on engine.
