**Wreckage site located in
mountainous terrain**

GWI18G example

Arnaud TOUPET
Senior Safety Investigator

- On **24 March 2015**, **Prads-Haute-Bléone (Alpes-de-Haute-Provence, France)**, an **Airbus A320-211** registered **D-AIPX** operated by **Germanwings**
- Scheduled flight 4U9525 from Barcelona to Dusseldorf
- 2 flight crew and 4 cabin crew
- 144 passengers
- Copilot pilot flying

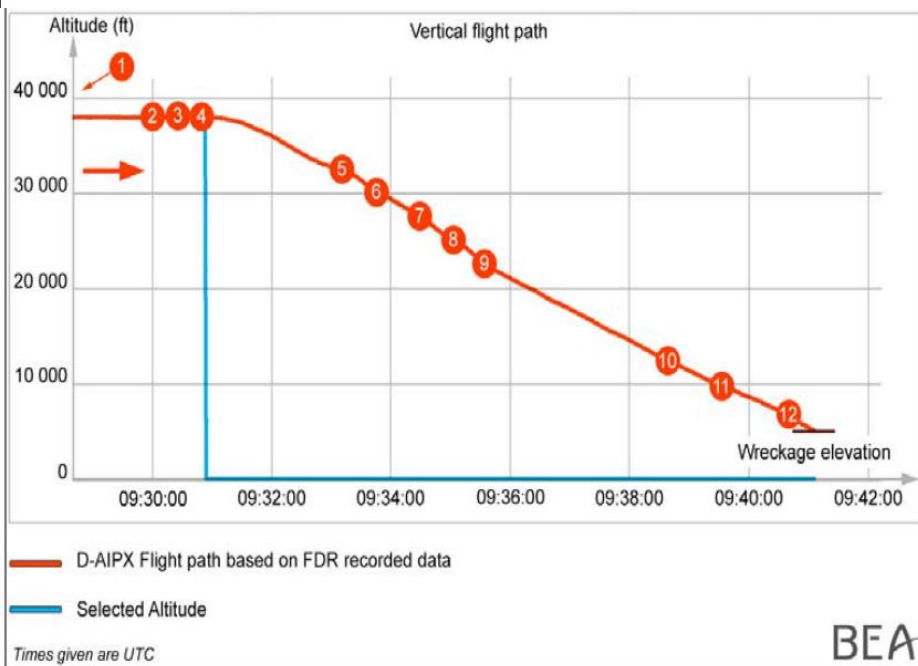
- 1 : Level off at FL 380
- 2 : Last communication with ATC from Captain (direct IRMAR)
- 3 : Captain quit cockpit
- 4 : selected altitude 38000 to 100 ft and A/P in OPEN DES mode

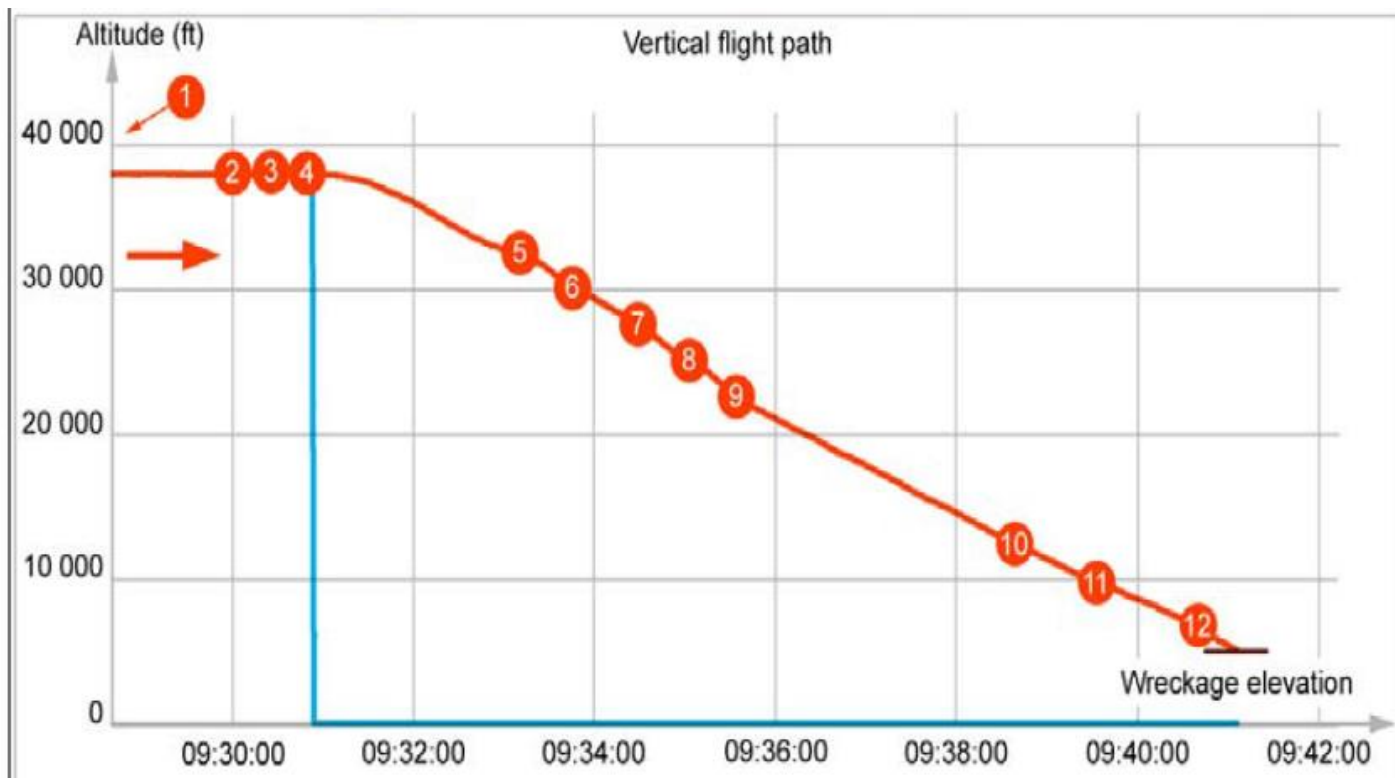
- 5 : selected speed 308 kt (from 273 kt)
- 6 : ATC ask to level, no answer
- 7 : buzzer requesting cockpit access
- 8 : selected speed 350 kt

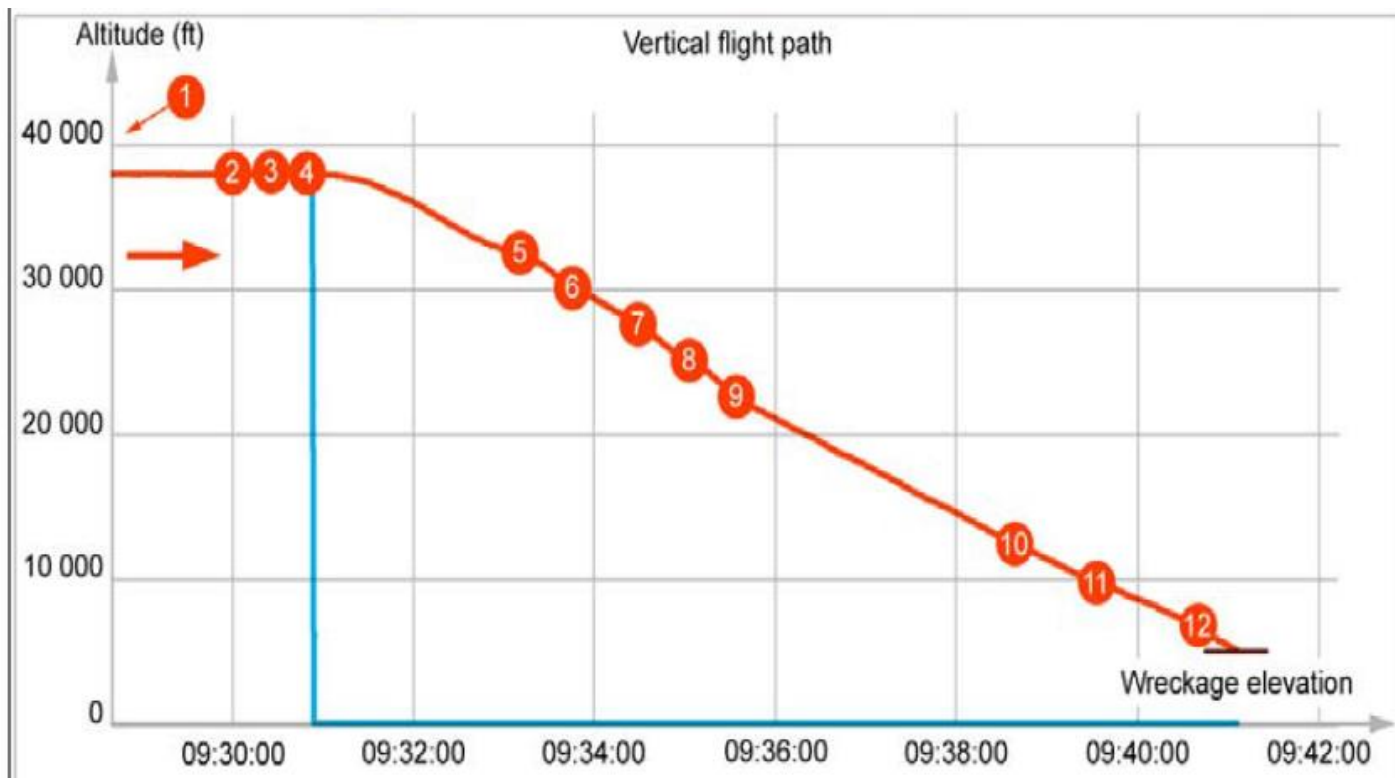
- Cockpit call signal from the cabin interphone (4 times between 9h35min04 and 9h39min27)
- 5 calls from ATC on 2 frequencies from 9h35min07 to 9h37min54, no answer
- 9 : knock at the door on 6 occasions until 9h39min02
- Muffled voices several times from 9h37min11 to 9h40min 48
- 10 : French Air Defense calls 3 times, no answer

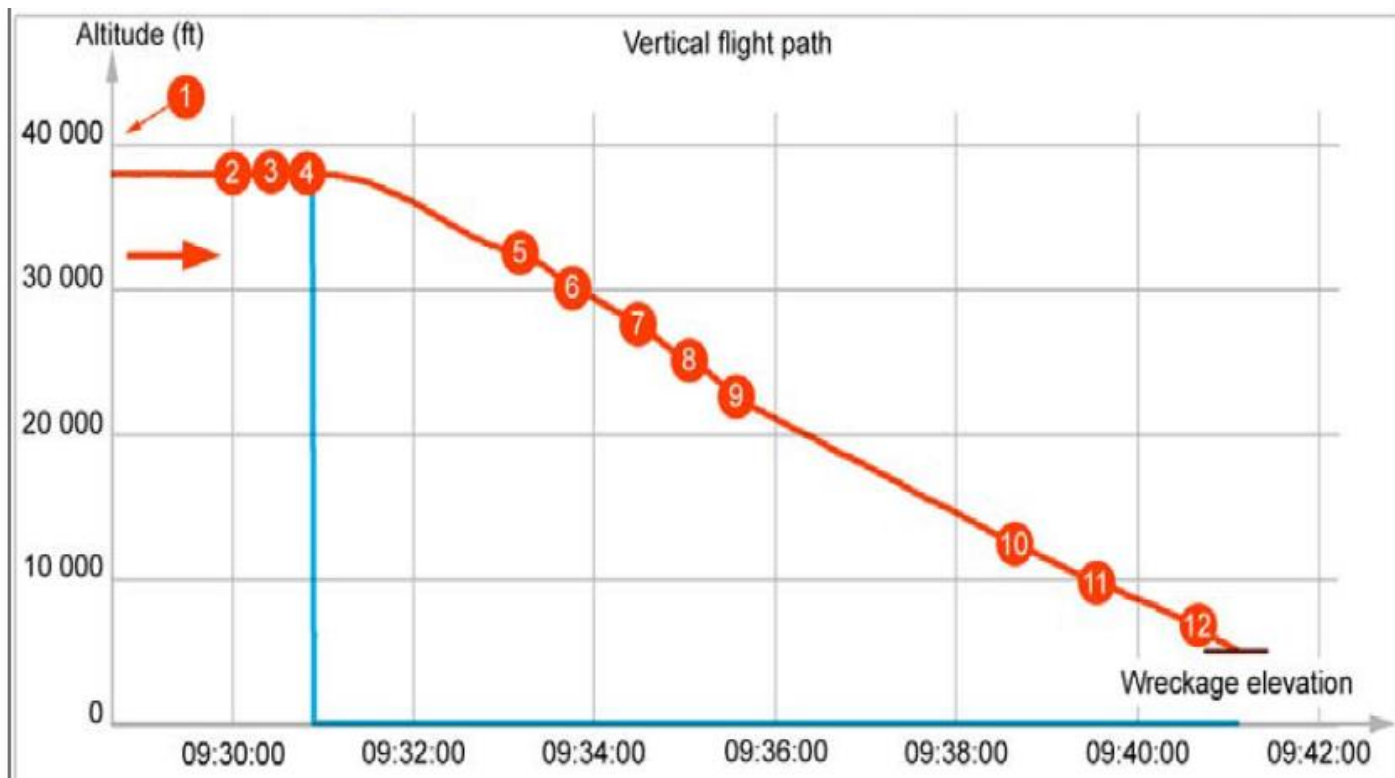
- 11 : noise of violent blows on the cockpit door (5 times)
- Low amplitude inputs of the copilot sidestick from 9h39min33 to 9h40min07
- Another aircraft tries to contact at 9h39min54, no answer
- 12 : GPWS « Terrain terrain pull up pull up »

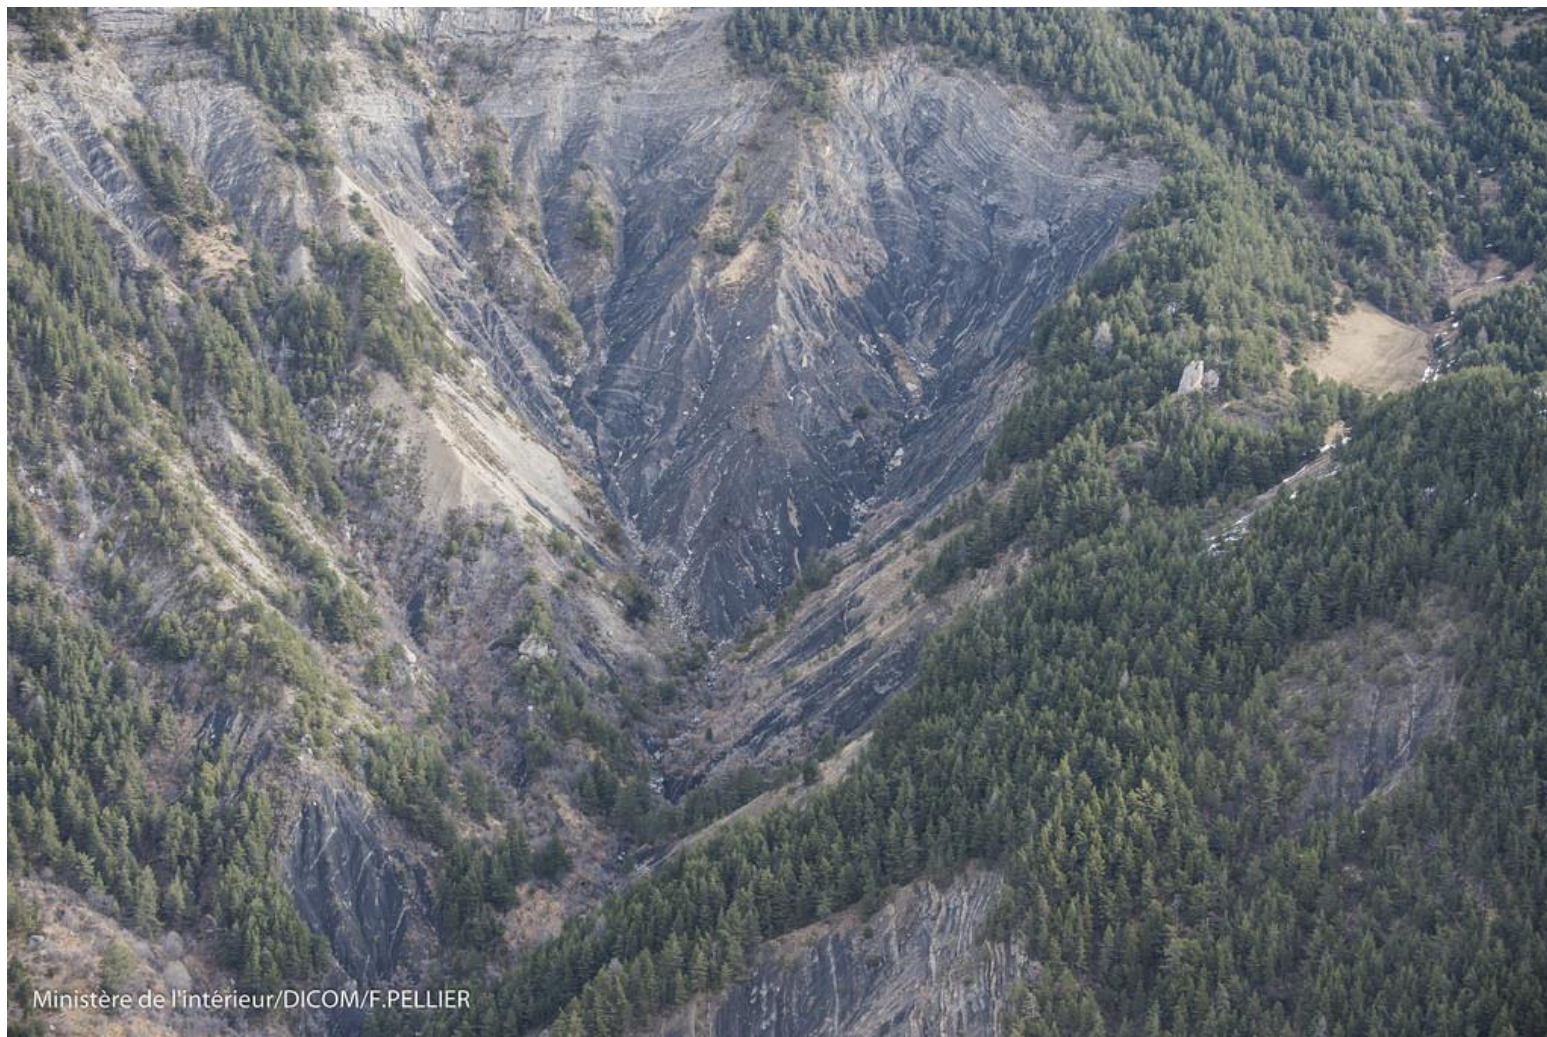
Wreckage site – general view

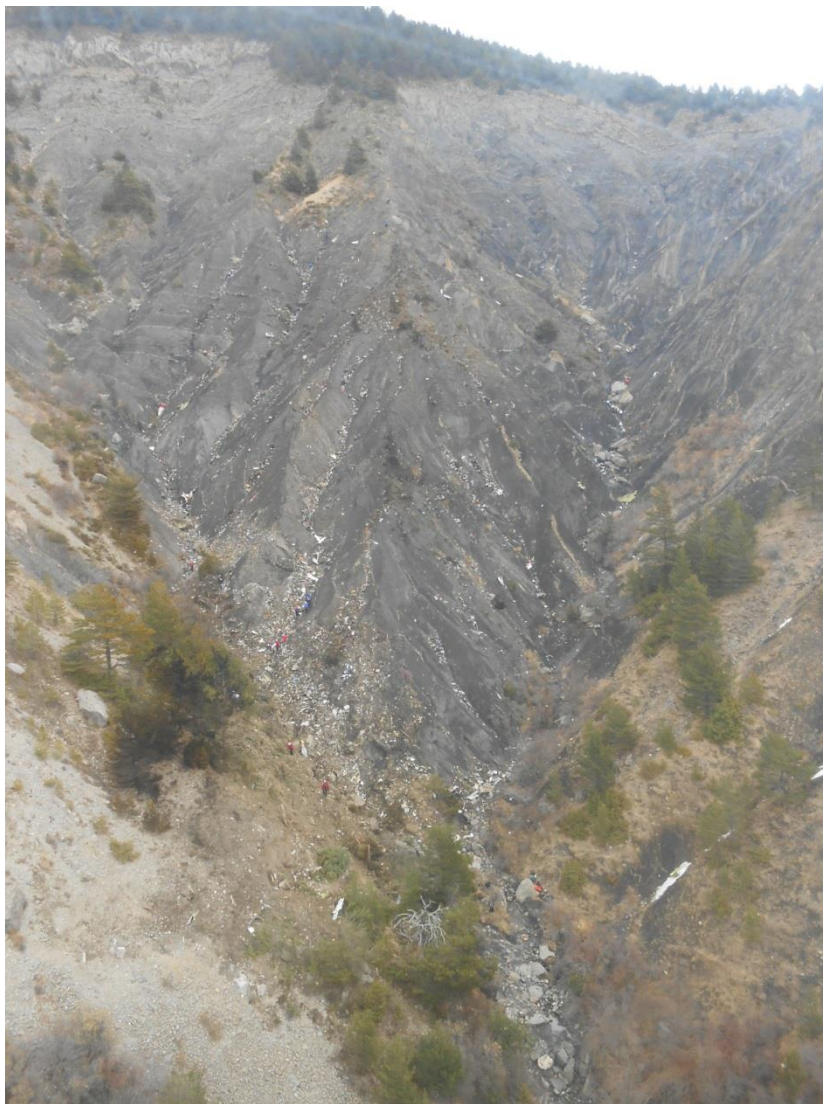
Wreckage site – closer view

- Altitude = 1500 m
- Strong slope
 - ➔ Physical constraints
- Vast area
 - ➔ 10 acres (40 000 m²)

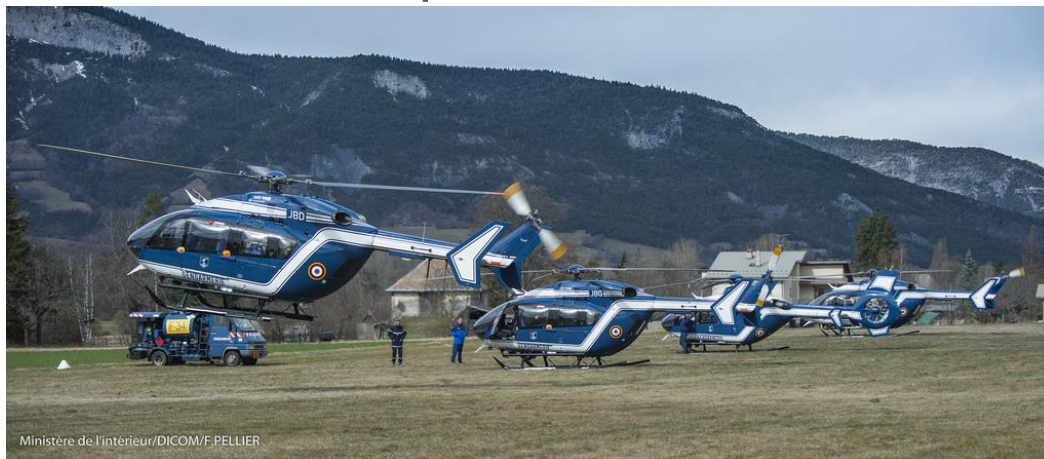
- 5 helicopters from gendarmerie (on site operations)
- 1 plane for radiocommunications
- 13 helicopters from French Army (no-fly zone, SAR, VIP and specialits transport)
- 3 helicopters and 1 reco plane from firemen services

Many resources available = no need to use BEA's own means

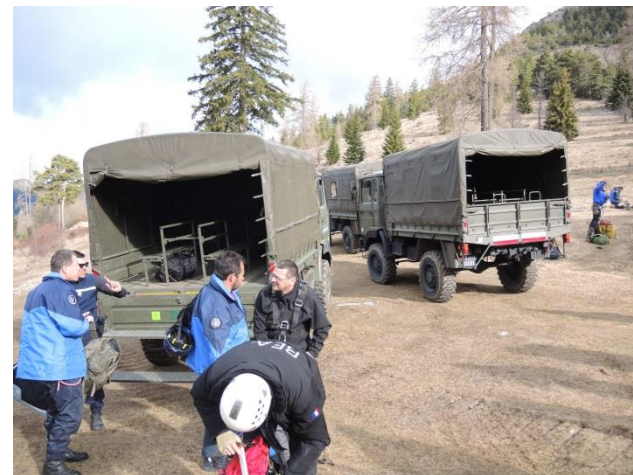
Offroad trucks

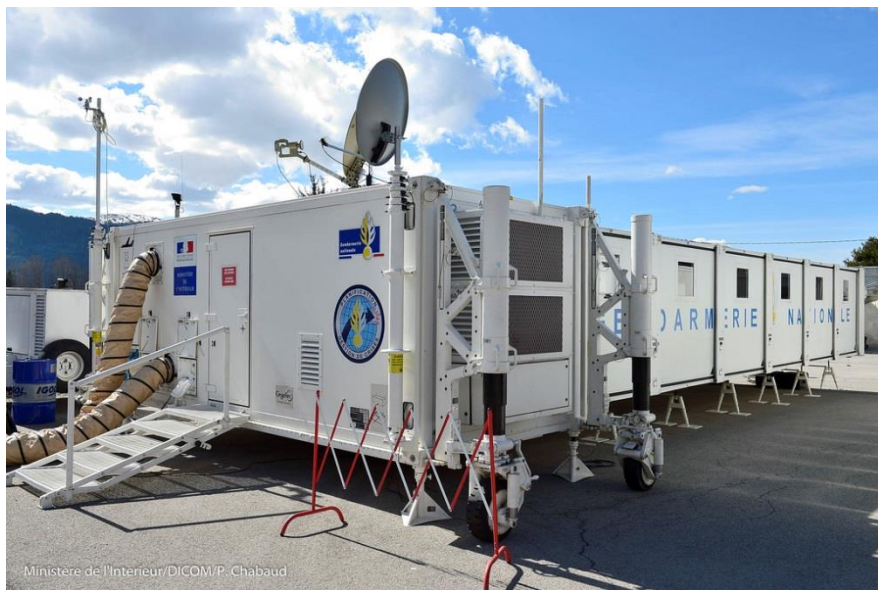
Mobile Headquarters

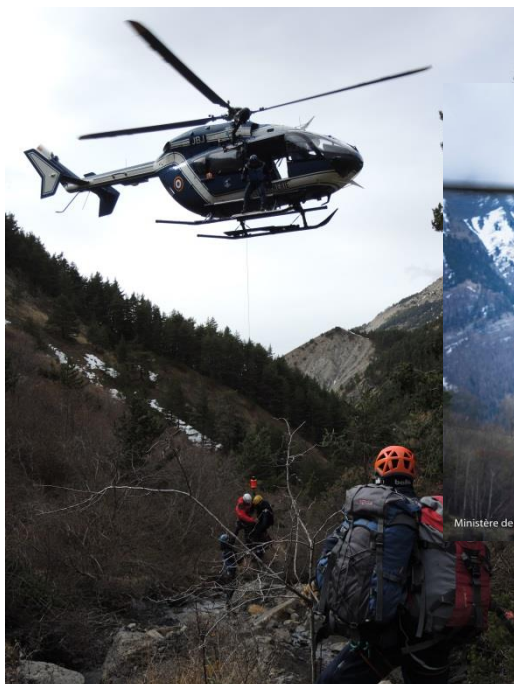
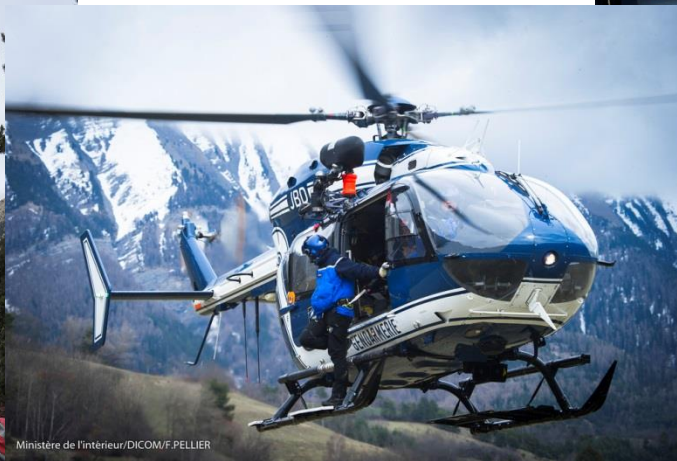
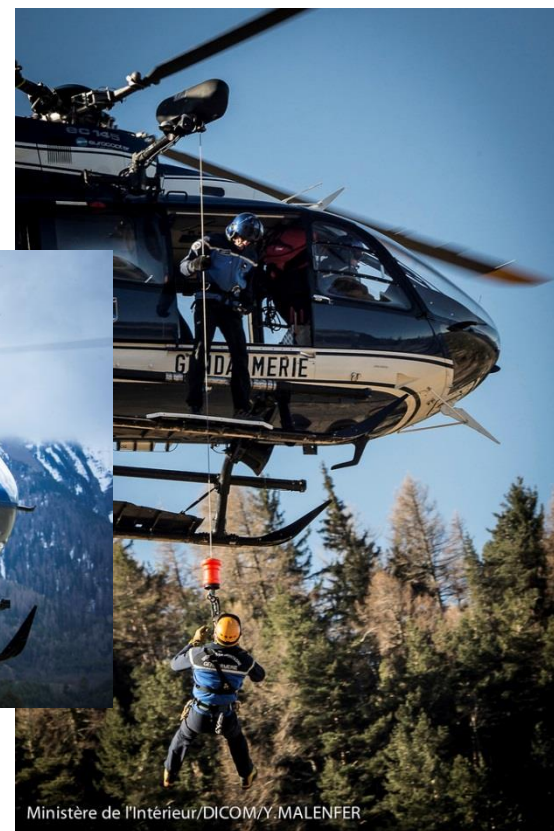
- Transportation (1h30 walking / average 45° slope)
 - ➔ Helicopter winching (days 1 to 3)
 - ➔ Helicopter sled drop and recovery due to wind (days 4 to 5)
 - ➔ Offroad truck and walking (days 6 to 7)
 - ➔ By road from day 8

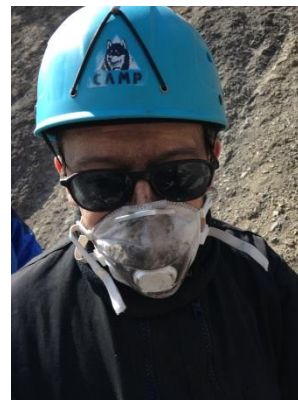
During

- ➔ FFP3 disposable mask (⚠ breathing)
- ➔ Protective footwear (crushing)
- ➔ Gloves (Kevlar + nitril + leather)
(cut + fluid + perforation)

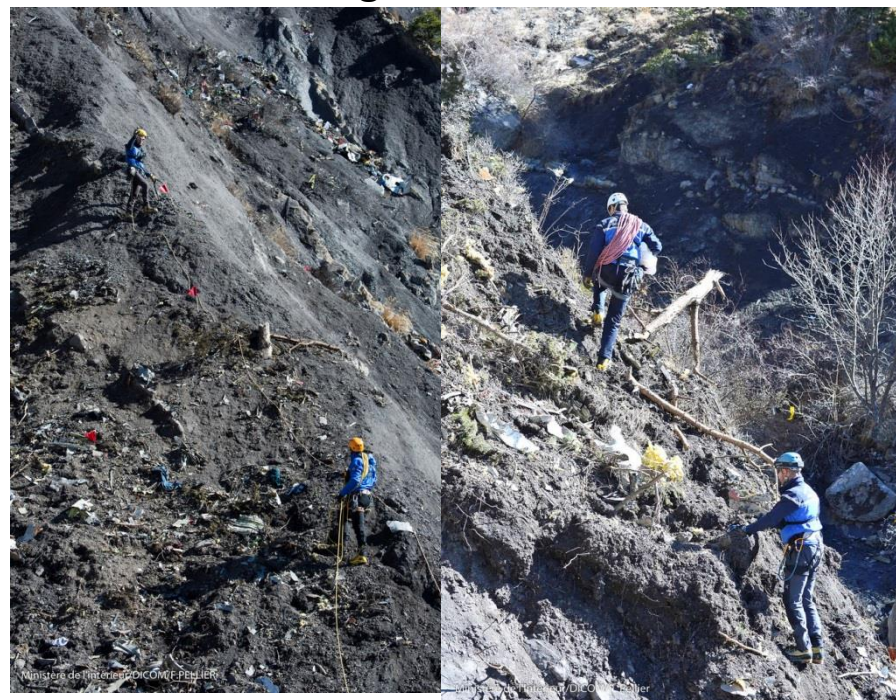
- ➔ Helmet and harness

(provided by high mountain specialists)

- ➔ Team = 1 BEA + 1 specialist

(with rope + crampon + ice axe)

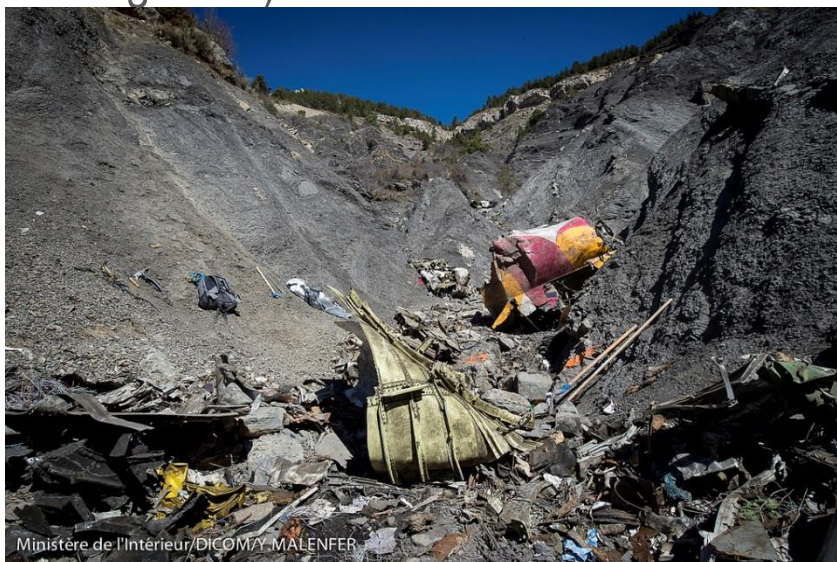
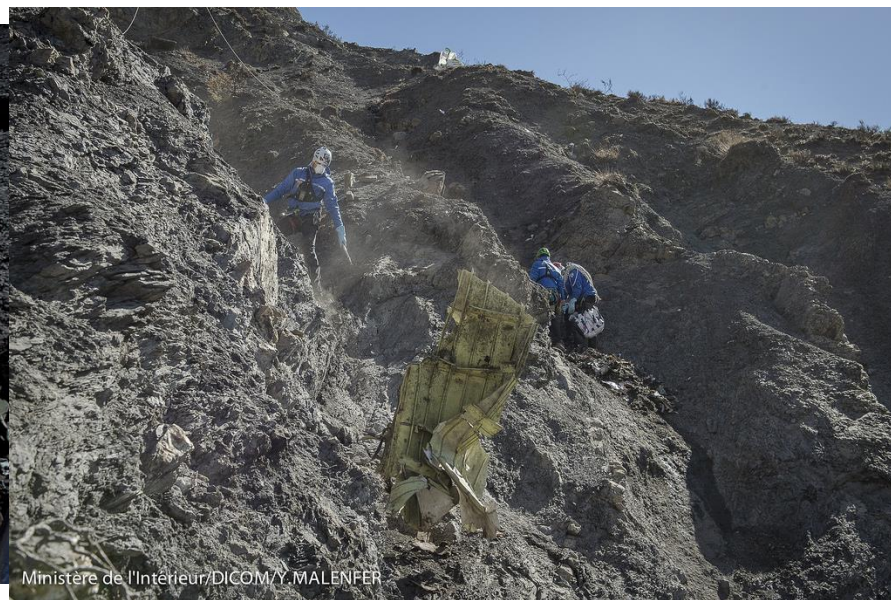
■ Dangers on site

- ➔ Poisoning by fuel (smell remaining during 8 days)
- ➔ Composite material (low risk – no massive fire)
- ➔ Psychological risk (body parts)
- ➔ Slippery surface more difficult going up (increasing slope and unsteady ground)

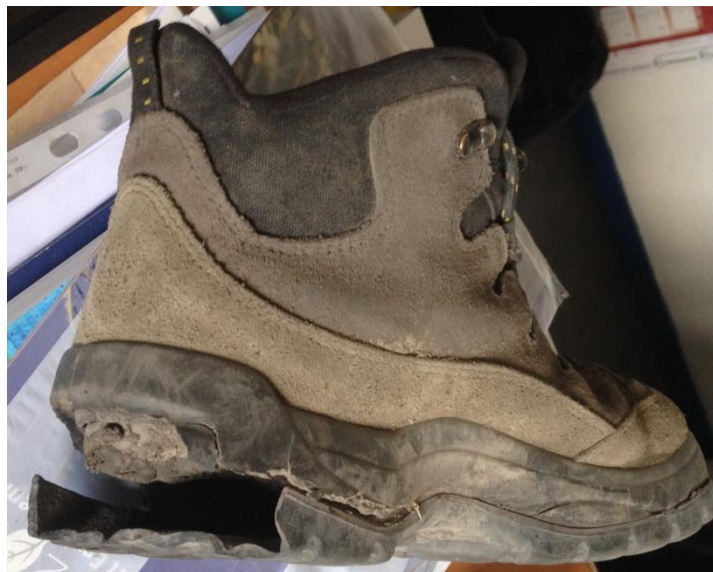
- ➔ No injury or damages except one investigator shoe
