# EL IMPACTO DE LA ACTIVIDAD VOLCÁNICA EN LA AVIACIÓN

Javier Velasco Rivera

MASAIR  
MÉXICO, D.F. SEPTIEMBRE 2014

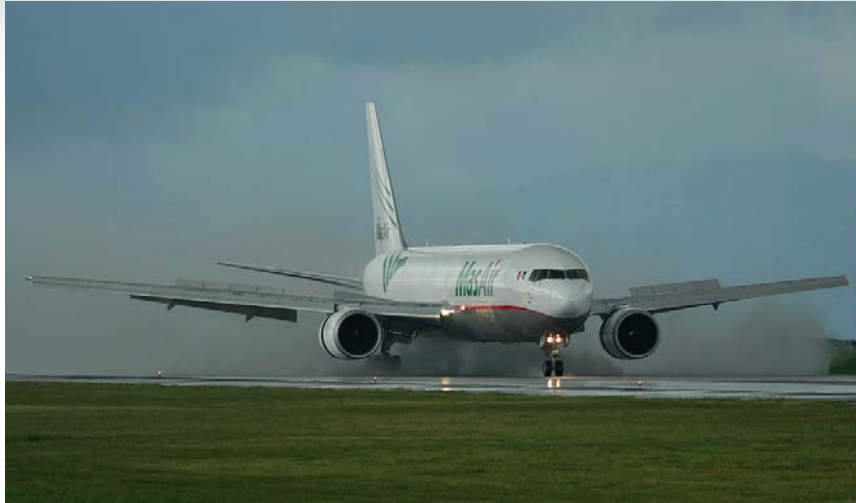
PERFORMANCE - LANDING - DISPATCH

ARPT INFO	767F-Wing-GE ARPT <b>WMMX</b>	<b>Go-Around</b> ▶ RTG	CALC
ADD ARPT	RWY <b>04R</b> ▶	<b>30</b> ▶ FLAP	SHOW ENROUTE
NOTAMS	WIND <b>0 KT</b> (0 TW/0 XW) KT	<b>0h</b> ▶ A/C	MEL
SHOW KYBD	OAT <b>18 C</b> (64 F)	<b>0h</b> ▶ A1	CDL
SHOW TAKEOFF	QNH <b>30.30 IN HG</b> (1026.1 hPa)		
EXIT	COND <b>STDNS WTR</b> ▶		
SEND OUTPUT

767-300 / CF6-80C2B6F			
Dispatch Landing Data for Rwy 05R:			
Normal:	Limit Wt	Vref30	
	147871 KG	147 KT	
Quick Turnaround Weight:	217724 KG		
Quick Turnaround Time:	75 minutes

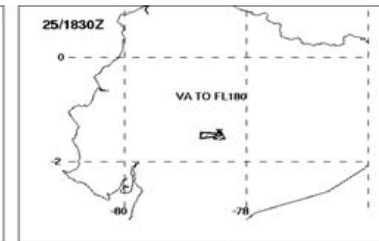
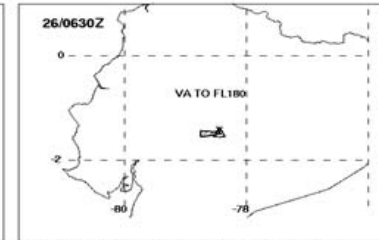
VOLCANIC ASH ADVISORY  
DTG: 20140925/1301Z  
VAAC: WASHINGTON  
VOLCANO: TUNGURAHUA 352080  
PSN: S0128 W07826  
SUMMIT ELEV: 16480 FT (5023 M)  
ADVISORY NR: 2014/427

INFO SOURCE: GOES-EAST, GES WINDS, VOLCANO WEB CAMERA.  
ERUPTION OF VAAC: VA EMISSIONS  
OBS VA CLD: SFC/FL180 S0126 W07844 - S0127 W07826  
SUMMIT HEIGHT: 16480 FT (5023 M)  
HEIGHT ASSIGNMENT: BASED ON WINDS AND WEB CAMERA INDICATING THE VA  
PLUME IS ABOUT SUMMIT LEVEL. ...LIDDICK  
NXT ADVISORY: WILL BE ISSUED BY 20140925/1900Z

FVXX20 KNES 251301  
VA ADVISORY  
DTG: 20140925/1301Z

VAAC: WASHINGTON

VOLCANO: TUNGURAHUA 352080  
PSN: S0128 W07826

OBS VA CLD: SFC/FL180 S0126 W07844 - S0127 W07826  
- S0129 W07825 - S0132 W07845 - S0126 W07844 MOVW 15KT

RMK: WEB CAM SHOWING CONTINUOUS LIGHT VA  
EMISSIONS OF ABOUT SUMMIT HEIGHT. VA JUST BARELY  
SHOWING UP IN VIS IMAGERY EXTENDING APPROX 17 NM  
TO THE WEST OF THE SUMMIT. HEIGHT ASSIGNMENT  
BASED ON WINDS AND WEB CAMERA INDICATING THE VA  
PLUME IS ABOUT SUMMIT LEVEL. ...LIDDICK
