MEVA/TMG/33 — WP/08
15/04/18

**Thirty third MEVA Technical Management Group Meeting (MEVA/TMG/33)
Willemstad, Curaçao, 29 – 31 May 2018**

**MEVA-III DISASTER RECOVERY RECOMMENDATION
MEVA III FLYAWAY ANTENNA**

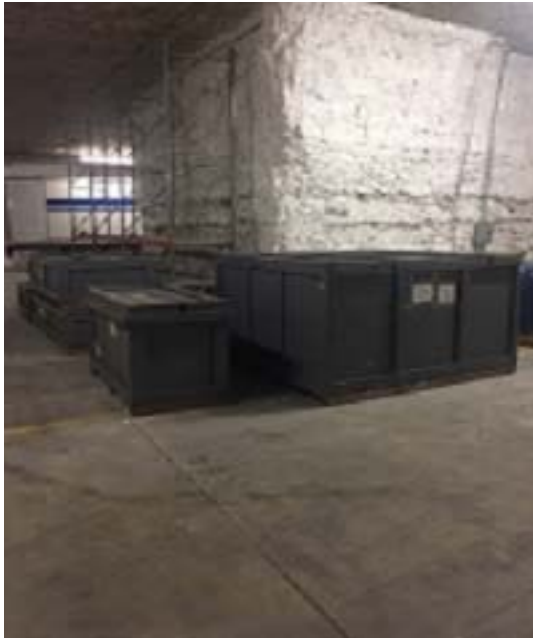
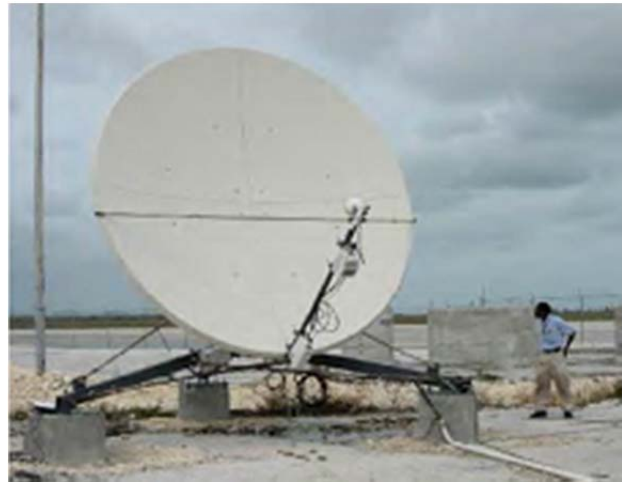
2.1. The current 3.8mm flyaway antenna is stored in five large crates weighing an estimated 4000 pounds. Its large size and heavy weight makes it costly and impractical for immediate deployment in the event of an emergency. Moreover, during its time in storage, the antenna has experienced heavy oxidation in several key areas and many of the components have suffered reduced solderability, which has resulted in component failure.

2.2 During the most recent hurricane season, the FAA recovered the flyaway antenna from its storage location in Independence, MO and had it restored to a working condition. However, due to its aging structure and the limitation on available parts its long-term sustainability is questionable.

3.1 The current flyaway antenna has reached the end of its life cycle and can no longer be relied on as an immediate solution to restore a damaged antenna. Furthermore, its heavy weight and bulk size makes it unsuitable as a quick deployment emergency solution.

- a) Update the MEVA-III Contingency Plan;
- b) review the Frequentis MEVA-III Emergency Antenna Commercial Offer; and
- c) provide recommendations or modifications as required
