AFI Comprehensive Implementation Programme (ACIP)

***ICAO Safety Management  
Systems (SMS) Course  
Handout N° 1 – G1  
Anytown City Airport accident***

### *Exercise N° 02/01 – The Anytown City Airport accident*

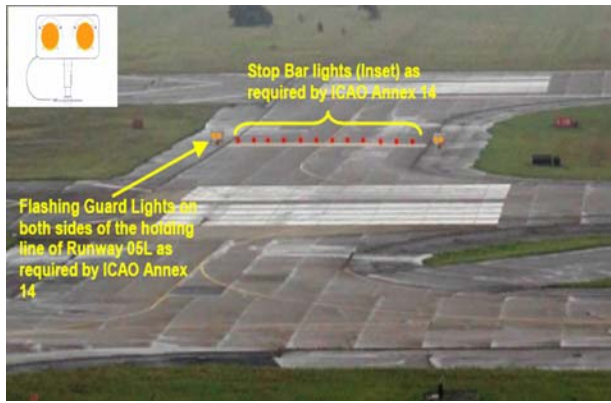
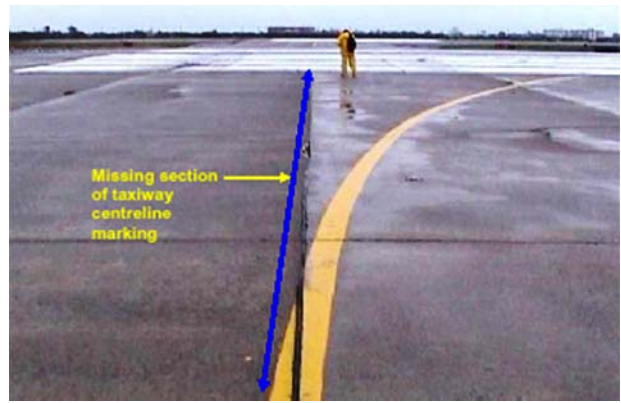
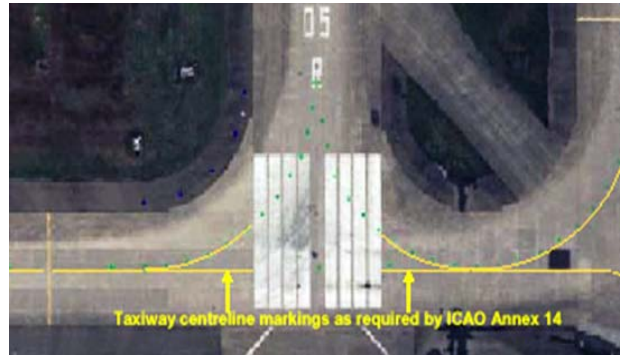
When investigators surveyed CKS four days after the crash, they found that the two taxiway lights designed to lead aircraft further down **N1** past the inactive **5R** to the active **5L** runway were not working perfectly. One was not illuminated at all, and the other was *"less intense than the other lights."* The lights, spaced about 25m apart, run straight down **N1's** centreline and meet up with another set of curved, green taxiway lights that connect **05R's** centreline with **N1's** north end.

Investigators found several other lighting and marking problems. Some of the runway edge lights on both **05L** and **05R** were either broken or *"aligned away from the direction of the runway length,"* report said. Also, there was nothing over the **05R** threshold markings that indicated the runway was closed.
