Report A-008/2013

Accident involving a BOEING B-757-300, registration D-ABOC, operated by Condor, at the Gran Canaria Airport on 22 March 2013

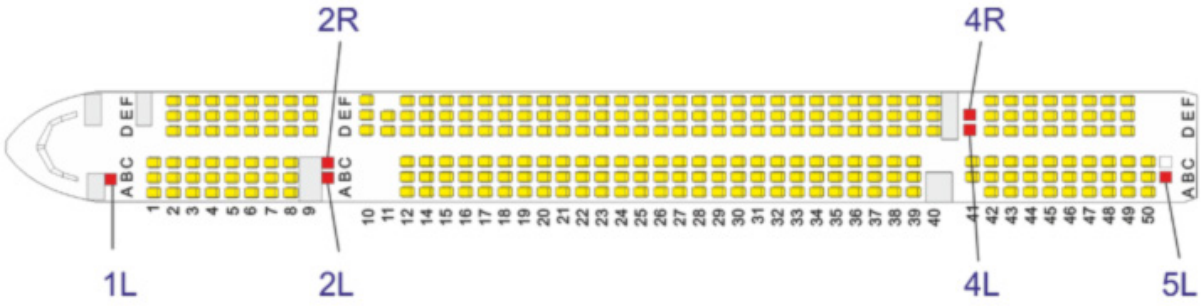
The crew coordinated with the control tower, which cleared them to do the test at position R1, which is next to the 03L threshold. A tractor towed the aircraft to that position, during which the aircraft only had the APU running. Onboard were all the crew, a maintenance technician and an operator from the airline's Gran Canaria base. Each crewmember was in position so they could immediately report any anomaly. Once at R1, the APU bleed and the left air conditioning pack were connected. As soon as this was done, a strong smell became noticeable and seconds later, the cabin crew reported that the two crewmembers in the 2L/R positions were having physical problems.

Figure 1. Seating map of the aircraft showing the positions of the cabin crew

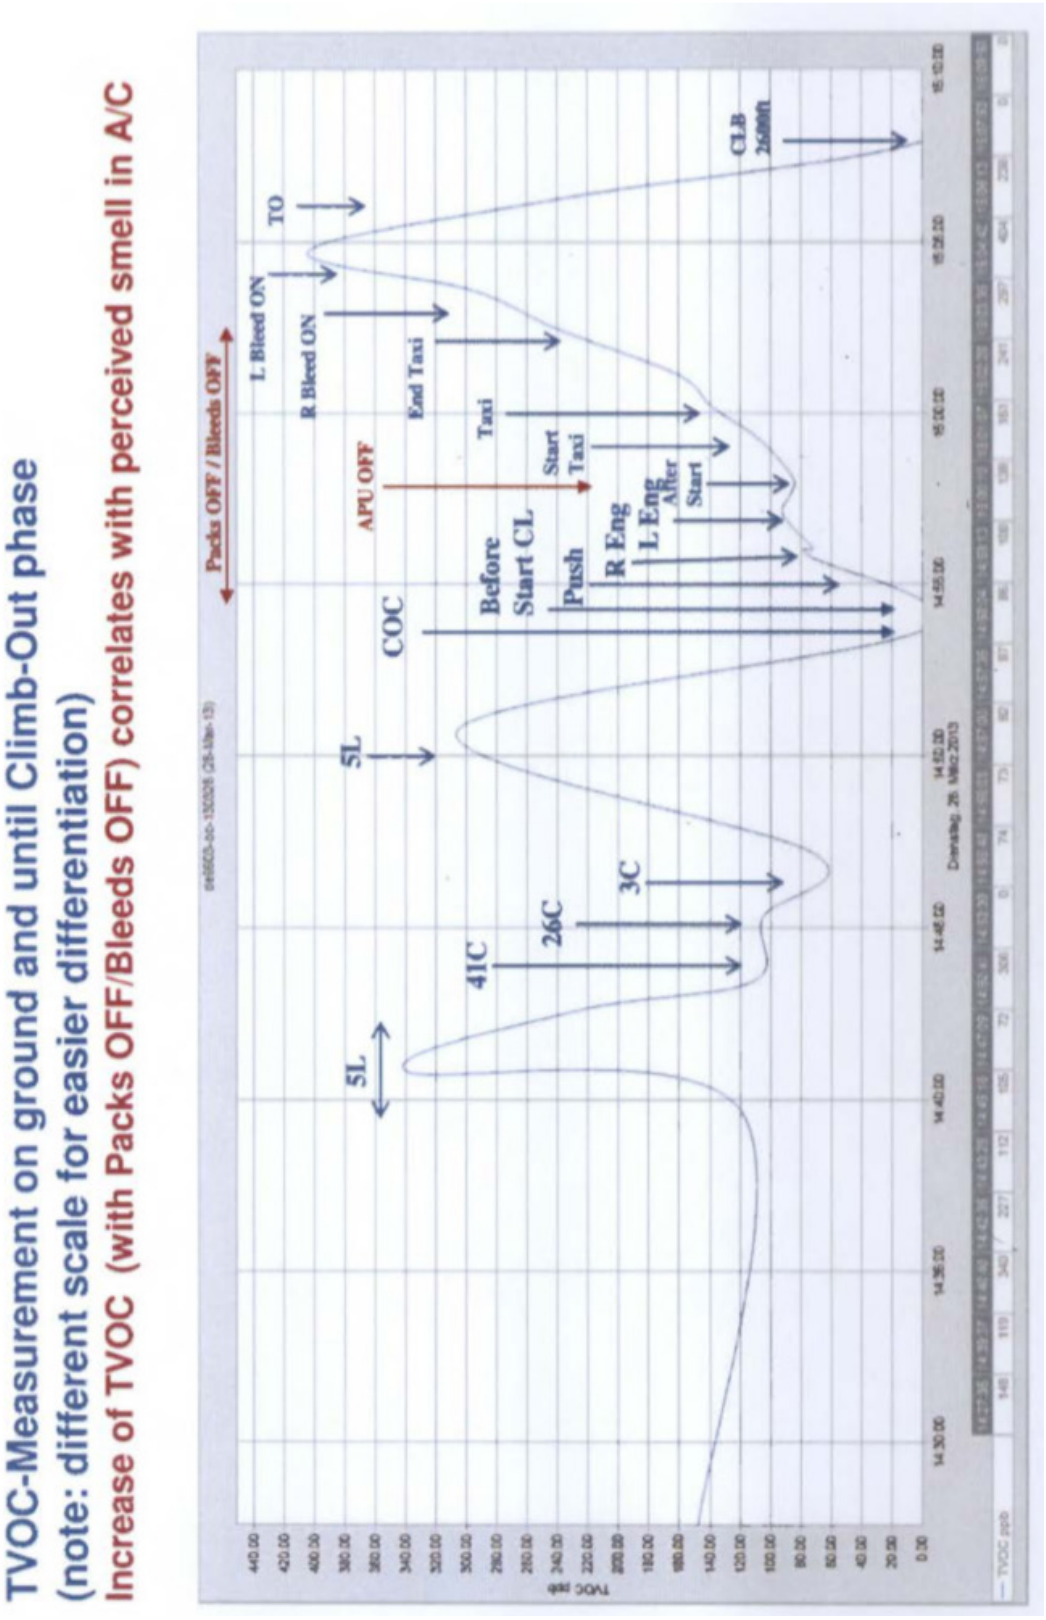
Figure 3. Graph with the TVOC readings of the Graywolf sensor from the time the crew boarded the aircraft until the initial climb phase

The Graywolf sensor recorded increases in TVOC coinciding approximately with those times when the strange odor was smelled by the occupants.

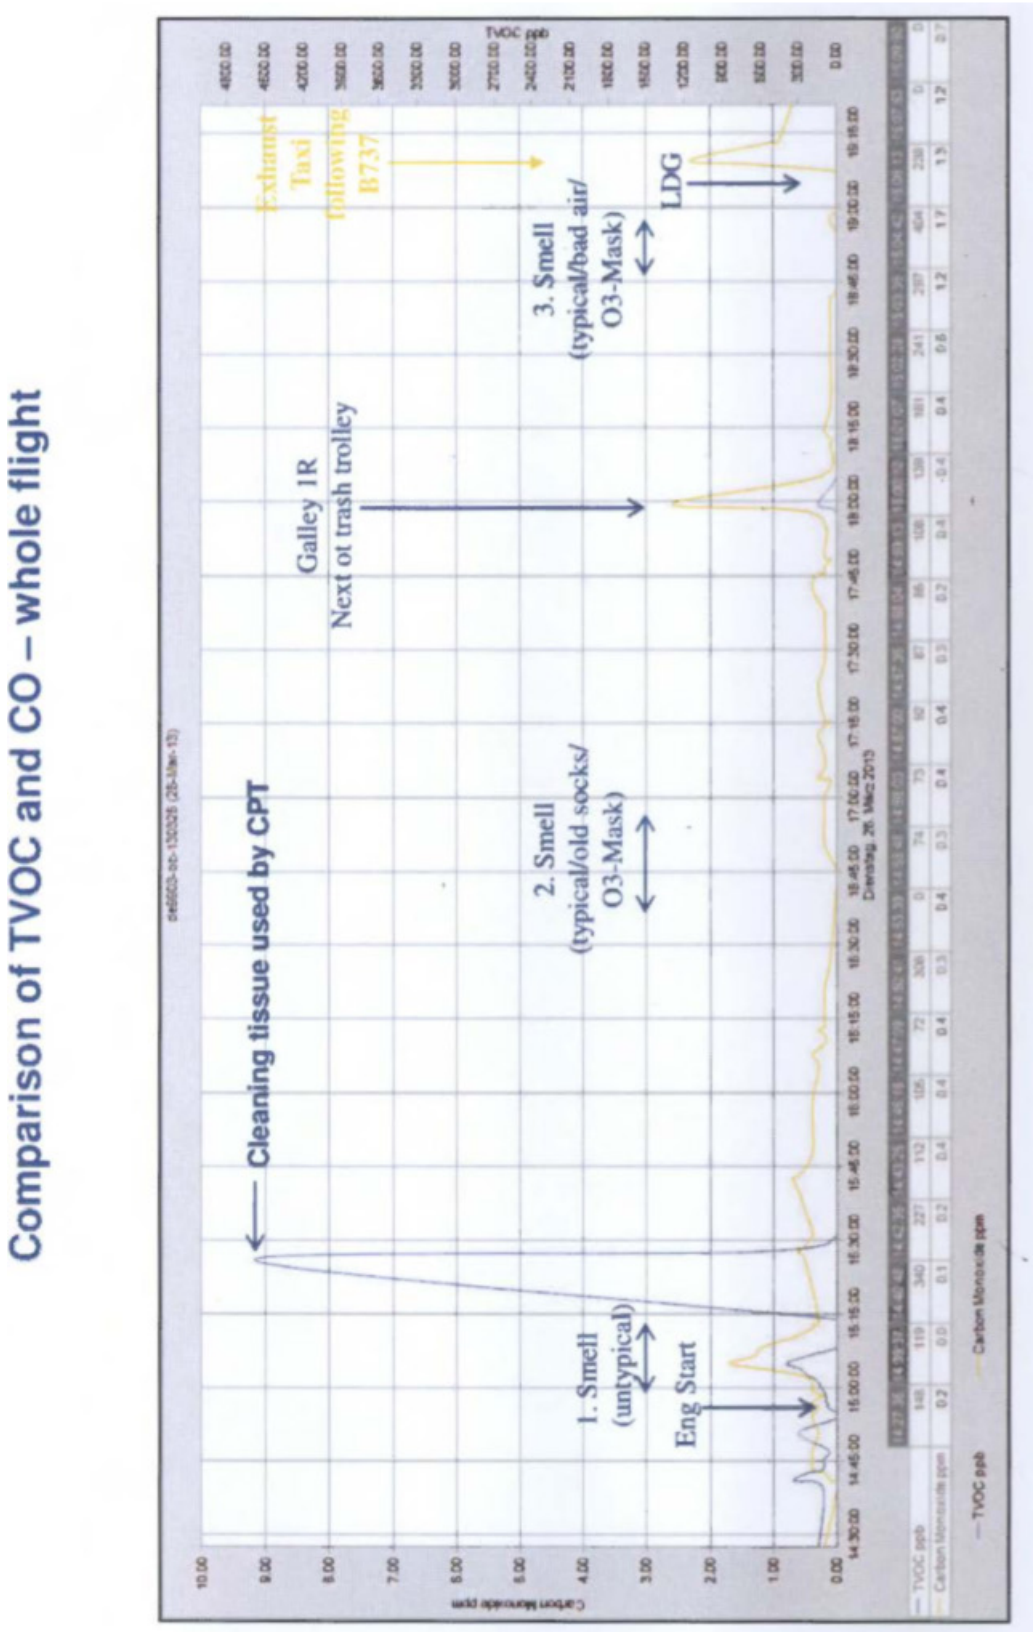
Figure 4. Comparison of TVOC and CO readings throughout the flight

The reason why the Graywolf did not give any indications during these phases could be because the odor was caused by compounds that are not ionized in the unit's probe (those with an ionization energy higher than 10.6 eV). Examples of such compounds include the following:

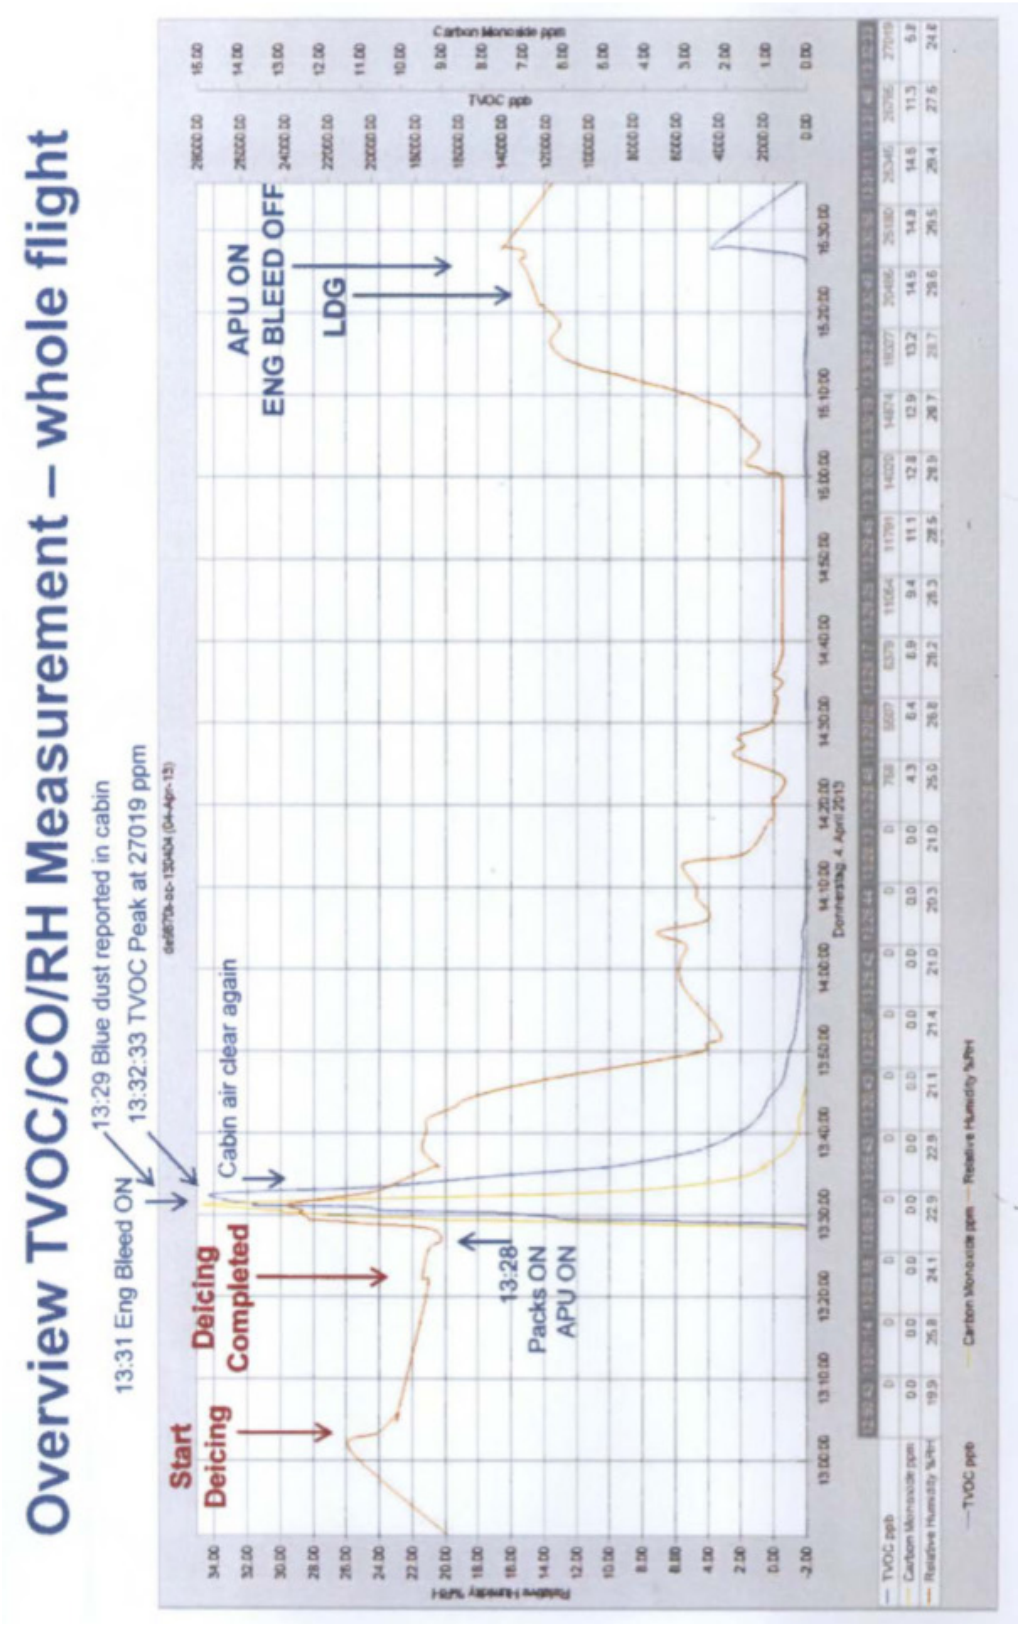
Figure 5. TVOC, CO and relative humidity readings during the flight of 04/04/13, which had undergone a deicing treatment

This time a large amount of smoke entered the cabin, both on the ground with the APU supplying the air conditioning packs, and in flight, with the air supplied by the engines. The Gray Wolf displayed a rise in TVOC values.

In light of the results of this test, the operator decided to prohibit deicing treatments with the APU running.

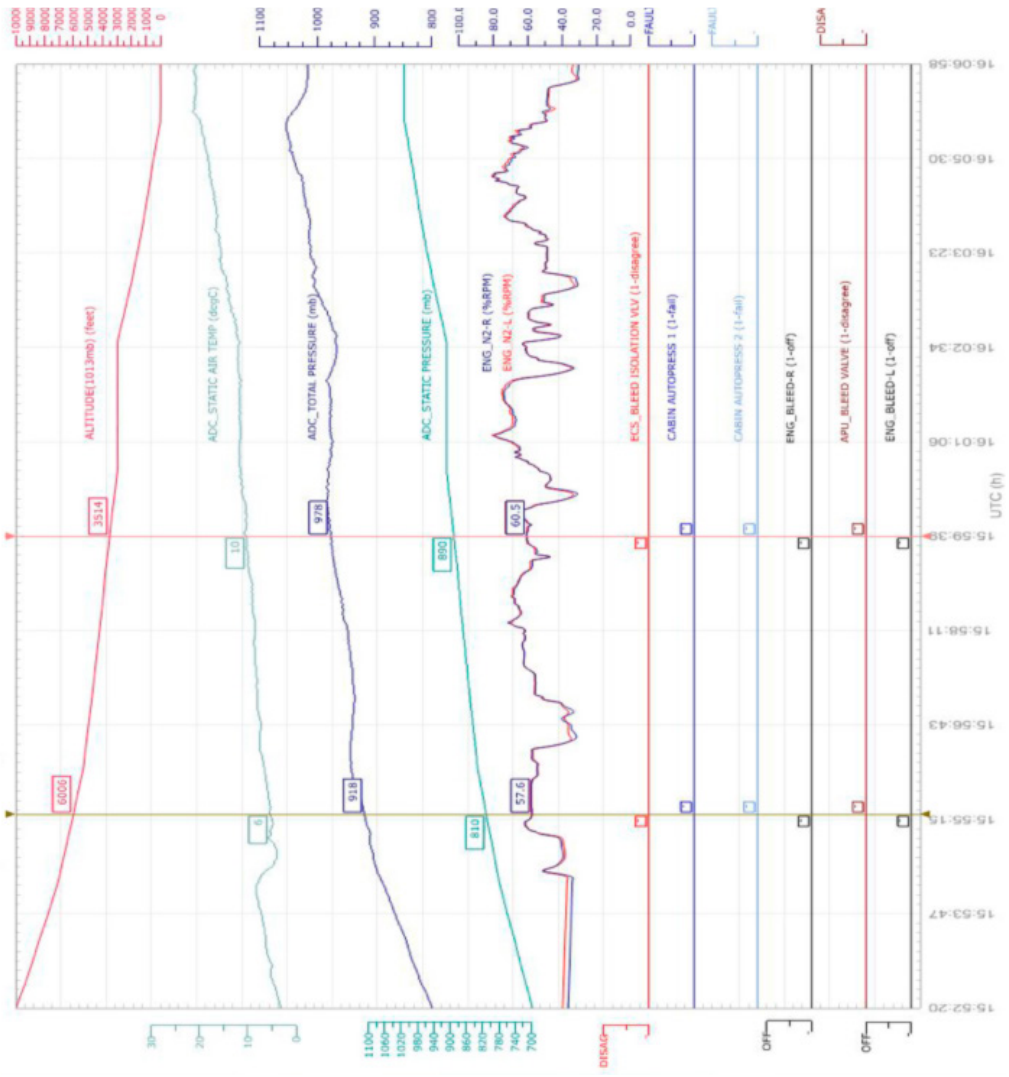
The information contained in the recorder did not indicate the presence of any abnormalities.

Figure 6. Graph showing several parameters during the approach

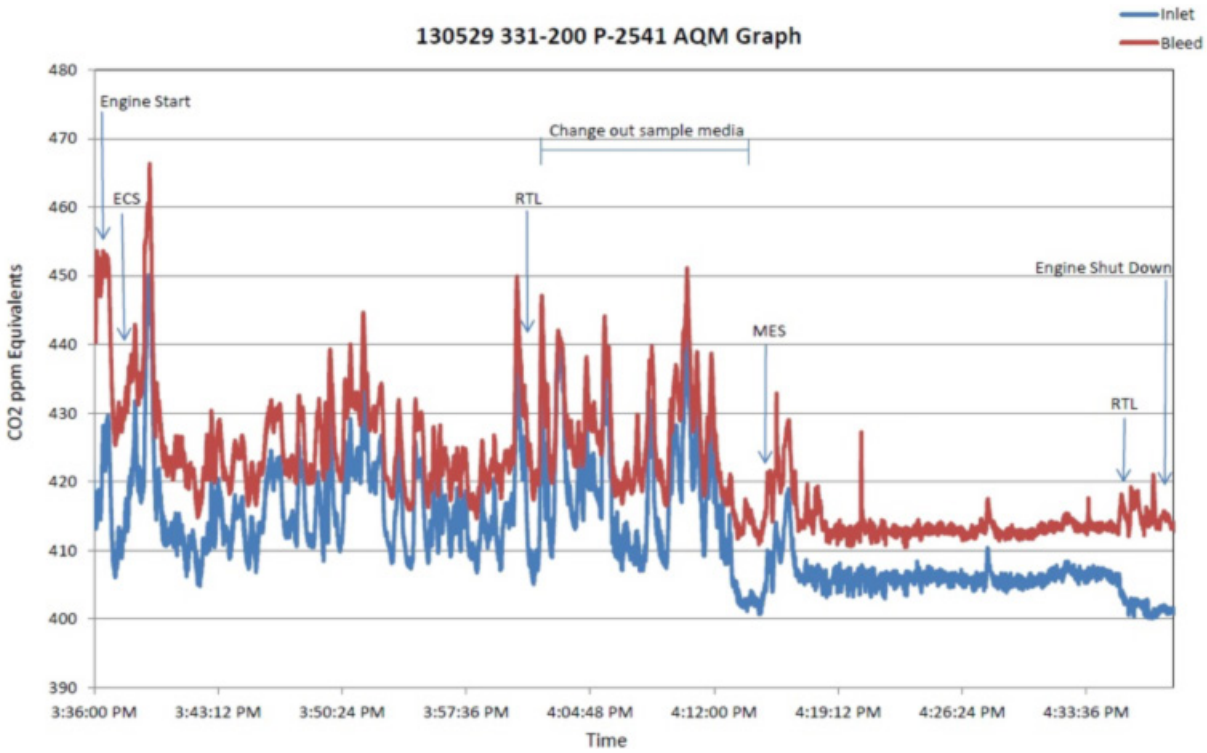
Figure 7. Results of the AQM

- Traces of multiple compounds and TICs9 were detected, with the highest levels being for isopropyl alcohol (2-propanol), acetone, butanone, toluene and carbon disulfide, all of which were below the odor perception threshold.

- The only smell reported by any of the participants was a "dirty" smell, with no reference being made to an "oily" smell.
