AIRCRAFT ACCIDENT REPORT 2/2018

AAIB
Air Accidents Investigation Branch

Report on the serious incident to
Boeing 737-86J, C-FWGH
Belfast International Airport
on 21 July 2017

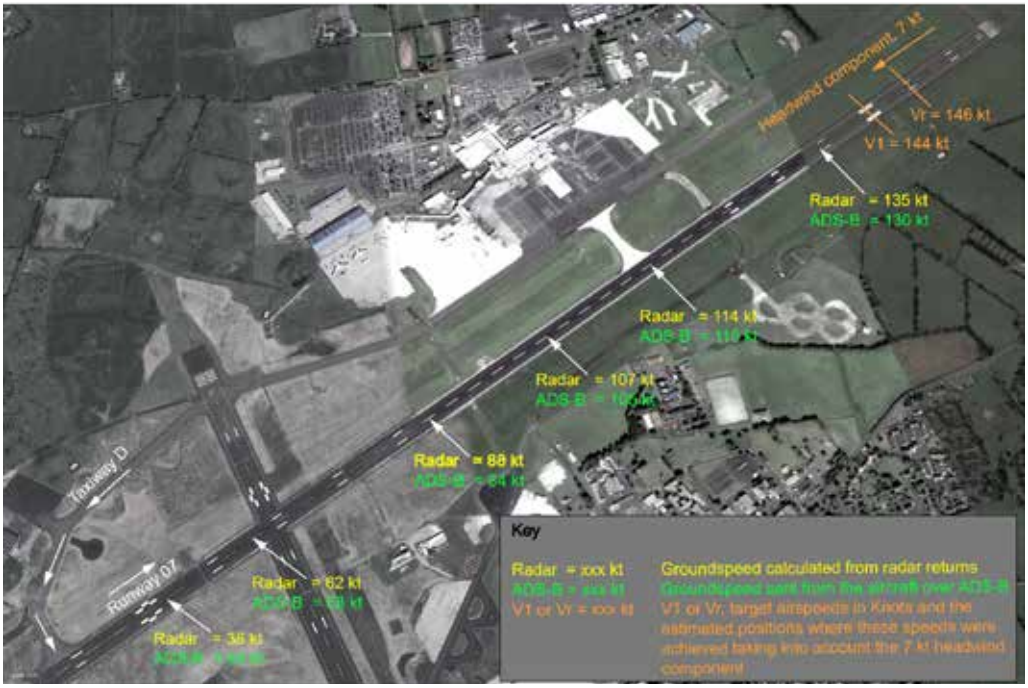
The radar installation at Belfast International Airport tracked C-FWGH along Runway 07 and during initial climb-out, when altitude data also became available from the aircraft's transponder. The radar returns allowed groundspeed for the aircraft to be calculated which was supplemented by both groundspeed and altitude data transmitted from the aircraft over its Automatic Dependent Surveillance – Broadcast (ADS-B) datalink. This data is shown in Figure 10 for the ground roll, where the text in yellow represents calculated groundspeed data from the radar track and, in green, the received ADS-B groundspeeds. Orange lines show the approximate position where the aircraft achieved airspeeds equivalent to the EFB-calculated V_1 and V_R, considering the 7 kt headwind component. V_R would have been achieved approximately 300 m from the end of the runway.

Groundspeed data for the takeoff in relation to the EFB calculated V_1 and V_R
© 2017 Google, Image © 2017 DigitalGlobe

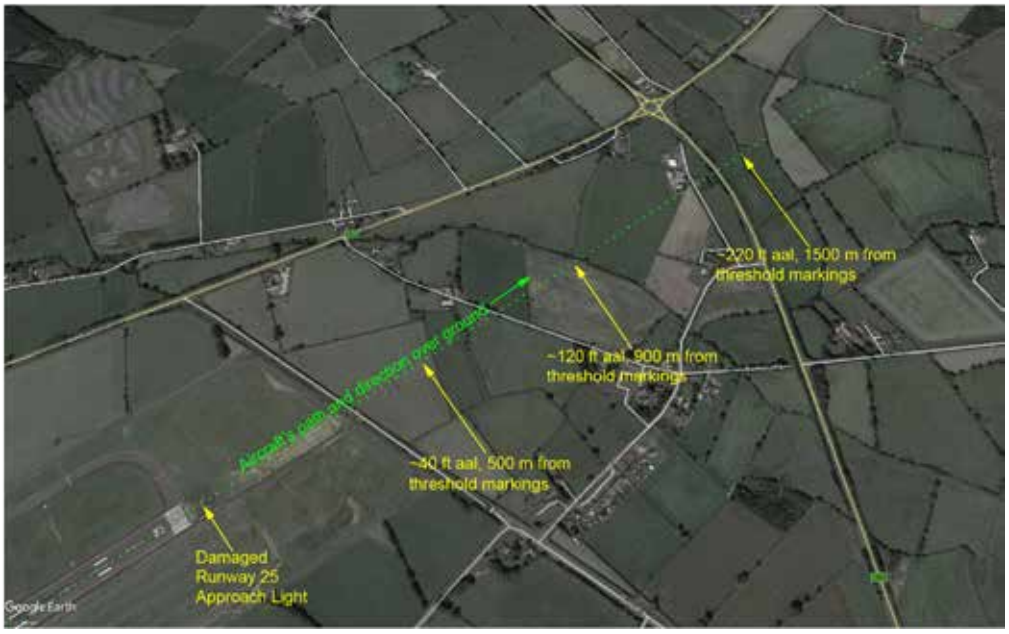
Figure 11 shows spot heights above the elevation of BFS (268 ft amsl) for the aircraft's initial climb, derived from the aircraft's ADS-B reports.

Vertical profile for the initial climb-out
© 2018 Google

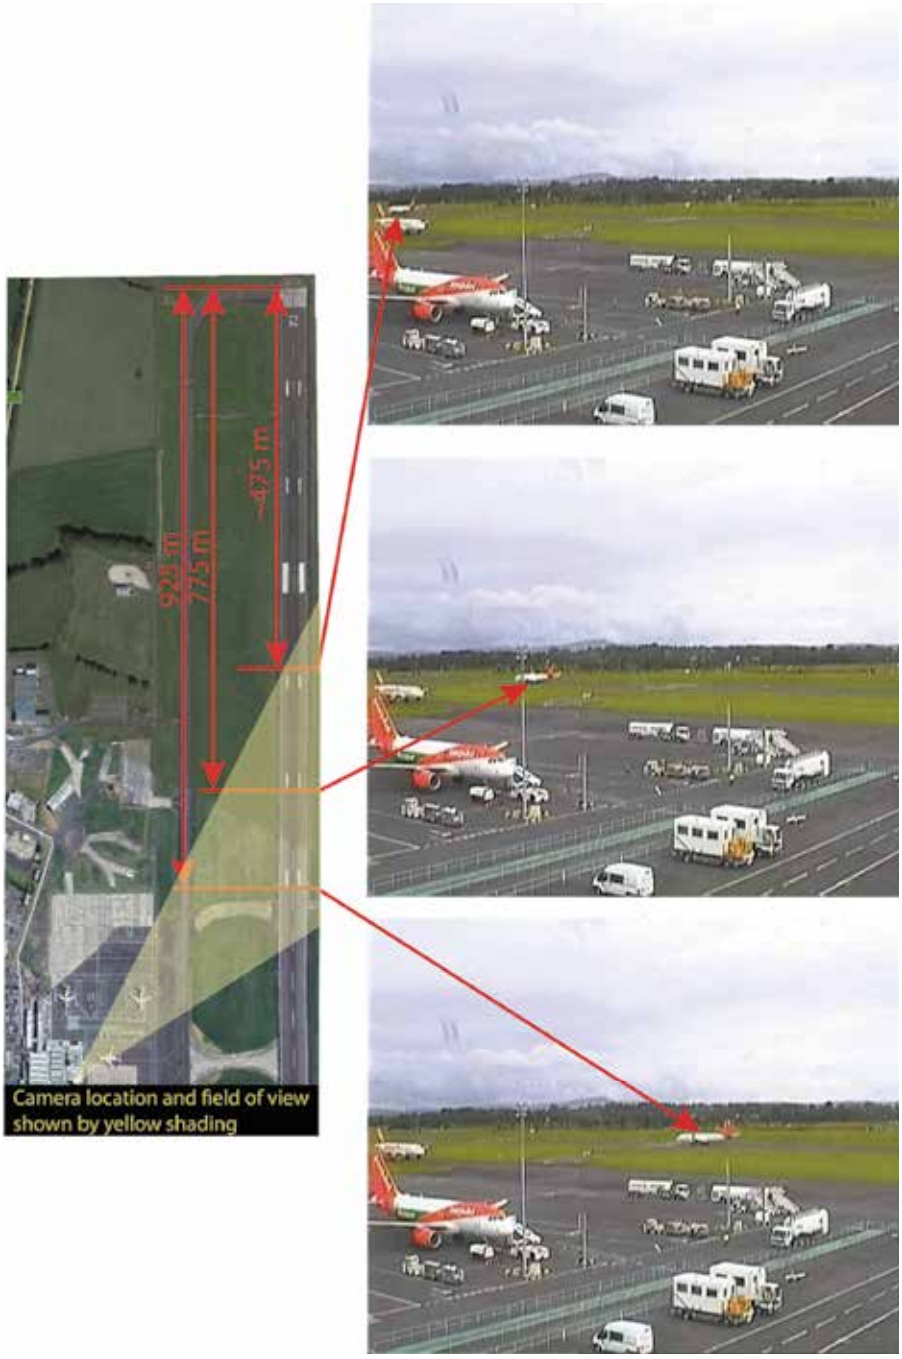
Figure 12

The airport operator provided the AAIB with closed-circuit television (CCTV) recordings of C-FWGH's takeoff from two cameras. The first camera's field of view recorded the segment between 1,000 m and 475 m from the departure end of Runway 07. At the end of this segment, C-FWGH had not rotated (Figure 12).

The first CCTV recording showing C-FWGH's takeoff

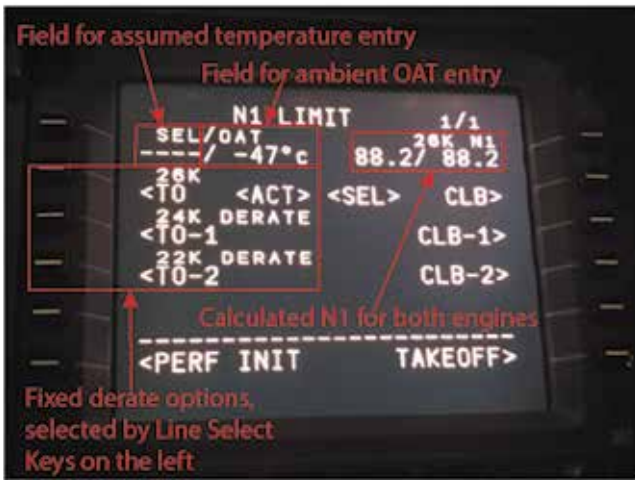
Figure 15

N1 LIMIT CDU page

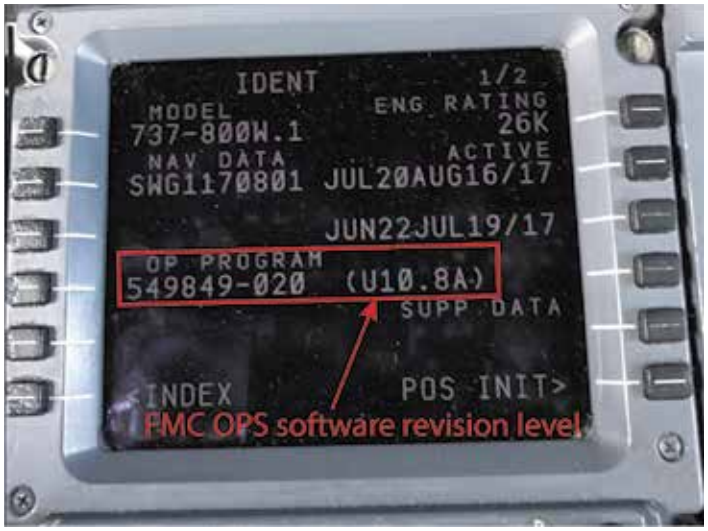
Figure 18

At the time of the serious incident, C-FWGH had an earlier revision of FMC OPS software installed, U10.8A (Figure 18), which did not include this crosscheck.

CDU IDENT page of C-FWGH

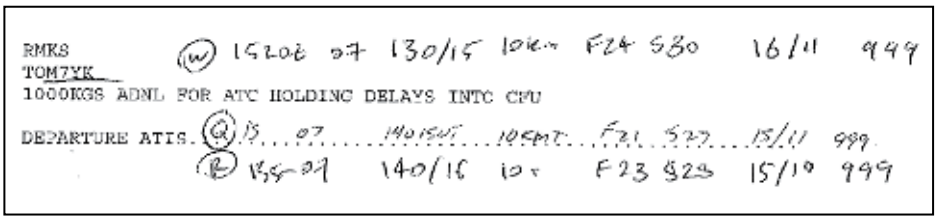
Figure 21

ATIS as recorded by PM on the pilot's log

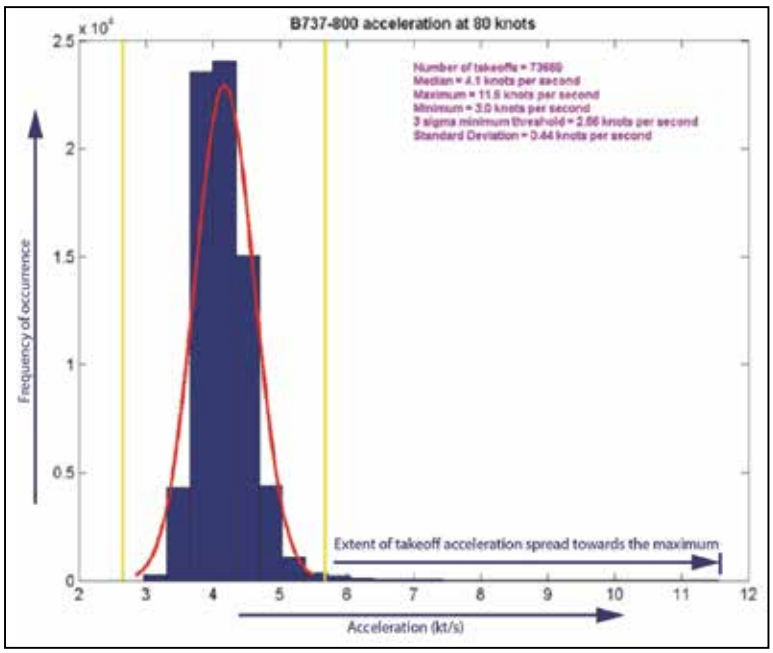
Further analysis of the data for each aircraft type showed that the acceleration required to reach this point on the runway was concentrated around a single value and, when this data was plotted as a histogram, any skew was on the side of higher, not lower accelerations. There were few cases where the acceleration was lower than that expected. This is shown below in Figure 20 for the Boeing 737 data set.

Histogram showing acceleration rates across the Boeing 737 data set
© 2018 Honeywell International Inc.

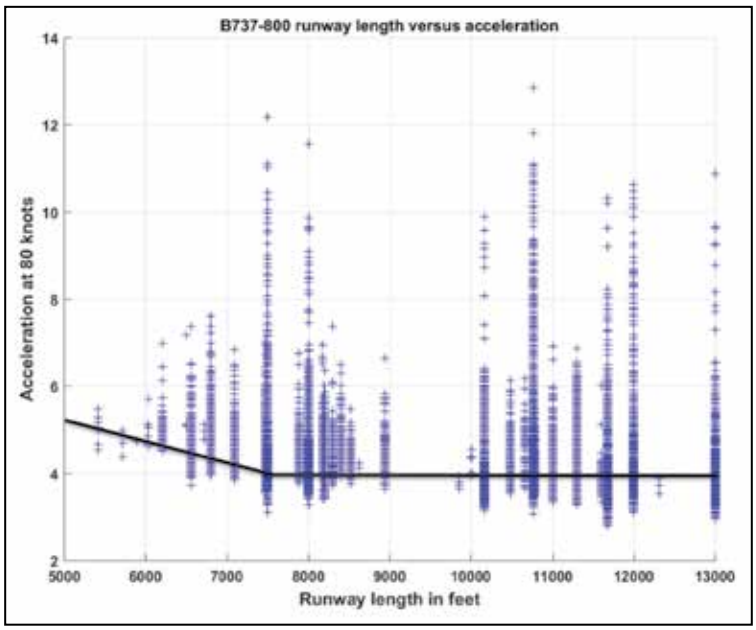
Figure 21

Although it was found that the minimum expected acceleration was constant for most runway lengths, on shorter runways an increase was noted in its value. For the Boeing 737 data, this is shown graphically in Figure 21.

Variation of acceleration rates with weight across the Boeing 737 data set
© 2018 Honeywell International Inc.
