FINAL REPORT

AIRBUS A380, REGISTRATION 9V-SKE
DIVERSION TO BAKU, AZERBAIJAN

5 JANUARY 2014

AIB/AAI/CAS.101

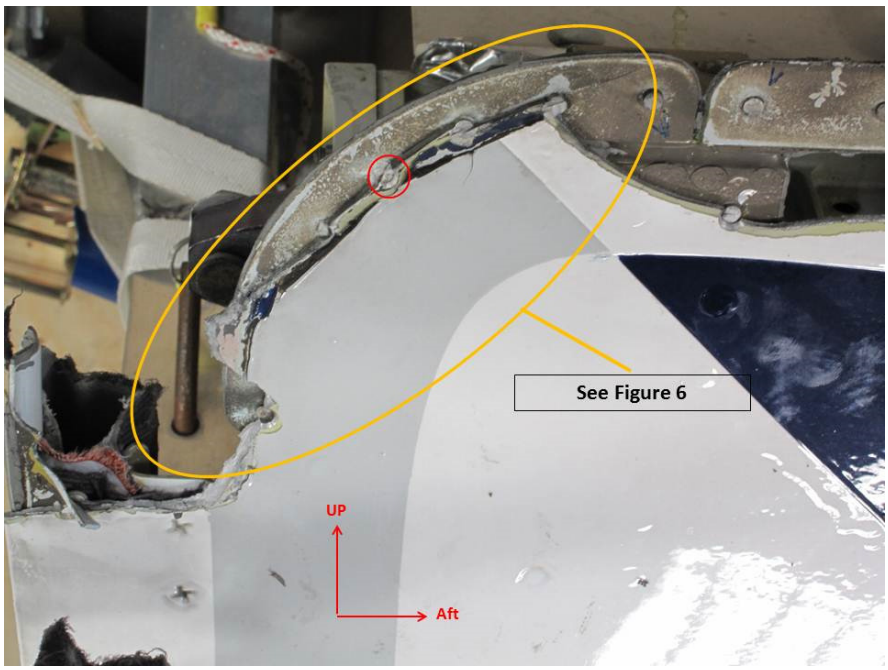
Figure 5: Damage at Door 3L upper left corner

1.3.1 The skin of Door 3L was found torn and bent outwards at the top left hand corner of the door (**Figures 3** and **4**). As a result, the aircraft was unable to maintain pressurisation. The Door 3L window shade was found collapsed. (**Figure 5**).

1.7.1.4 **Figure 5** shows the damage at the upper left corner of Door 3L in more detail.

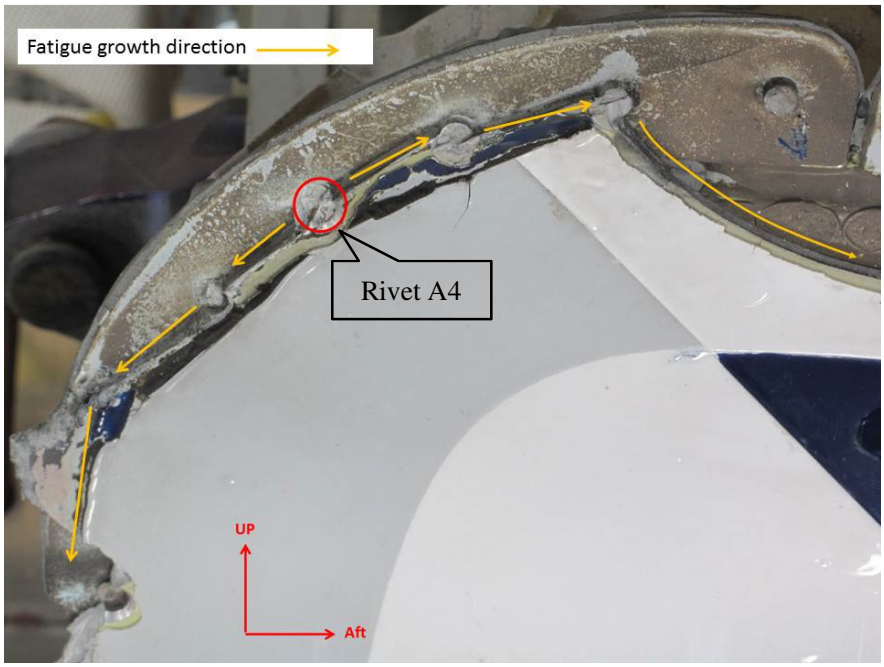
Figure 6: Crack growth direction indicated by arrows initiated from rivet highlighted in red

1.7.1.5 SEM examination of the cracked surface revealed predominantly fatigue induced fractures originating from some rivet holes (Figure 7). The crack is likely to have started at Rivet A4 and propagated away from Rivet A4 as shown in Figure 6. An analysis of the crack by the aircraft

2.1.1 The root cause of the Door 3L failure was traced to a crack passing through a number of rivet holes on the door skin. The crack was probably induced by high cycle fatigue under varying amplitude loading caused by fluttering of the Batch 1 coverplate (CP) that was initially installed on the aircraft. The replacement of the Batch 1 CP by a stiffer Batch 3 CP could not prevent further propagation of the crack.

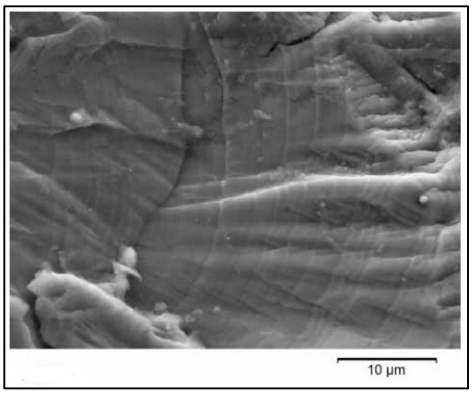
Figure 7: SEM image of fracture surface showing striation lines indicating fatigue failure

manufacturer suggests that the fractures were due to high cycle[10] fatigue failure under varying amplitude loading.

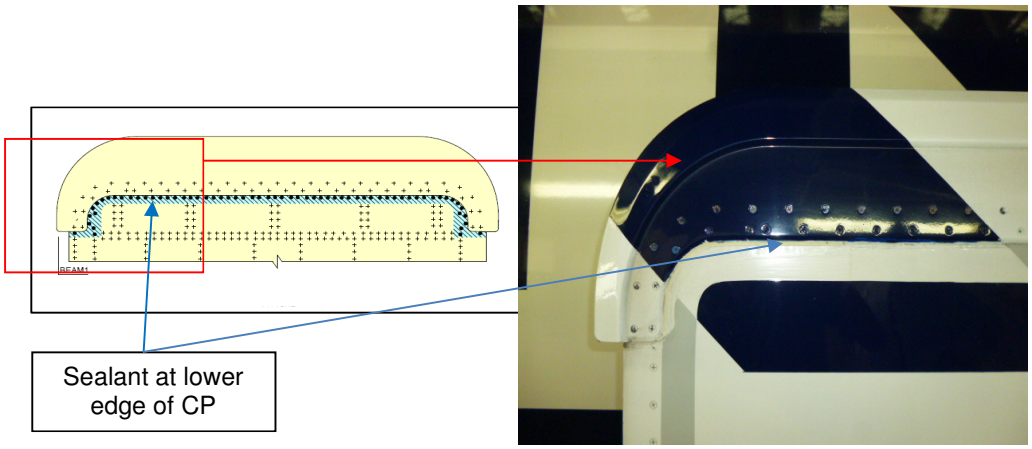
Figure 8: Location of affected row of rivets

1.7.1.6 The row of affected rivets is located just below the bottom edge of the CP (**Figure 8**).

2.2.2 When the CP is in place, the lower edge of the CP would almost cover the row of rivets in question (see Figure 8) and, as mentioned in paragraph 1.7.1.6, a fillet of sealant is applied to seal the lower edge of the CP. The sealant application job does not include an inspection of the row of rivets. Anyway, it is doubtful if maintenance personnel focusing on the sealant application job would notice any such missing rivet heads, especially if the cavity left by the missing rivet heads had been filled with sealant.

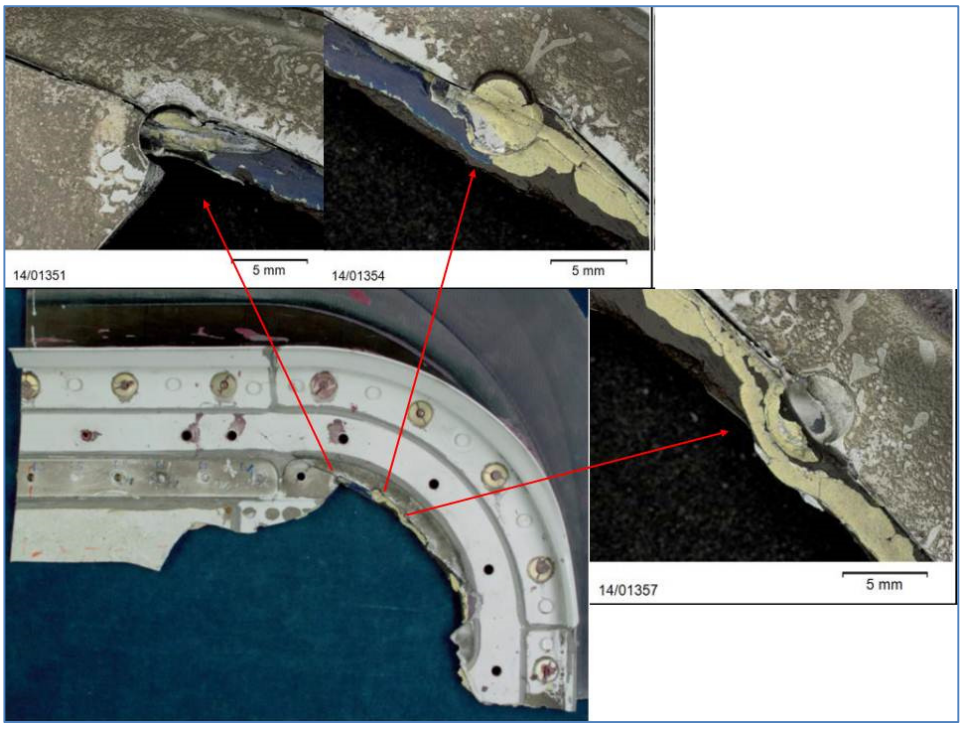
Figure 10: Paint and sealant on countersunk surface of missing rivet holes

1.7.1.8 In addition, there were three missing rivet heads at the cracked area with paint and sealant found on two of the missing rivet heads' countersunk surface (**Figure 10**). Analysis of the paint revealed that the paint was PPG CA8000 (a top coat paint approved by the aircraft manufacturer).

2.2.1 Traces of sealant and paint were found on the crack surfaces as well as on the countersunk surfaces of two of the rivet holes with missing rivet heads. This means the crack was already present in August 2012 during the CP replacement and subsequent painting work. The rivet heads could also have been missing by then.

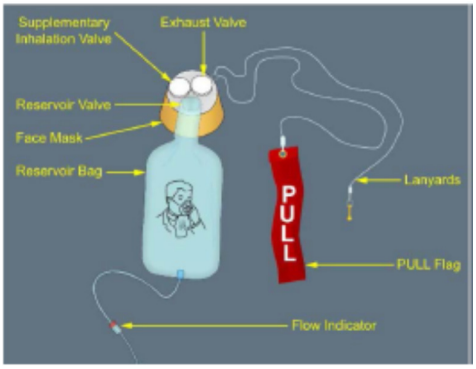
Figure 11 – Oxygen mask arrangement

(c) A lanyard is latched to the oxygen mask. Pulling on the oxygen mask will cause the lanyard to release a pin in the oxygen dispenser mechanism, thereby opening a valve to allow oxygen to flow into the tube.

(b) The lanyard pins of seven of the 13 PSUs in the CCRC were not released and there was therefore no oxygen flow. The others were found with green band indicating that the oxygen flow was activated.

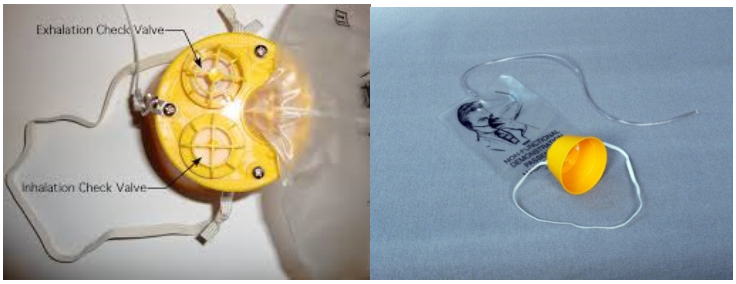
Figure 12 – Oxygen mask construction

(d) When a person inhales through the oxygen mask, air in the aircraft cabin will also be drawn into the mask through an inhalation check valve (**Figure 12**). Therefore, what a person is breathing in is actually a mixture of oxygen from the aircraft's oxygen supply system and air from the aircraft cabin. The resultant composition of the air mixture depends on the oxygen flow rate (which depends on the cabin altitude).

2.4.1 As regards the feedback from passengers that the PSUs above their seats did not appear to be dispensing oxygen, post-examination of these PSUs shows that the PSUs were in working conditions and the green band on the tubes connecting the oxygen mask to the PSUs suggests that oxygen did flow in the tubes. Given that the cabin altitude was below 12,000 feet when the oxygen system was activated, the oxygen flow rate was likely to be minimal, and users of oxygen masks would have to inhale fairly deeply to draw in the oxygen supplied through the tube. However, the air pressure in the cabin was such that the cabin air drawn into an oxygen mask through the inhalation check valve would have allowed adequate breathing.
