Statens haverikommission
Swedish Accident Investigation Authority

Final report RL 2016:11e

Accident in Oajevágge, Norrbotten County, Sweden on 8 January 2016 involving the aeroplane SE-DUX of the model CL-600-2B19, operated by West Atlantic Sweden AB.

File no. L-01/16

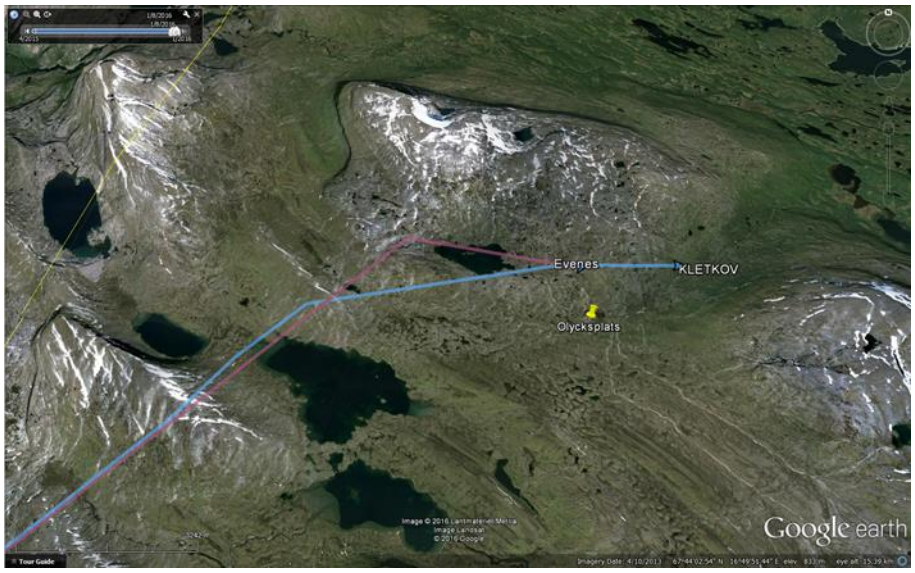
Figure 20. Radar data from Evenes and Kletkov in magenta and blue. Map: Google Earth. Map data: © Lantmäteriet Reference number R61749-13002.

Selected radar data was inserted into a Google Earth map. The tracks in figure 20 below are drawn with straight lines between the few recorded radar positions.

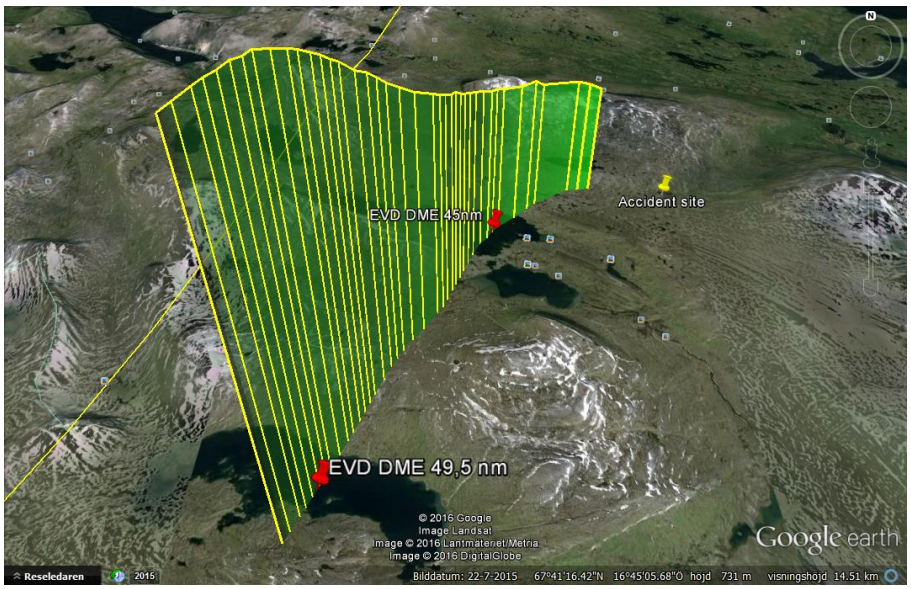
Figure 21. WAM data in Google Earth. The altitude profile and DME distances from Evenes VOR (EVD) are based on recorded DFDR-data. Map data: © Lantmäteriet Reference number R61749-13002.

WAM data from the Swedish ANS provider LFV has been inserted into a Google Earth map. According to LFV the positions have a position accuracy of 60-80 meters (Figure 21).

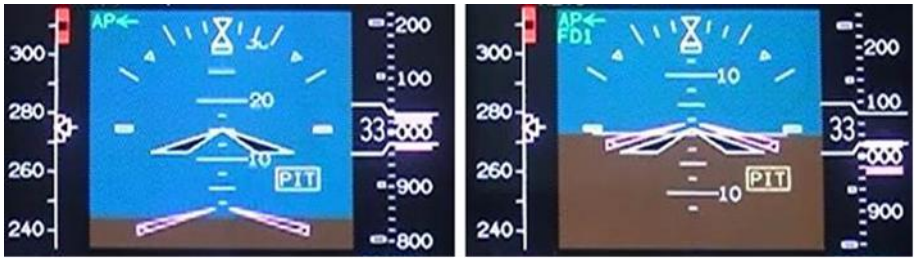
Figure 25. Left and right PFD at **t2**.

The figure 25 below shows the information that is believed to have been displayed on PFD 1 and 2. The Pitch angle on the left PFD was about 15 degrees but unchanged on the right PFD.

Since the difference between the units exceeded 4 degrees, the PIT symbol was displayed flashing in yellow. No audible warning (Master Caution) had yet been recorded which is likely due to the delay which is built into the system. The activation of the PIT display shall coincide by design with an EFIS COMP MON caution on the EICAS display. The flight director indicator went down to give control commands to lower the nose of the aircraft as the autopilot was in the altitude hold mode called Altitude Track.

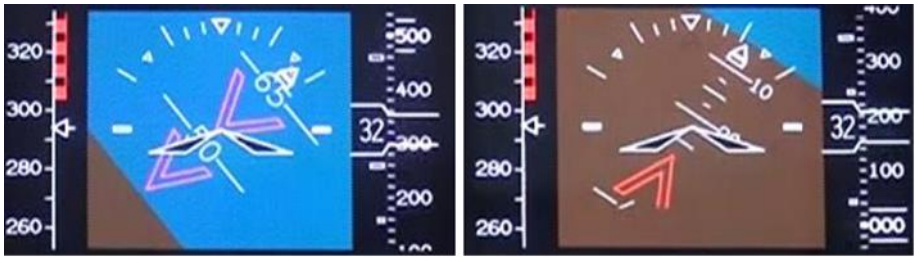
Figure 28. Declutter mode on right PFD at **t13**.

At approximately **t13** the Pitch Angle on the right side PFD reached minus 20 degrees which meant that the declutter mode now was activated on this side (see figure 28 below). The co-pilot exclaimed the first operational callout "Come up". At about the same time the warning for stabilizer movement, Stab Trim Clacker, was activated and another Triple Chime sounded which was cut-out by two Bank Angle warnings.

The situation at this time meant that the crew were presented with two contradictory attitude indicators with red chevrons pointing in opposite directions. At the same time none of the instruments displayed any comparator caution.

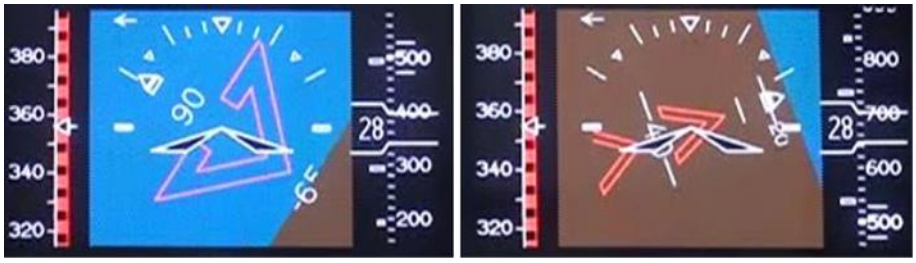
Figure 29. Display of the simulation at **t22**.

At **t23** the Mach number had increased to 0.90 which is significantly higher than M_{MO} (M_{MO}=0.80 at the current altitude).

The speed and attitude in combination with the spatial disorientation of the flight crew at this point meant that the possibilities to recover from the loss of control of the aeroplane now were minor.

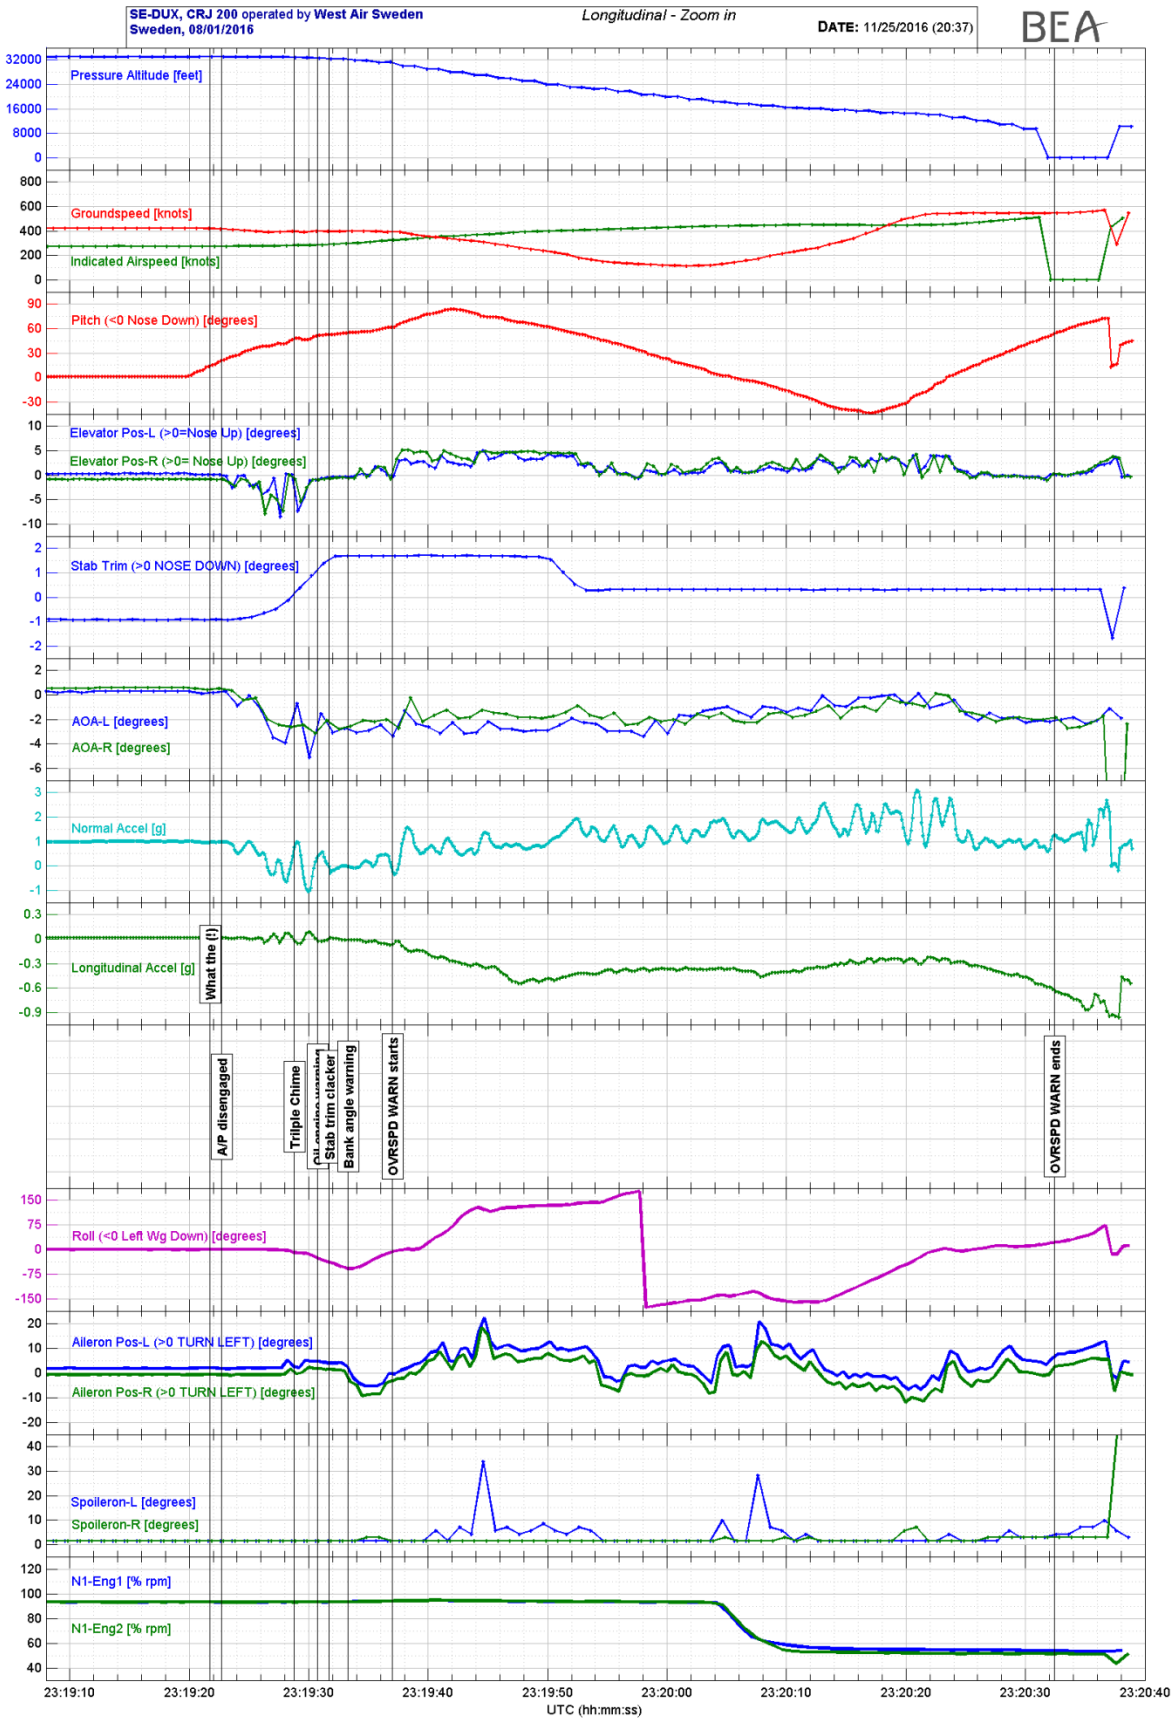
Pressure altitude, ground speed*, indicated airspeed, pitch angle*, elevator position left/right, stabilizer trim, angle of attack left/right, normal acceleration (G), longitudinal acceleration (G), rollangle*, aileron position left/right, spoileron left/right, N1 speed for left/right engine.

* Those parameters are not compatible with the aeroplanes motion.
