Air Accidents Investigation Branch

Accident Report No: **2/2008 (EW/C2005/10/05)**

Aircraft Type and Model: Airbus A319-131

Registration: G-EUOB

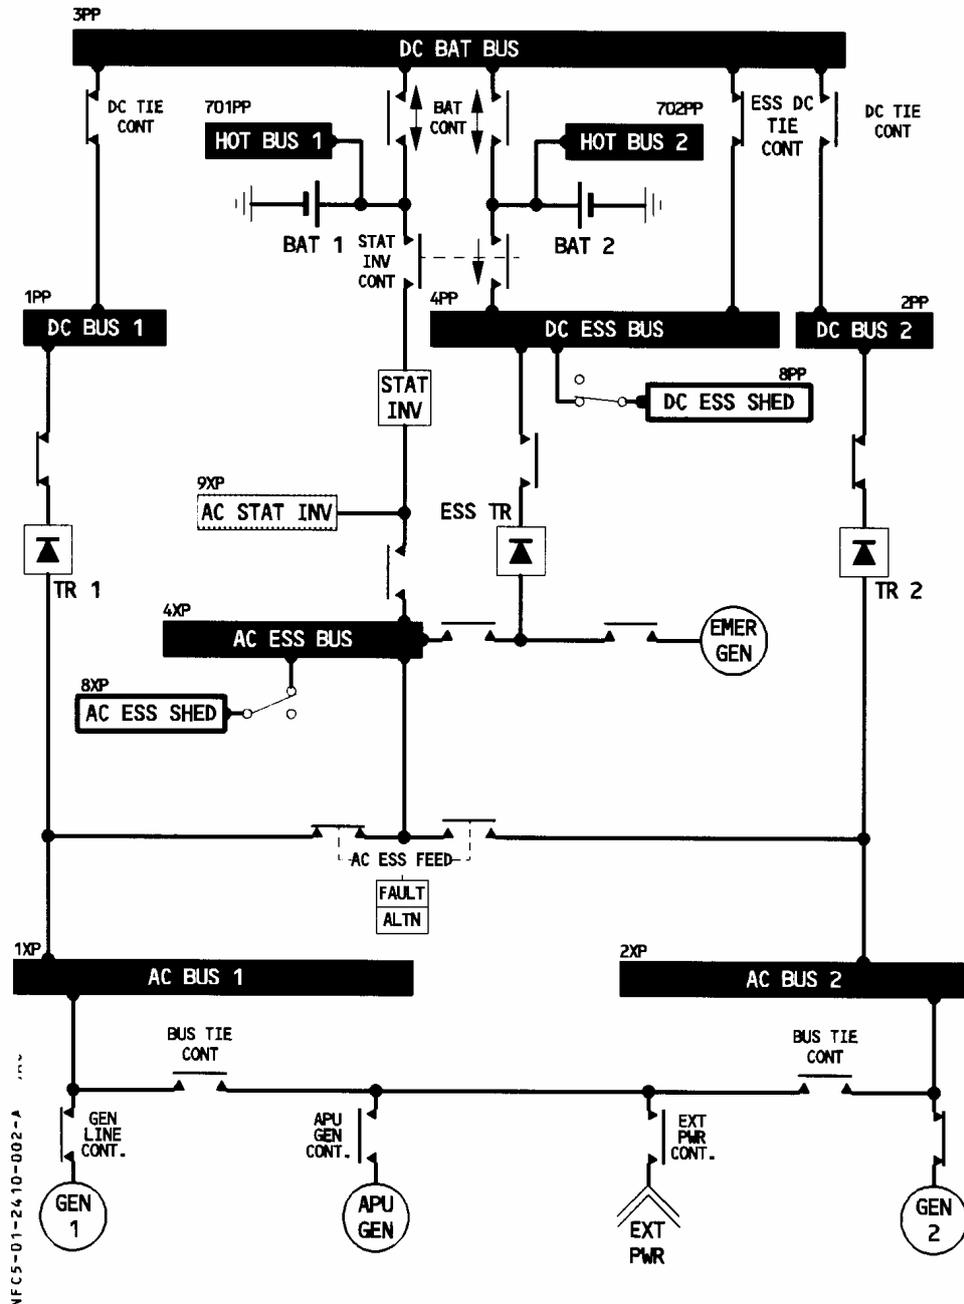
Figure 1

The two networks are subdivided into busses and sub-busses, based on their functionality (Figure 1). The IDGs supply three-phase 115/200 volt, 400 Hertz constant-frequency power to the left and right AC busses, AC BUS 1 and AC BUS 2. AC BUS 1 in turn, supplies the AC Essential bus (AC ESS) via the AC Essential Feed (AC ESS FEED) contactor. The AC ESS bus, in turn, supplies the AC ESS SHED bus.

A319 Electrical System Architecture
(Normal Flight Configuration shown)

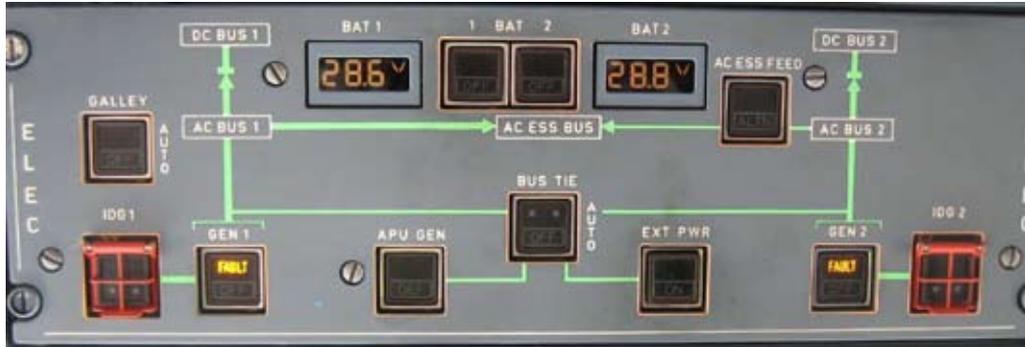
Figure 2

Electrical system control panel

The panel also provides for annunciation of the status of the electrical system and fault conditions. The generator control switches are identified as GEN 1, GEN 2 and APU GEN for the left, right and APU generators. If a fault occurs with a generator, a fault legend will illuminate on the respective generator control push button switch. Selection of a generator control switch causes its respective auxiliary relay to energise, which causes the GLC coil to be energised, coupling the generator to its on-side AC bus (AC BUS 1 or AC BUS 2). The AC ESS FEED push button switch is also located on this panel. If the AC ESS bus is unpowered, a fault legend will illuminate on the AC ESS FEED switch.

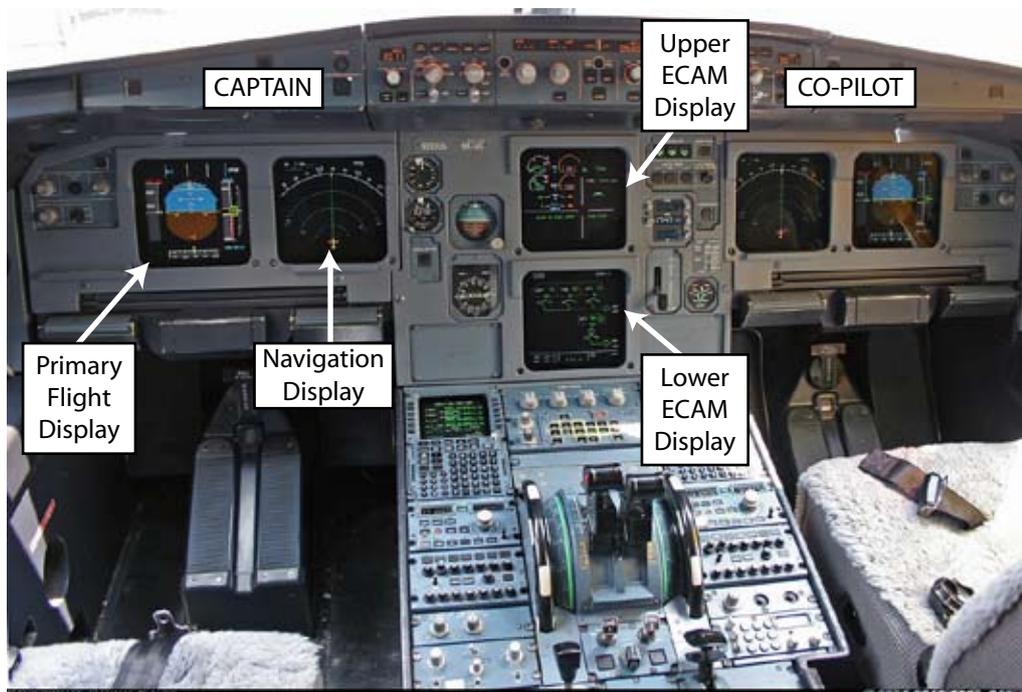
Figure 3

A320 family aircraft are equipped with an Electronic Instrument System (EIS), incorporating six identical display units (Figure 3). These include the captain's and co-pilot's Primary Flight Displays and Navigation Displays, the Engine/Warning display and the Systems display. The latter two are commonly referred to as the upper and lower ECAM displays.

A320 family Electronic Instrument System Layout

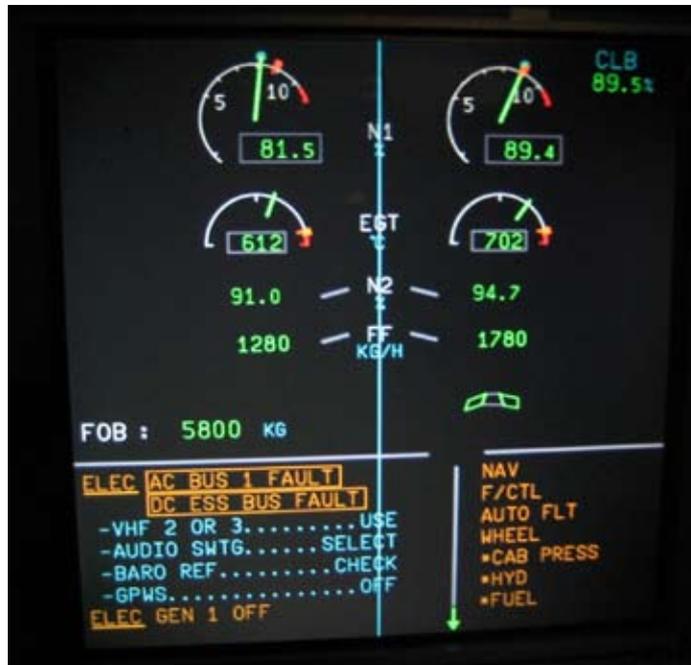
Figure 4

The upper ECAM display presents engine primary data, wing flap/slat positional data and ECAM warning messages and memos. Following an aircraft systems failure, the affected system(s) are automatically listed on the lower part of the upper ECAM display, together with checklist actions to be carried out by the crew (Figure 4).

Upper ECAM Display showing sample failure messages and checklist actions

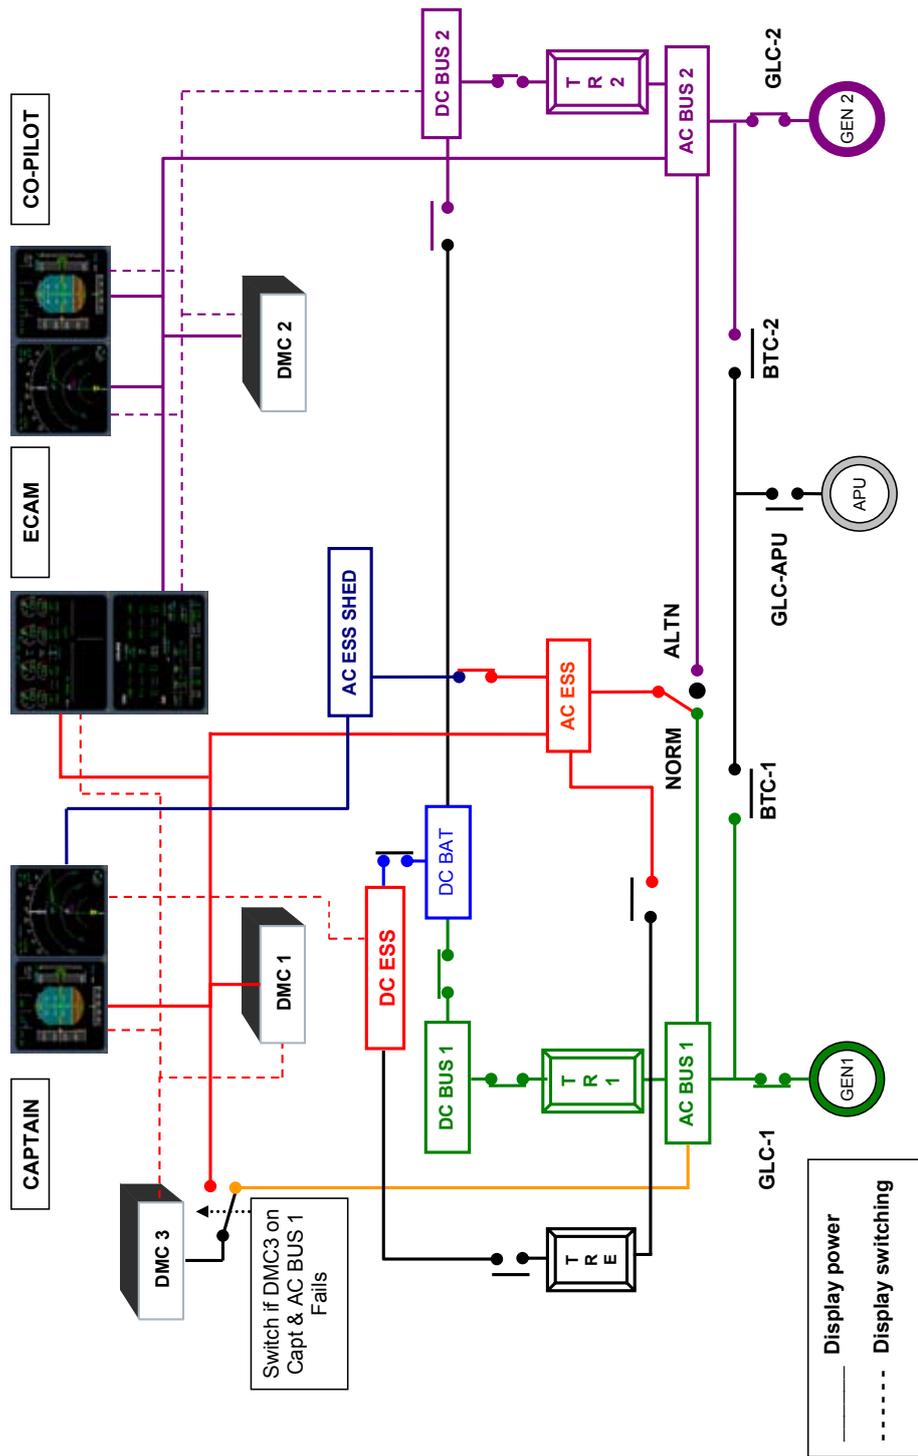
The normal EIS power supply configuration is shown in Figure 5. The expected effect on the EIS displays due to an AC BUS 1 failure is shown in Figure 6. Figure 7 shows the EIS power supply configuration after selection of the AC ESS FEED switch to 'ALTN'.

Figure 5
EIS Normal Power Supply Configuration

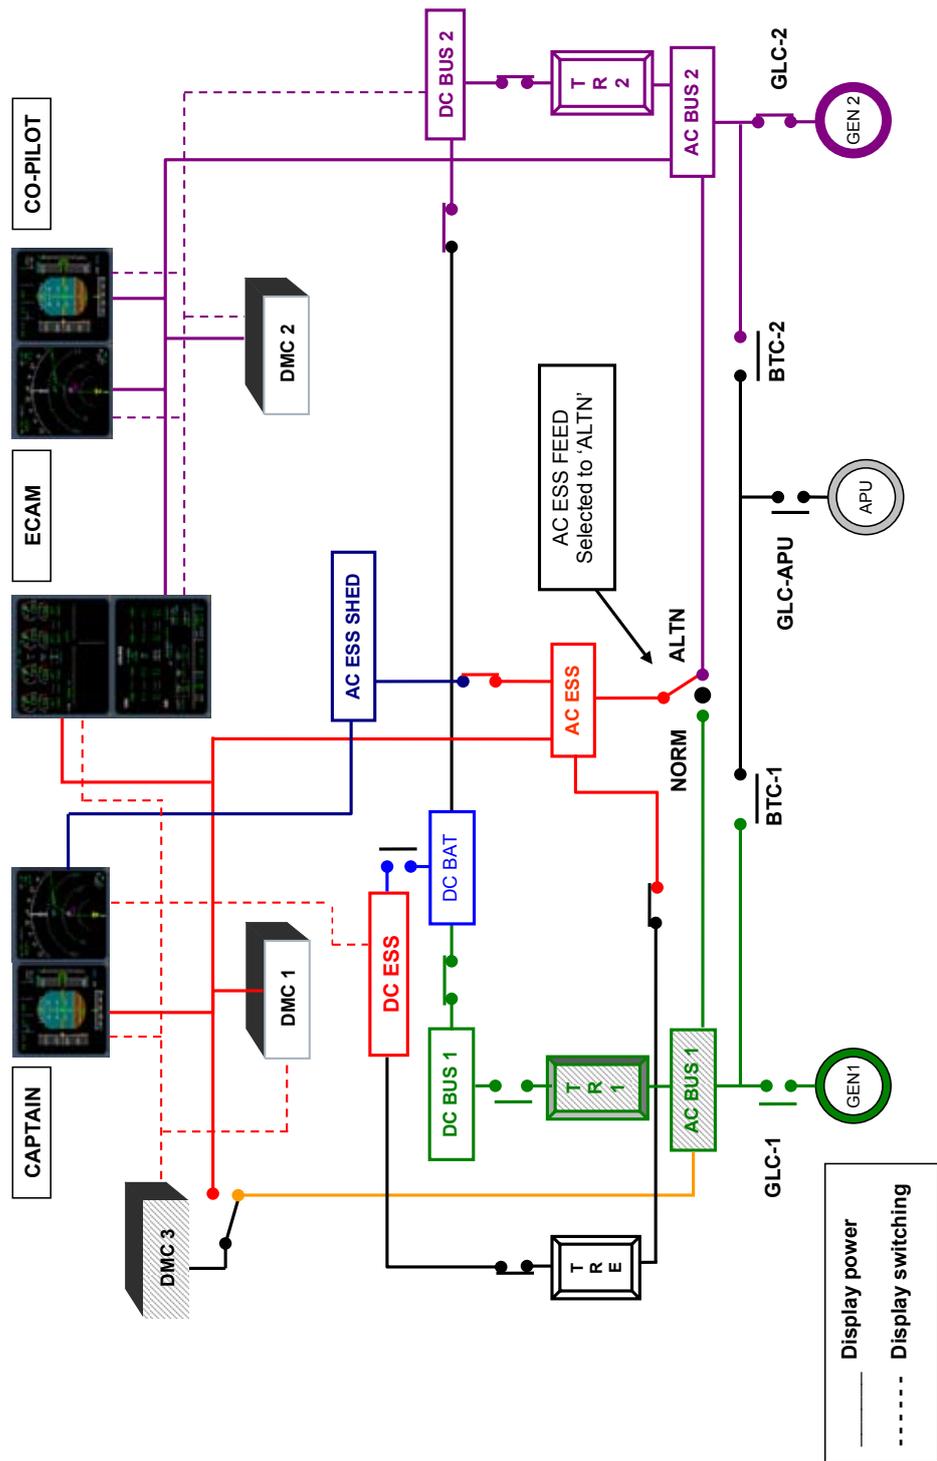
Figure 7

This ECAM action was the ninth or tenth item on the list and was not initially visible; it would only have appeared on the lower ECAM display after some of the preceding actions had been cleared. The co-pilot was hampered in carrying out the ECAM actions by the lack of lighting on the panels, with the result that the AC ESS FEED push button switch was selected to 'ALTN' some 90 seconds after the initial failure.

EIS Power Supplies - AC ESS FEED selected to 'ALTN'

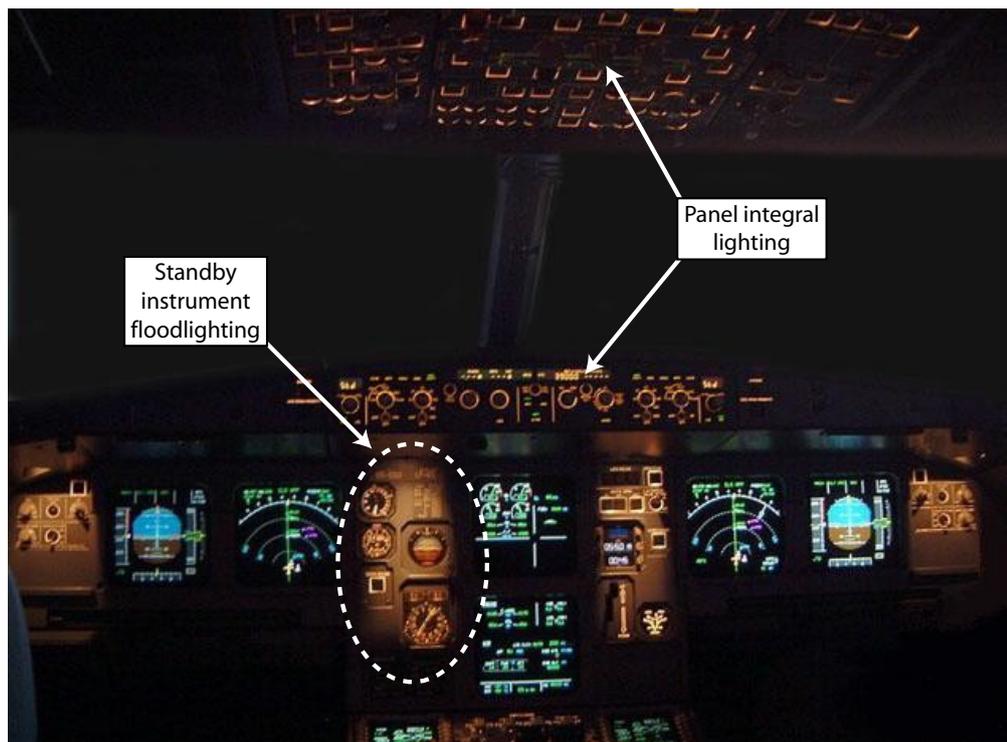
Figure 8

The cockpit is provided with various sources of background and specific illumination (Figure 8). The instruments (including the standby instruments) and the panels in the cockpit (apart from the EIS display units) are provided with integral lighting, which is adjustable in brightness. The power for this lighting is supplied by AC BUS 1, with the exception of the standby compass integral lighting, which is powered from the DC ESS bus.

View of instruments by night showing lighting and EIS displays

the dome light was switched off, the standby instruments became unreadable due to lack of light. The centre instrument panel floodlight, which can be used to illuminate the standby instruments (Figure 8, page 26), was no longer available.
