Investigation Report

7X010-0/07
February 2009

Type of occurrence:	Serious incident
Date:	23 August 2007
Location::	Mannheim
Type of aircraft:	Helicopter
Manufacturer / Model:	EUROCOPTER / EC135 P2+
Injuries to persons:	No injured persons
Damage to aircraft:	Aircraft not damaged
Other damage:	None
Source of information:	Investigation by BFU

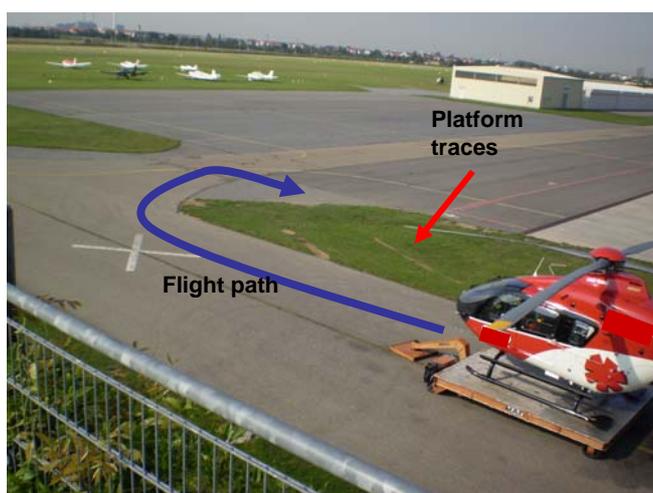
At 10:36 a.m.¹ the Air Rescue Center was alarmed for a primary rescue operation. The pilot and the paramedic entered the helicopter, standing on the helicopter transport platform and connected to the outboard power supply. According to the statements of the pilot and the emergency physician, the emergency physician stood outside the helicopter and monitored the starting of the engines. After a hand signal of the pilot, he pulled out the connector of the outboard power supply. He closed the flap at the helicopter and placed the connector on the floor in front of the platform. After that, the paramedic entered the helicopter and reported the cabin ready for take-off.

In this case, the emergency physician placed the connector on the ground without becoming aware that a cable loop had formed around the tip of the right skid. The missing color contrast between the black skid and the black cable may have contributed to this.
