White list to Black List Plan by Australia

Greg Dunstone

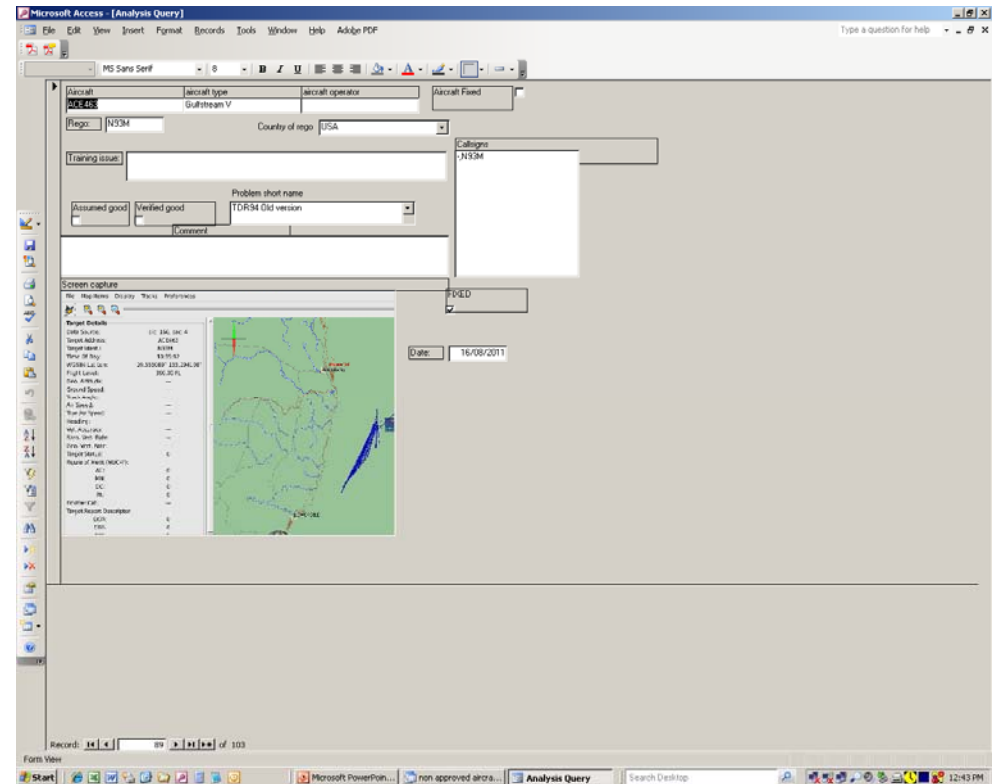
- ADS-B data from 43 ADS-B receiver sites in Australia
- Tools & Database developed
- From 21 January till 3 October 2011
- A number of problem aircraft found
 - Some in already approved aircraft (most)
 - Some in not approved aircraft

Number of issues is low
