Third Meeting (ATM SG/3)
(Cairo, Egypt, 22 – 25 May 2017)

WAKE TURBULENCE SEPARATION IN RVSM AIRSPACE

Interim Report

Type of Occurrence:	Accident
Date:	7 January 2017
Location:	Enroute, above the Arabian Sea
Aircraft:	<ol style="list-style-type: none">1) Airplane2) Airplane
Manufacturer / Model:	<ol style="list-style-type: none">1) Bombardier / CL-600-2B16 (604 Variant)2) Airbus / A380-861
Injuries to Persons:	<ol style="list-style-type: none">1) Two severely injured passengers, two passengers and one flight attendant suffered minor injuries2) None
Damage:	<ol style="list-style-type: none">1) Aircraft severely damaged2) None
Other Damage:	None
State File Number:	BFU17-0024-2X
Published:	May 2017

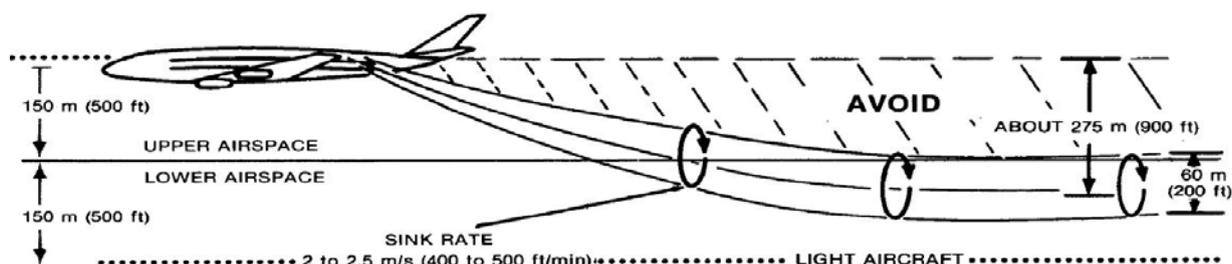
Figure 1.

1.4 Flight tests have shown that vortices from large aircraft sink at a rate of about 2 to 2.5 m/s (400 to 500 ft/min). They tend to level off at about 275 m (900 ft) below the flight path of the generating aircraft. Wake turbulence strength diminishes with time and distance behind the generating aircraft. (Figure 1 refers).

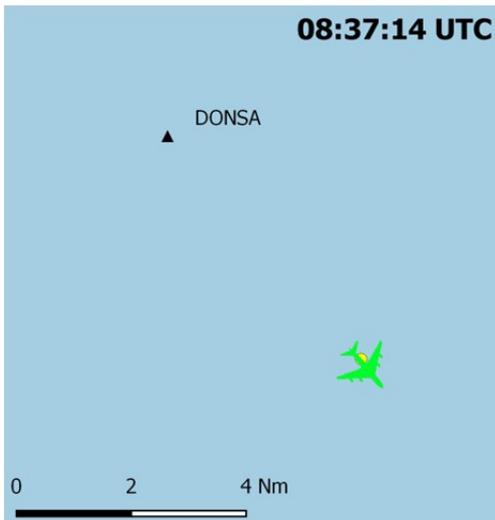
At about 0837:14 UTC the A380 passed at FL350 the position, where later the CL604 was subject to temporary loss of control.

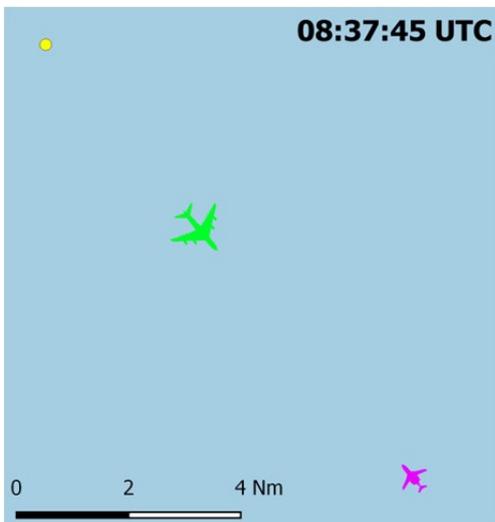
At about 0837:45 UTC the A380 TCAS captured the CL604 on opposite track (TCAS message proximate). At that time the distance between the two aircraft was 6 NM and 1,000 ft vertical.
