AIIG 2 Meeting/Workshop, Jeddah, 13 Sep 2022

Fan Hub Rupture

© Copyright Airbus 2022 / A Never Give Up Story

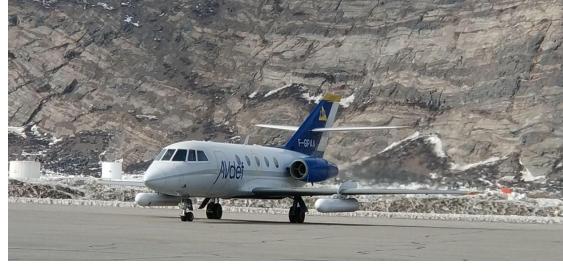
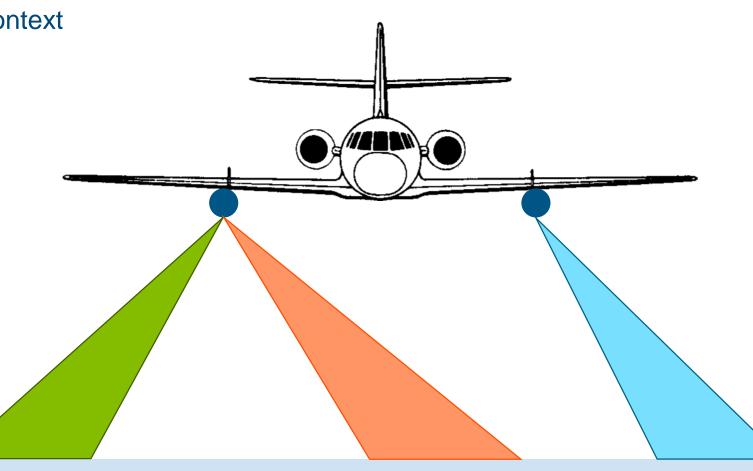
Making the Search Happen - Aerial Search Campaign

- BEA and Airbus collaboration with French research body ONERA
 - Synthetic Aperture Radar <u>technology</u> never deployed in such context
- Reasonable confidence of detection, although no guarantee
- Go-ahead decision given the criticality of hub recovery for root cause determination
- ONERA contracted

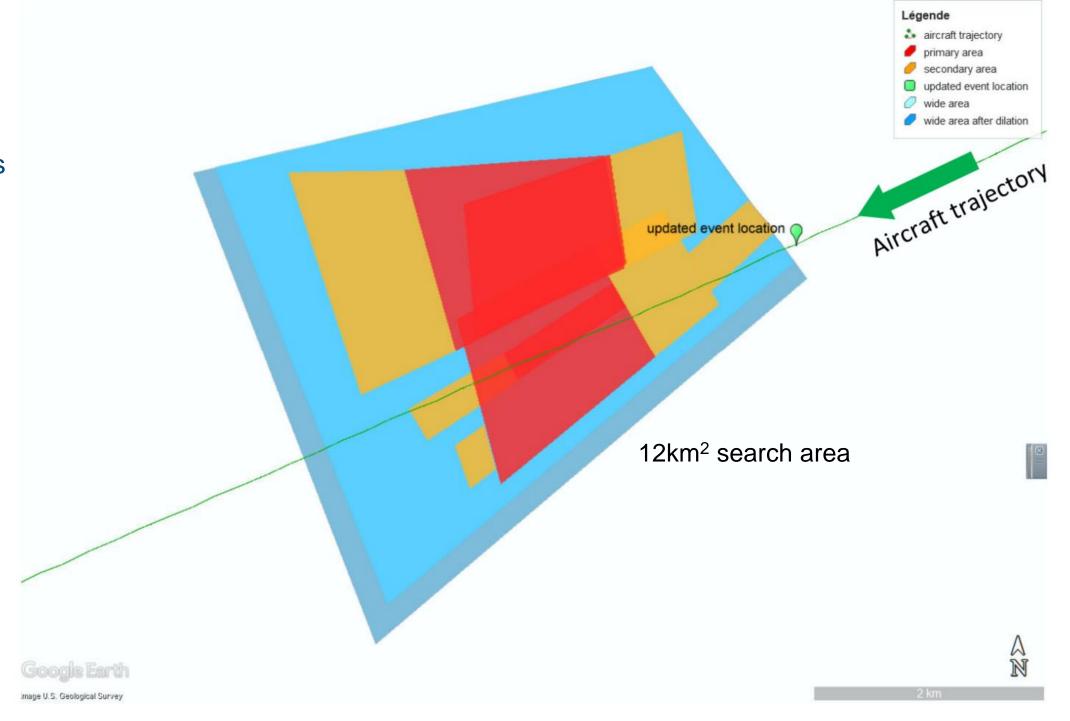
Making the Search Happen - Search Area

- Independent ballistic computations
 - BEA, Airbus and ArianeGroup
 - NTSB and their technical advisors
- Similar areas of probability

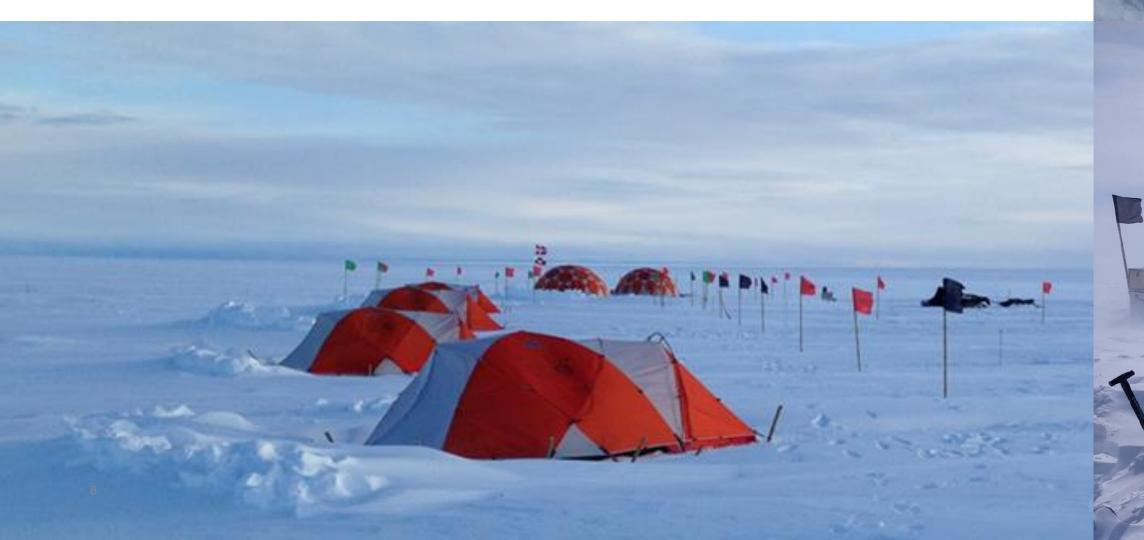
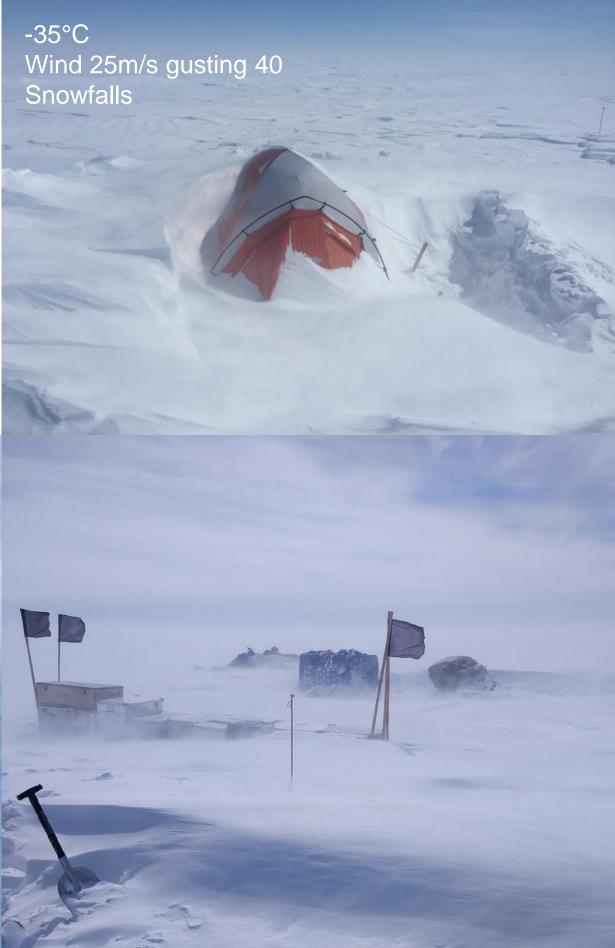
Making the Search Happen - Ground Expeditions

- Geological survey institution of Denmark and Greenland (<u>GEUS</u>)
- Highly experienced in field work in Greenland

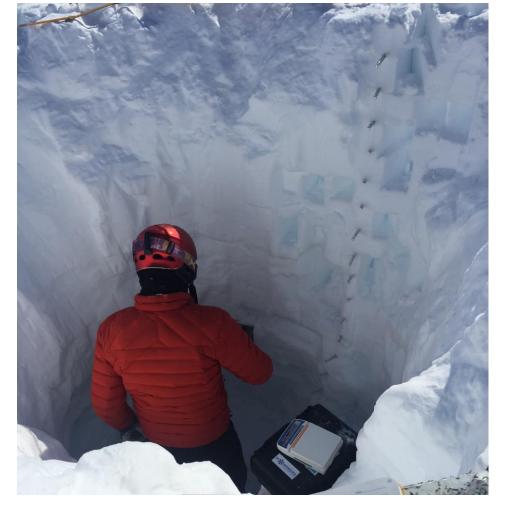
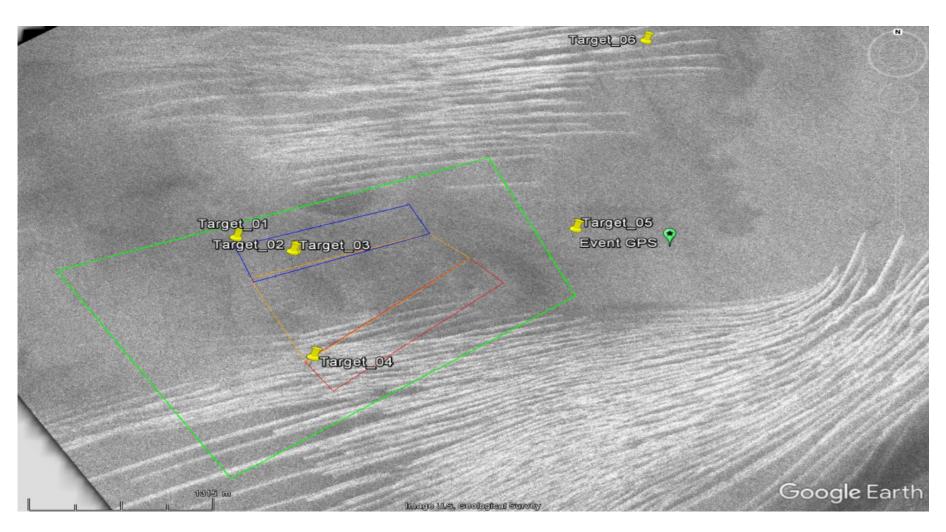
Complex Radar Data Treatment - Ground Search Stepbacks

- Radar scanning of defined area over April 2018
- Recovered data less readable than expected
- Strongest targets given to ground team

- Hazardous terrain and weather conditions
- Tons of snow and ice removed without success
- Search phase closure in June 2018
 - Unsafe ground conditions
