FINAL REPORT

AAIU Formal Report No: 2008-023

Operator: Aer Lingus

Location: Approach to Runway (RWY) 22R,
Chicago O'Hare Airport (KORD), USA

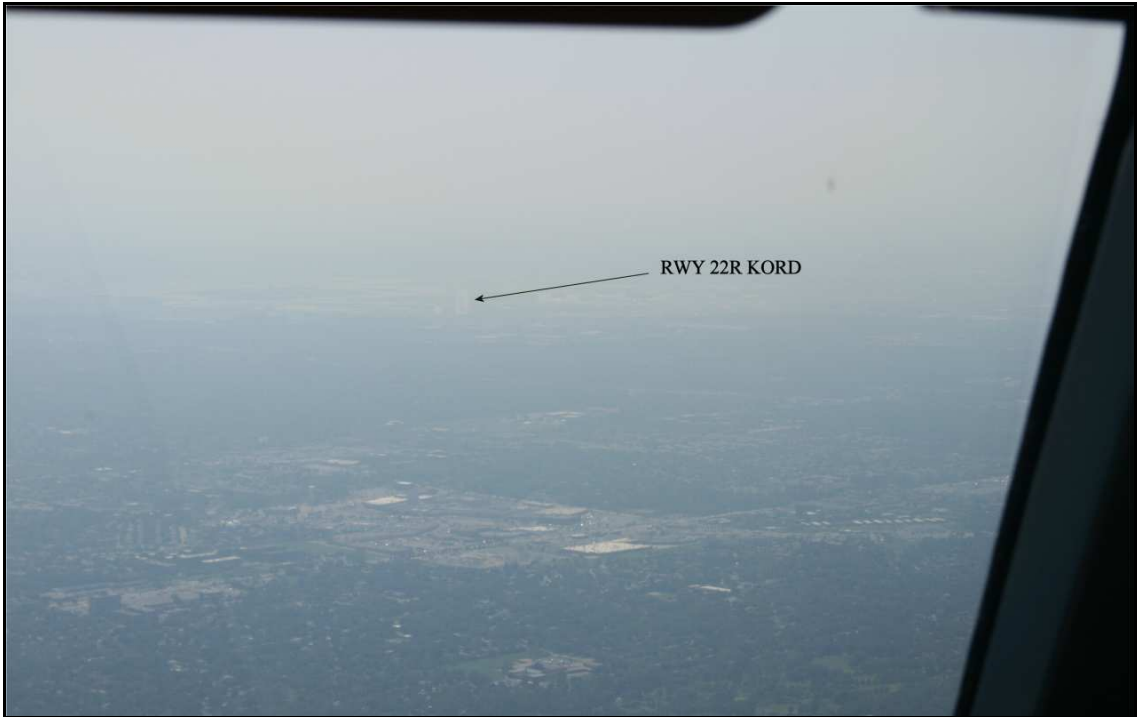
Photo No. 1

As the approach was conducted in the late afternoon in the autumn, it is probable that the runway approach lights and the airport itself would have been difficult to identify at a distance even though the visibility was probably in excess of 10 miles (**Appendix B Photos 1 & 2**). The former was due to the southwesterly approach into diffused sun light and the latter due to lack of terrain colour contrast at that time of year.

KORD RWY 22R Approach at 6 nm

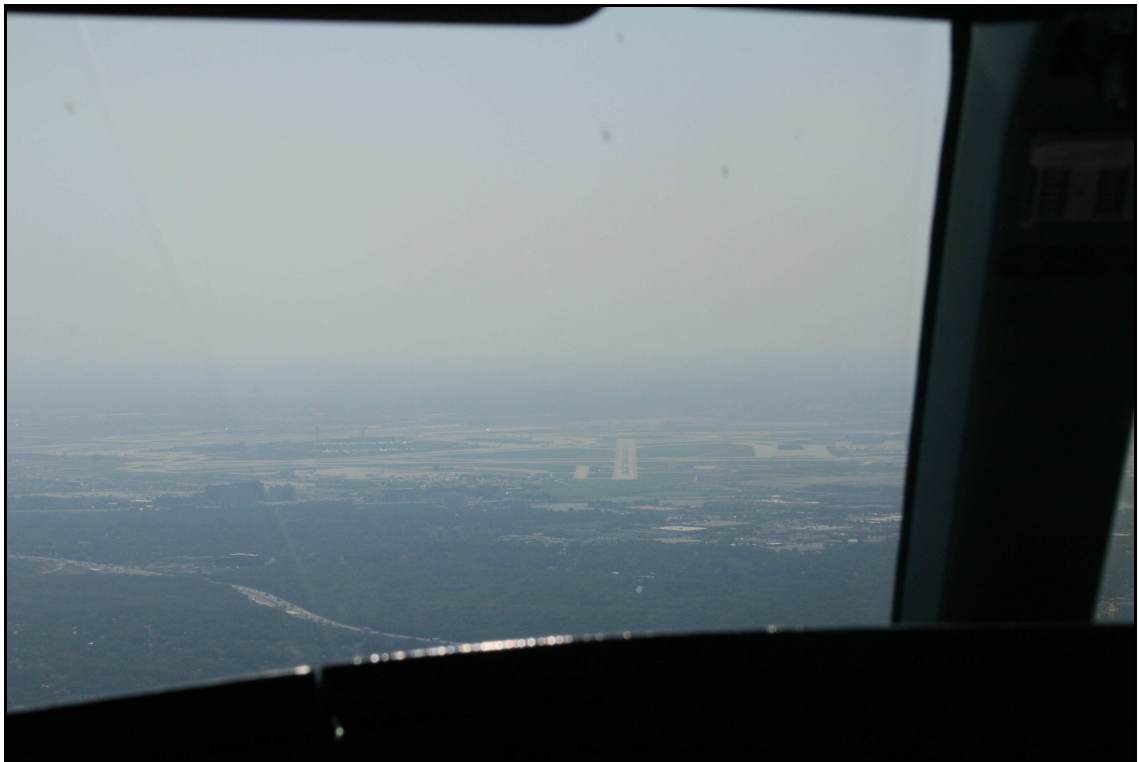
Photo No. 2

KORD RWY 22R at 3 nm in good visibility
