Investigation report

C11/2010L

A330 Jetliners' Engine Bleed Air System Failures: Serious Incidents on 11 and 22 December 2010

AIRBUS A330-302

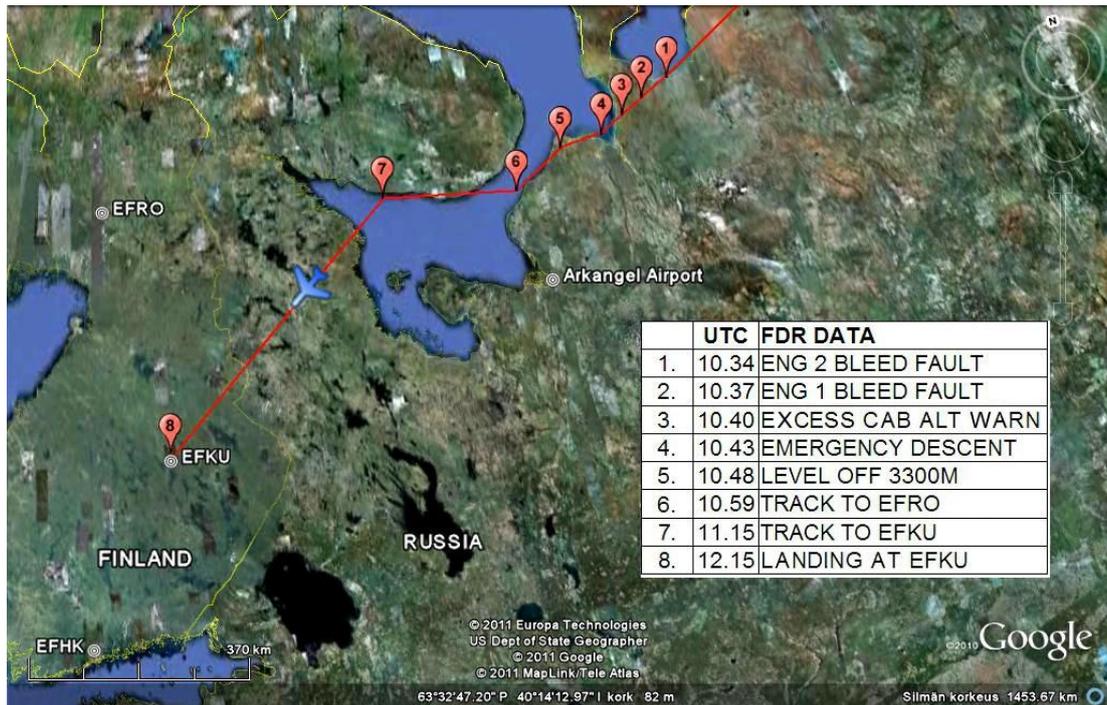
Figure 1. Key events associated with the serious incident of OH-LTO.

The flight crew re-planned the remaining leg of the flight. At 10:59 they requested a clearance to Rovaniemi (EFRO); according to their calculations they had sufficient fuel to reach this route alternate airport. After having talked to their Network Control Center, (NCC) they chose to divert to Kuopio airport (EFKU) since Kuopio was as far from them as Rovaniemi. They headed towards Kuopio at 11:15.

The approach and landing at Kuopio airport, which took place at 12:15, proceeded uneventfully. Following the landing, for the purposes of safety investigation, the flight crew attempted to preserve the Cockpit Voice Recorder (CVR) recording in the avionics bay by following the instructions of the operator's technical personnel. However, they did not succeed in doing it.

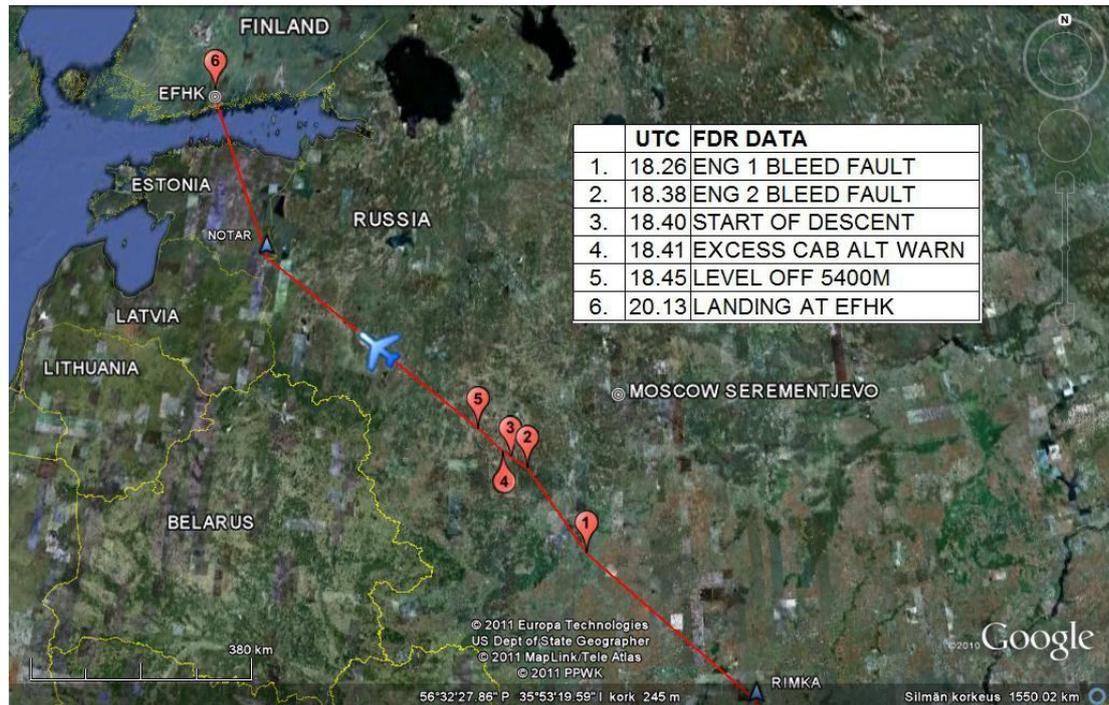
Figure 2. Key events associated with the serious incident of OH-LTS.

At 18:38 the bleed air system of the right engine failed as well (AIR ENG 2 BLEED FAULT). The flight crew requested that ACC Moscow clear them to a lower altitude because cabin altitude was on the rise. A moment later they received a clearance down to flight level 5400 m (17700 ft). The flight crew tried to reset the bleed air system of the left engine, which had malfunctioned earlier, to no avail. Following this, they continued to fly with both engines' bleed air systems being inoperative.

At 18:52 they began to climb to FL 217 (6600 m), reaching it in two minutes. They continued to fly to Helsinki-Vantaa airport, the planned destination, at this new cruising altitude. During the final leg the flight crew managed to reset the bleed air systems of both engines.

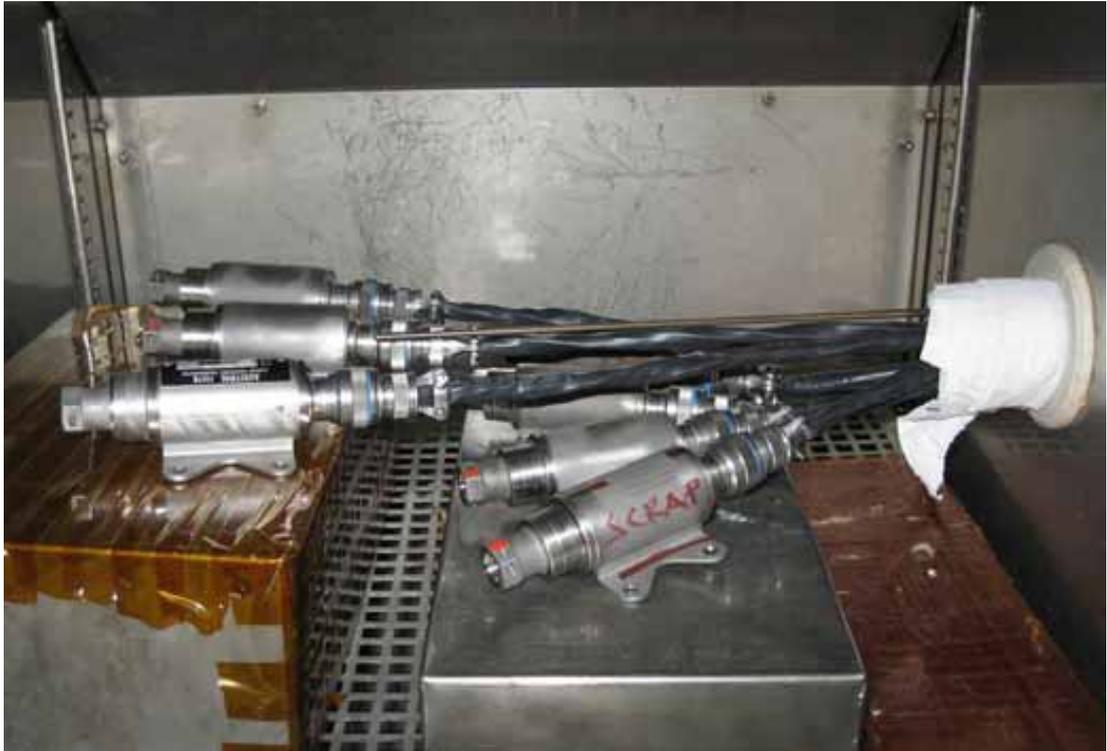
Figure 18. Pressure transducer output signal stability test arrangements in the test chamber. Source: Esterline-Auxitrol⁵.

Following the visual inspection all pressure transducers were subjected to the output signal stability test. Test arrangements are explained in figure 18. Tests detected water in three transducers. The clearest indication of this came from OH-LTO's transducer s/n ASA12571. The output signals of OH-LTO's transducers s/n ASA12736 and ASA12735 were inconstant during temperature changes. This is why they, too, were determined to contain water. Nonetheless, the presence of water in them was not as evident as in pressure transducer s/n ASA12571. Some of the water may have disappeared during removal and/or transportation. One of OH-LTO's pressure transducers, s/n 188, was of the first version manufactured. It passed the stability test. The ACMM does not require stability testing for first version pressure transducers.

Three pressure transducers that contained water on the basis of output signal stability test results were put into a 100 °C oven for two hours. After this, the stability test was repeated. Throughout the test the output signal of each pressure transducer remained constant. In other words, they passed the test. The result graphs of this test are also shown in appendix 9.

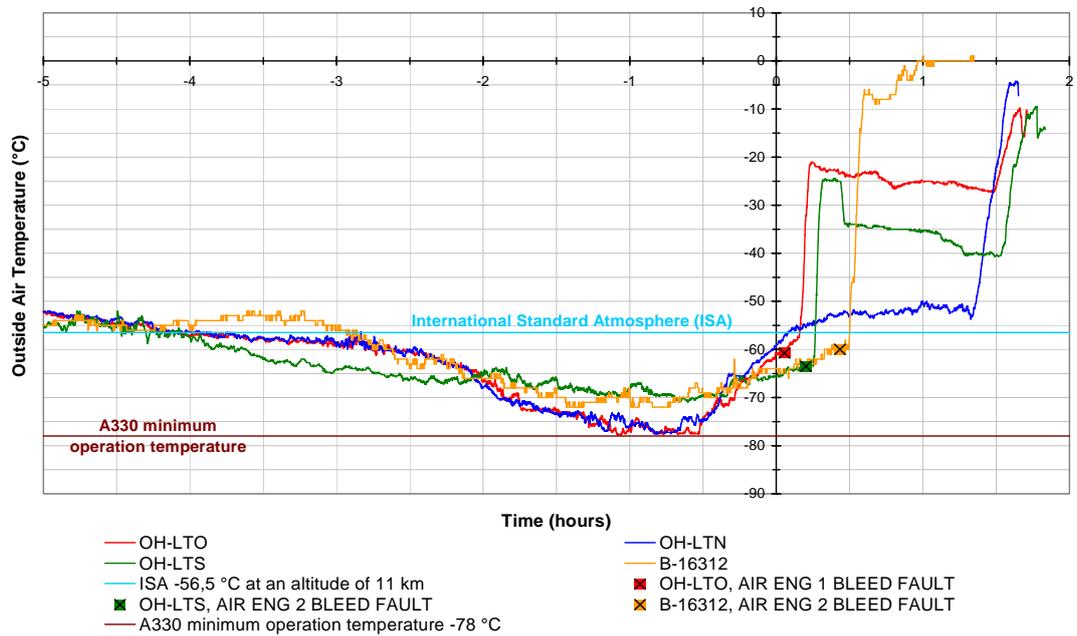
Figure 19. Ambient air temperatures on the reference flights as a function of time.

In addition to the occurrence flights, reference material was collected from two other flights. Due to identical flying weather conditions the investigation used measured ambient temperatures as reference material. Figure 19 shows the measured ambient temperatures of all four flights as a function of time for the final five hours before the first bleed air loss. The aircraft used for reference were A330s and the engines were type GE CF6-80E1.

In figures 19 and 20 the graphs of all reference flights meet the zero of the time axis at the point where the first bleed air losses occurred. The second bleed air loss points are marked on the graphs.

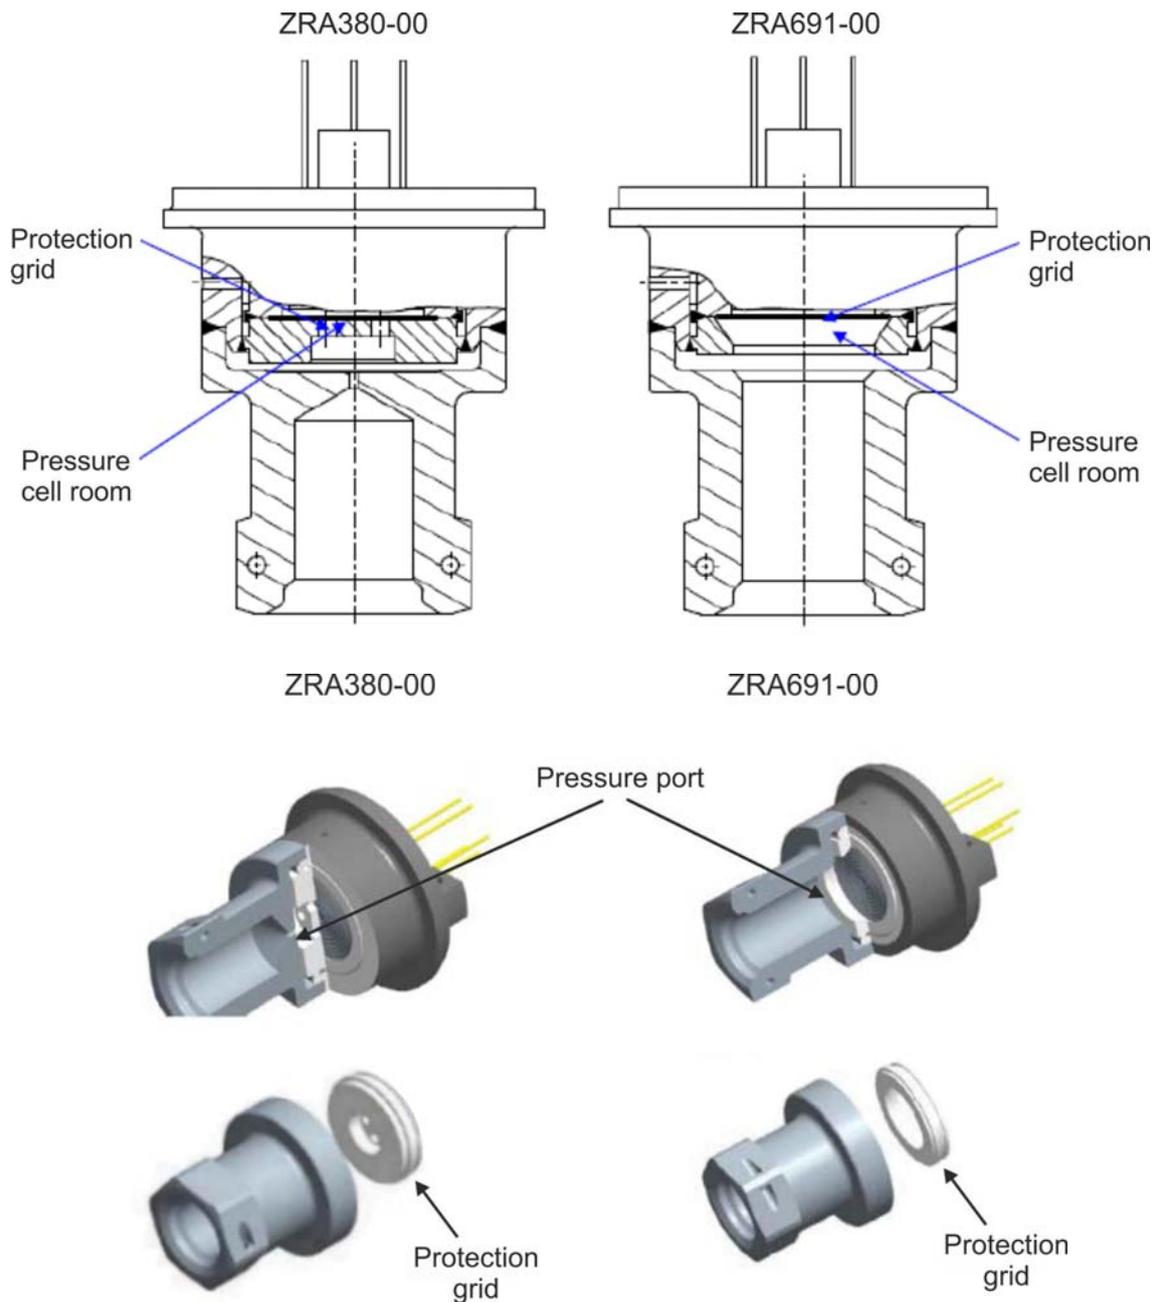
STRUCTURAL DIFFERENCES BETWEEN PRESSURE TRANSDUCERS P/N ZRA380-00 AND ZRA691-00

The third pressure transducer version, p/n ZRA691-00, was designed and manufactured by modifying p/n ZRA380-00, the second version. Their essential differences lie in the protection grid as well as the pressure cell room between the grid and the metallic membrane. In order to avert blockage caused by ice build-up, the four small holes in version no. 2 are no longer present in the third version. They are replaced by one large hole. Whereas the height of the second version's pressure cell room is 0.17 mm, it is 5.2 mm in the third version.

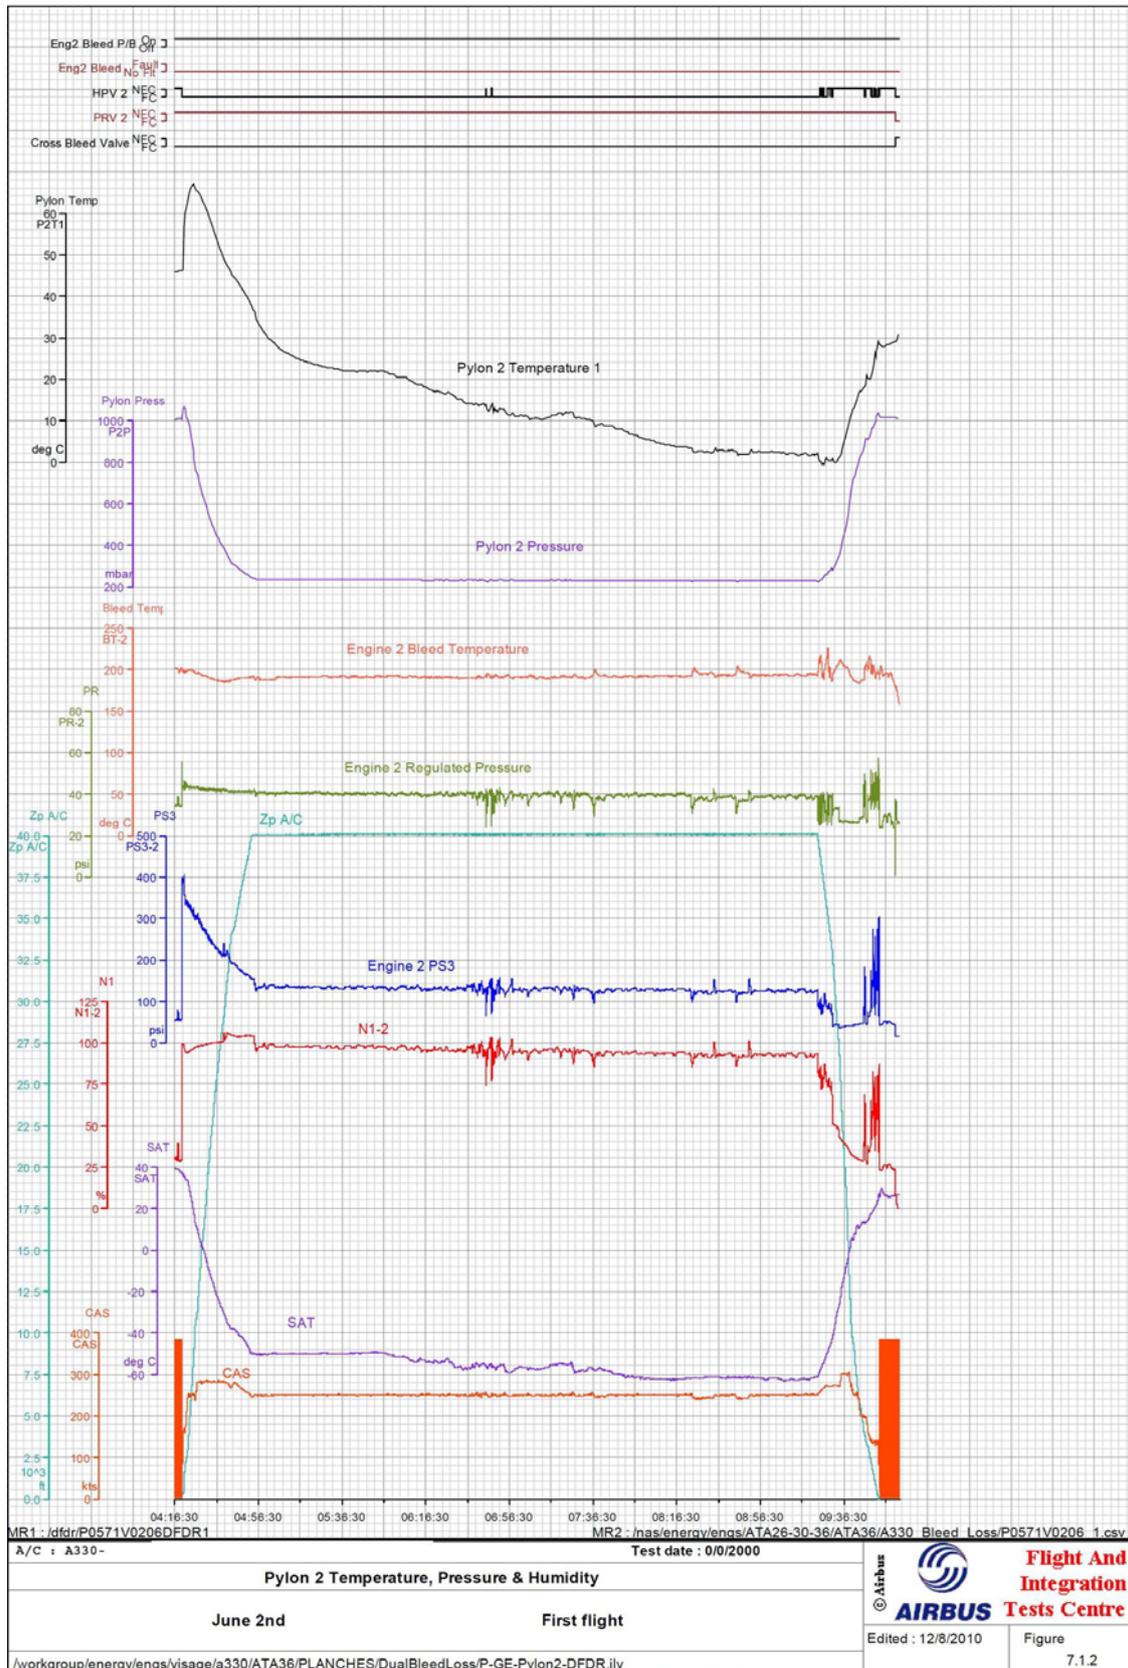
AIRBUS TEST FLIGHT RESULT GRAPHS

A330 - ATA 36 - Dual Bleed Loss Investigation

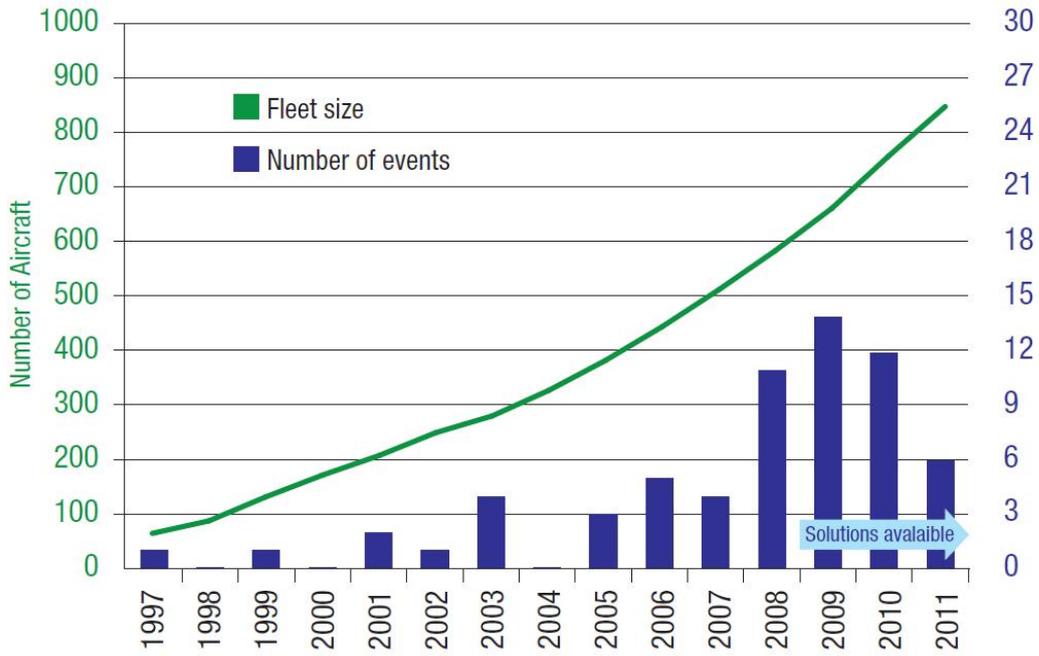
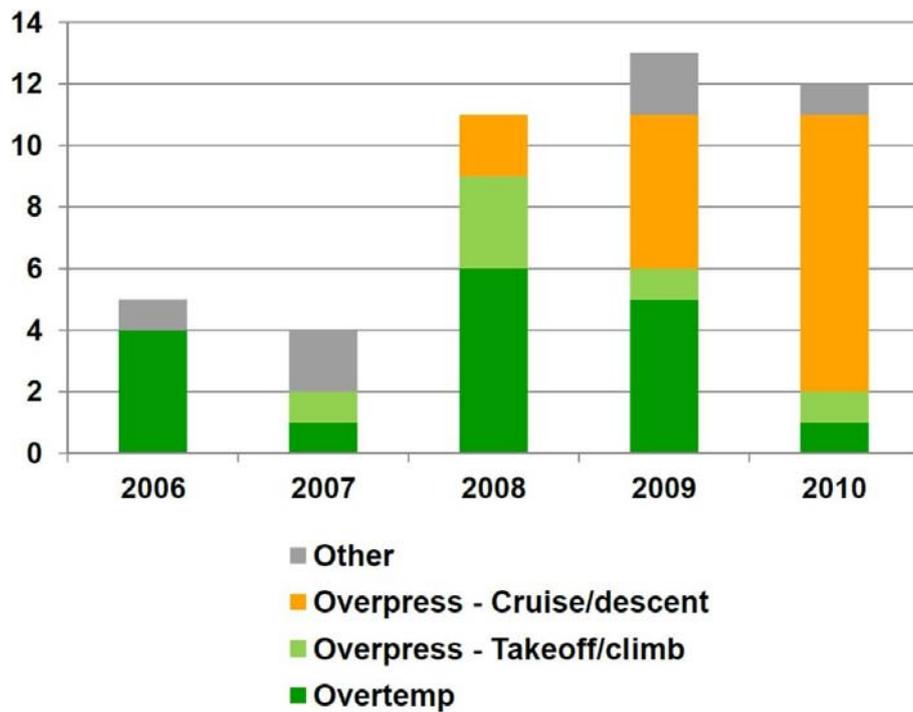
AIRBUS STATISTICS OF A330 DUAL BLEED LOSS OCCURRENCES

Although the number of events had remained stable since 2008, in 2010 a total of 12 events were reported, 7 of which in December. Subject OIT is released to advise operators of the latest developments and provide recommendations to prevent DBL re-occurrence.
