A U S T R A L I A N T R A N S P O R T S A F E T Y B U R E A U

AVIATION SAFETY INVESTIGATION

BS/20010005

Investigation into Ansett Australia maintenance safety deficiencies and the control of continuing airworthiness of Class A aircraft

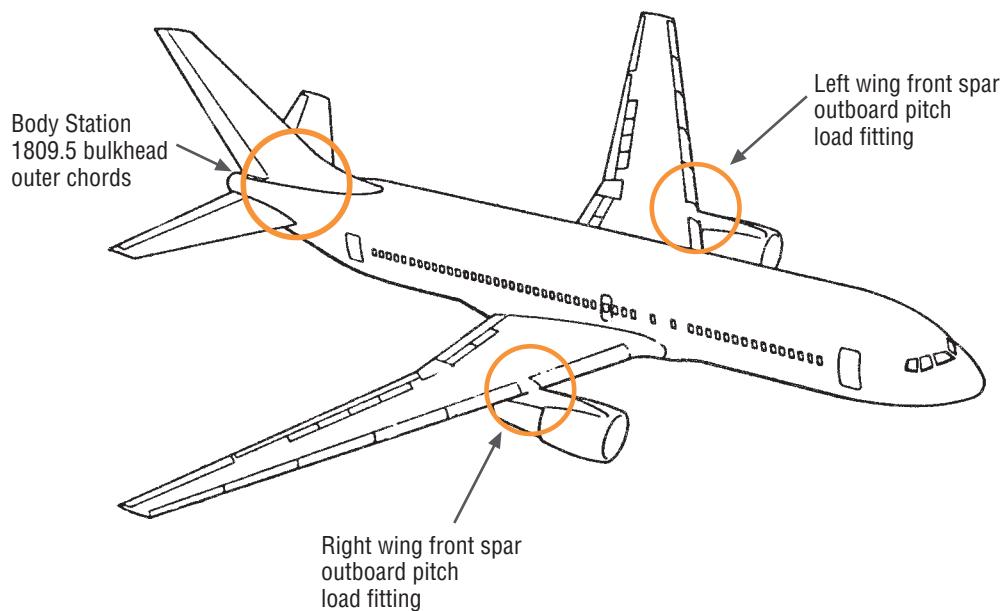
FIGURE 1:
Location of B767 Body Station 1809.5 bulkhead and wing front spar pitch load fittings

In December 2000 the concerns related to possible fatigue cracking in the Body Station 1809.5 bulkhead outer chord, in the rear fuselage of the aircraft. In April 2001 the concerns related to possible fatigue cracking of the wing front spar outboard pitch load fitting that connected the engine support structure to the wing (see Figure 1). In both cases undetected fatigue cracking had the potential to eventually lead to structural failure.

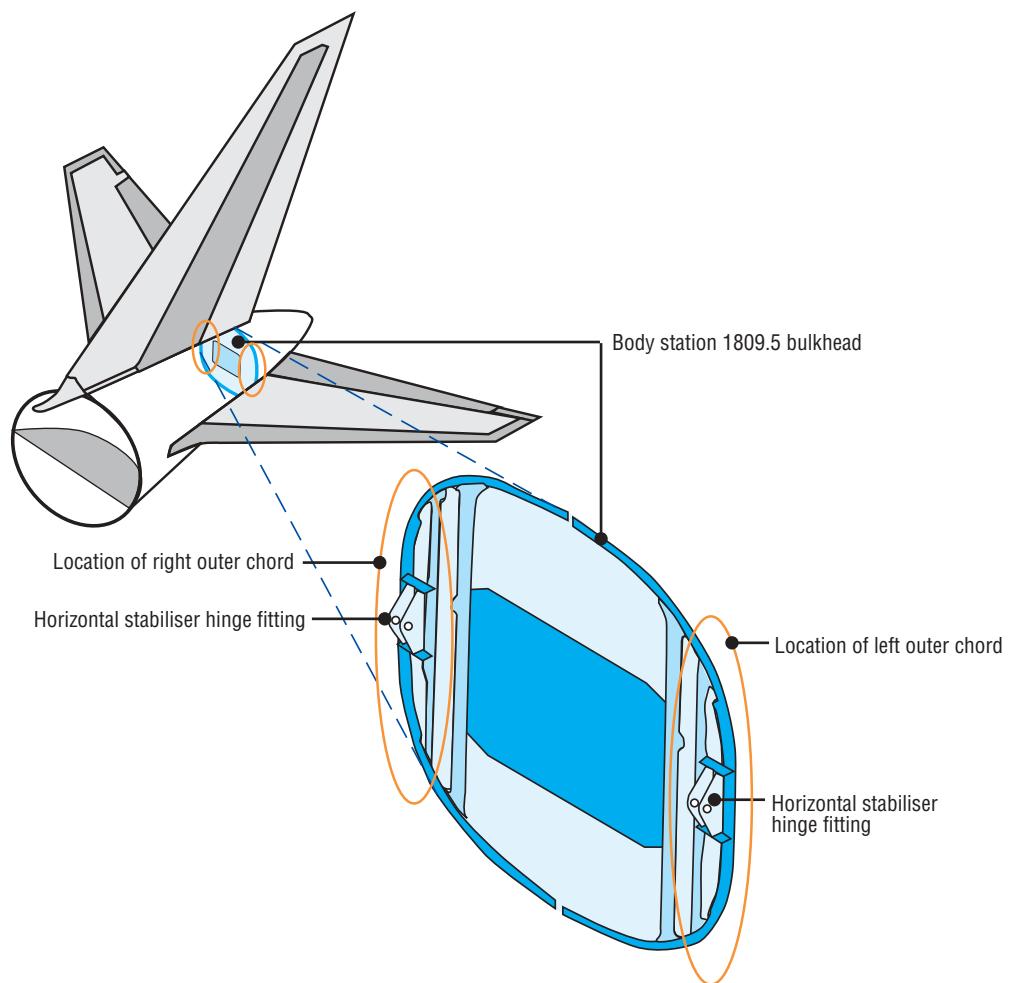
Figure 22:
Location of B767 Body Station 1809.5 bulkhead

The June 2000 revision of the *Maintenance Planning Data Document* section 9 included three further Airworthiness Limitations Structural Inspections with thresholds of 25,000 cycles that were potentially applicable to the Ansett B767 aircraft VH-RMD/E/F/G/H/K/L (see Table 3). All three of those inspections related to the Body Station 1809.5 bulkhead outboard chord (see Figure 22).

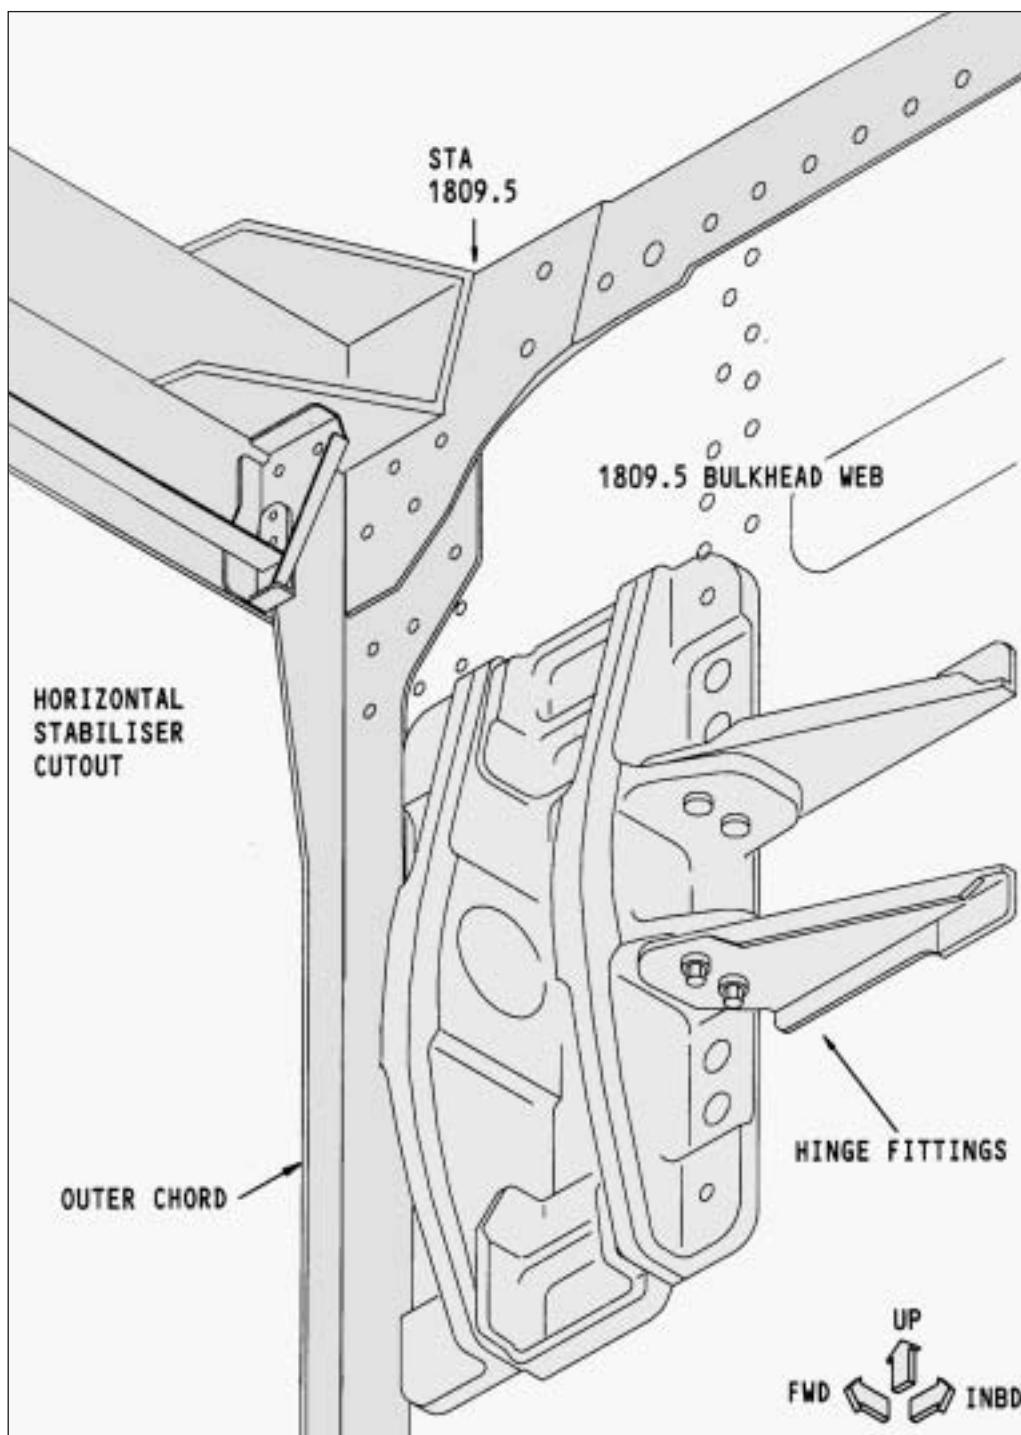
FIGURE 23:
Construction detail of B767 Body Station 1809.5 bulkhead area

Other B767 operators reported similar Body Station 1809.5 bulkhead cracks to Boeing, and cracks were also found in that area on the B767 fatigue test aircraft. The cracks were in the outer chord of the bulkhead, just above the horizontal stabiliser hinge fitting (see Figure 23). Fatigue cracks occurred in this area because the horizontal stabiliser flight loads in the upper corner of the bulkhead were higher than allowed for during design.

Boeing analysis at the time indicated that if the fatigue cracks in the bulkhead chord were not found and repaired, then cracks could develop in the adjacent structure. Adjacent structure cracks could result in expensive repairs and unscheduled removal of the aircraft from service (see section 6.4.1).

The Body Station 1809.5 bulkhead area was a difficult area in which to work (Figure 24). Ansett structural engineers contacted Boeing for advice and a repair scheme was subsequently devised and implemented. Ansett submitted major defect reports to CASA concerning the cracks identified in VH-RMG on 19 January 1996 and VH-RMD on 20 January 1997.

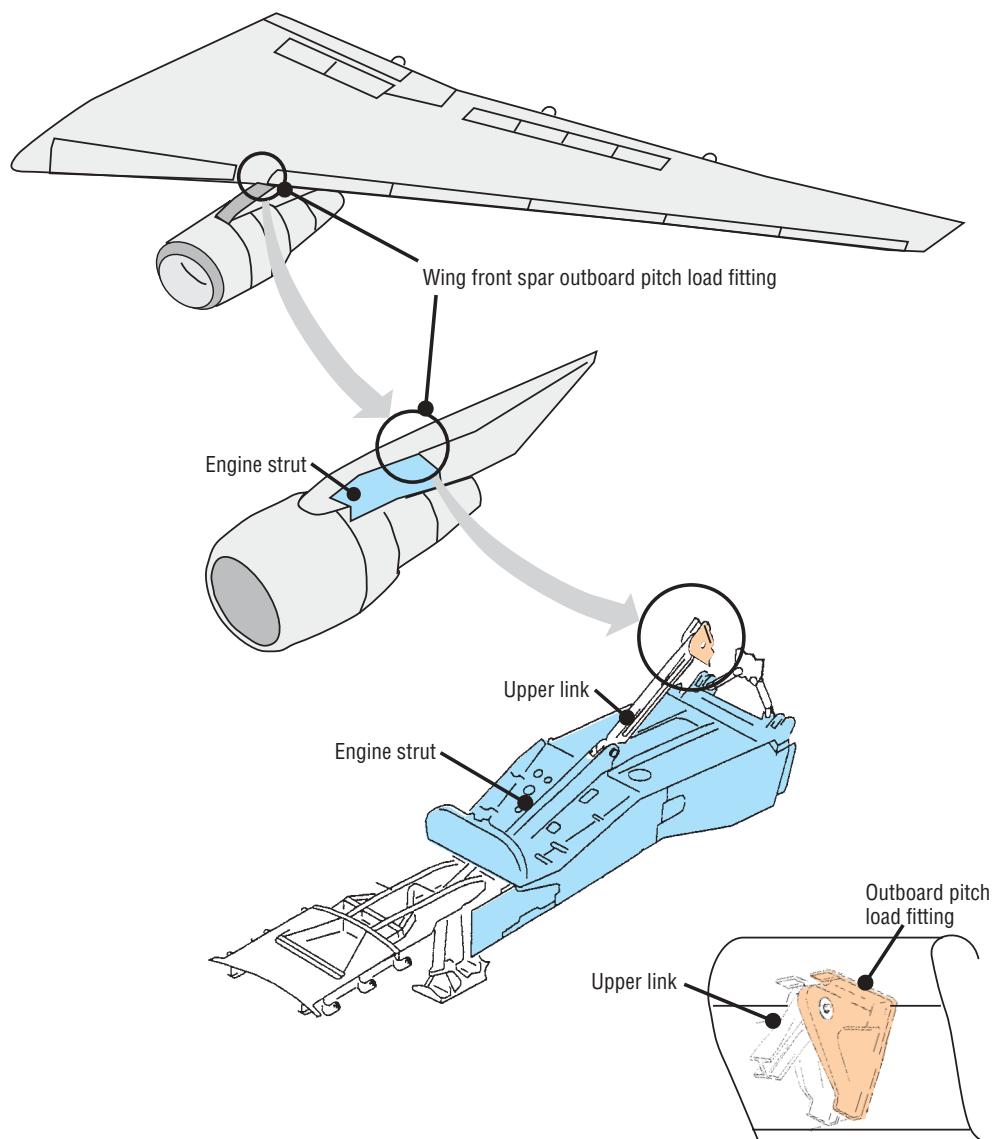
FIGURE 28:
Location of B767 wing front spar outboard pitch load fitting

On 2 March 2000, Boeing issued an Alert Service Bulletin (767-57A0070) to detect and repair cracks in the wing front spar outboard pitch load fitting for the engine mounting strut on B767 aircraft (see Figure 28). The service bulletin was applicable to all aircraft with production line numbers 1–101 inclusive and was based on seven reports that Boeing had received of cracked wing front spar outboard pitch load fittings on B767 aircraft in the world fleet. The youngest aircraft with detected cracks had accumulated 8,826 hours and 3,862 flight cycles, and the oldest aircraft with detected cracks had accumulated 54,502 hours and 26,684 cycles.

The wing front spar outboard pitch load fitting was part of the upper link load path between the engine and the wing. Cracks in the wing front spar pitch load fitting could have caused possible loss of the upper link load path and separation of the strut and engine from the wing.

The service bulletin provided instructions for the inspection of the outboard pitch load fittings for cracks and instructions for replacement of the fitting. The replacement fittings incorporated an improved radius and lug detail designed to discourage the formation of cracks (see Figure 29).

The service bulletin recommended that the work be carried out within 180 calendar days after receipt of the bulletin. If no cracks were found then it was recommended that the inspection be repeated after every 18 months or 3,000 flight cycles, whichever came first. The terminating action for the service bulletin, whether cracks were found or not, was to carry out the fitting replacement as detailed in the service bulletin.
