The Eighth Meeting of the Asia/Pacific
Aerodrome Assistance Working Group (AP-AA/WG/8)

SAFETY IMPLICATIONS OF RUNWAY MARKING OVERPAINTING ON RUBBER-CONTAMINATED SURFACES: RESULTANT FOREIGN OBJECT DEBRIS (FOD) RISKS AND MAINTENANCE CONSIDERATIONS

(Presented by AIRPORTS AUTHORITY OF INDIA, INDIA)

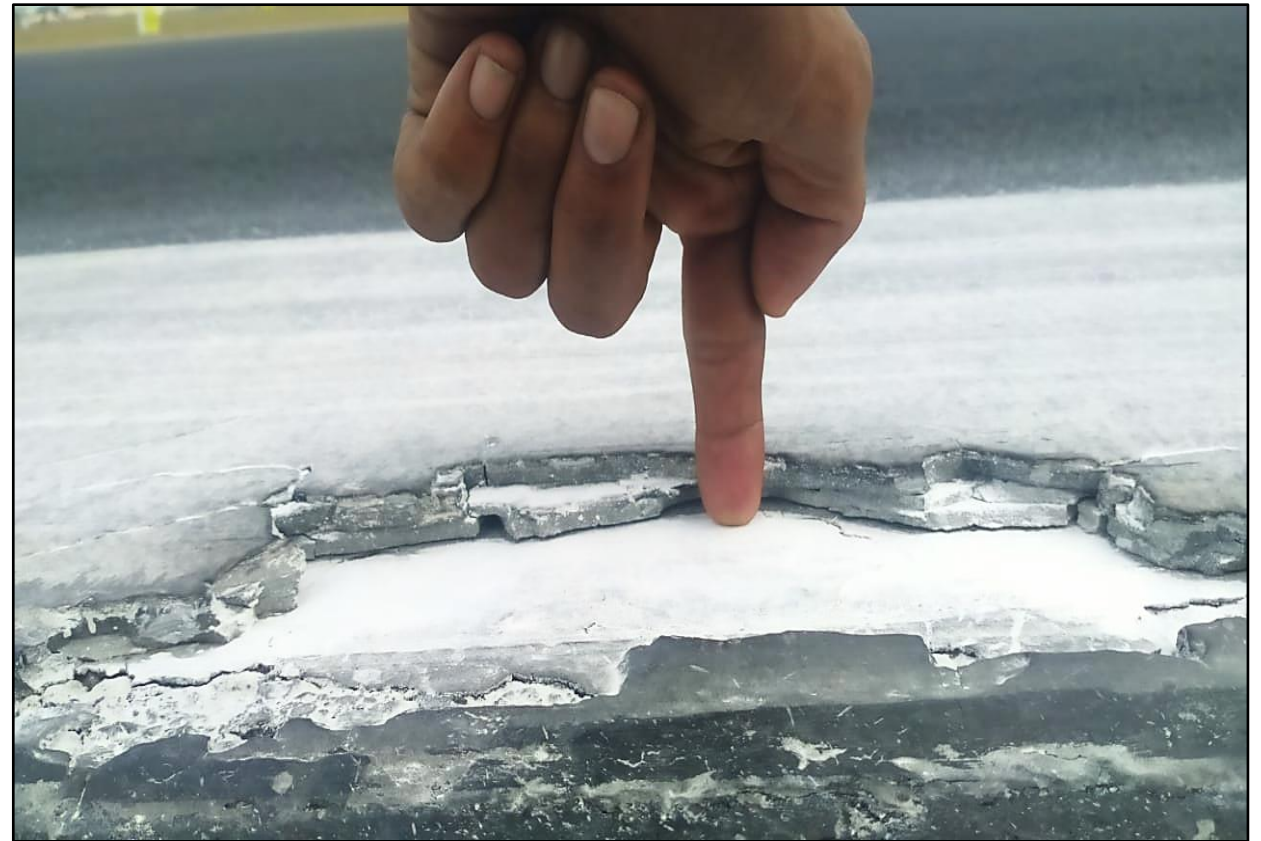
- 2.6 This layered application significantly reduces adhesion between marking material and pavement substrate. In addition, interaction between accumulated paint, rubber deposits, and the underlying pavement may induce micro-cracking or hairline fractures at pavement edges adjacent to markings.

- 2.7 With continued operational loading, thermal cycling, and weather exposure, these composite layers progressively deteriorate and may detach in hardened strips or fragments of sufficient size and rigidity to pose ingestion or impact hazards to aircraft during take-off or landing roll.

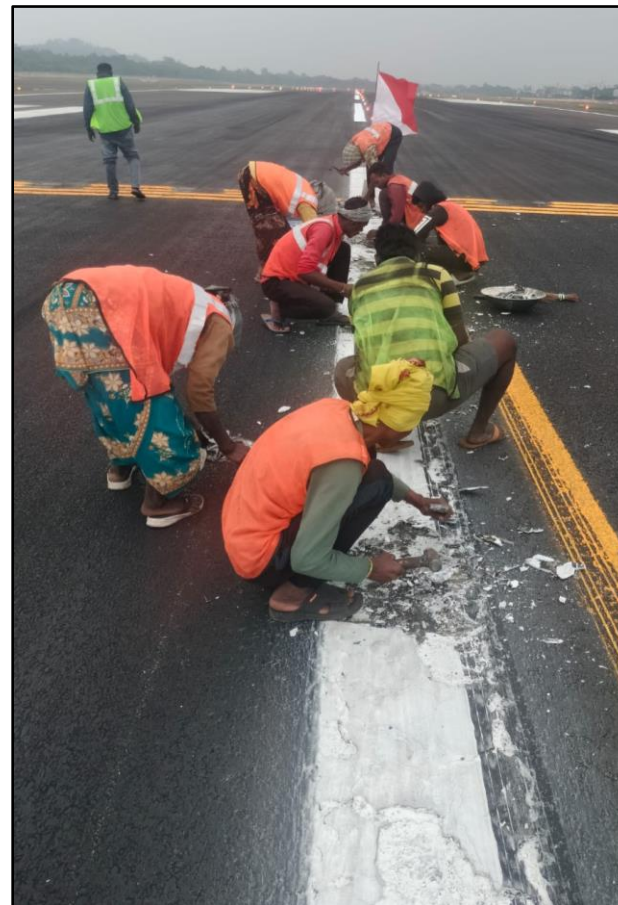
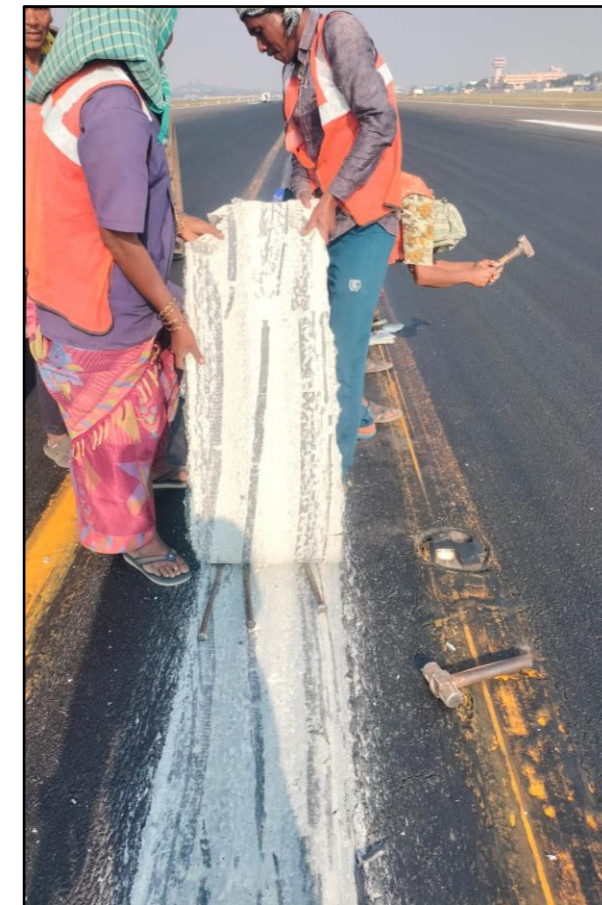
- I. At approximately 2220 hrs, information was received from a KLM engineer regarding the arrival aircraft SQ528 (9V-SCJ), which was parked at Stand 29. The aircraft was found to have puncture-like scratches/damage on its belly, specifically near the left air conditioning access panel (Panel No. 195C). Upon investigation, it was observed that the aircraft belly had punctures at four locations, with yellow paint chips present inside the affected areas. Subsequently, a detailed inspection of the runway and taxiway routing was carried out. While no FOD or loose paint chips were detected during the inspection, certain sections of the runway were found to have accumulated layers of paint. It was also noted that, at a few locations, the paint could potentially dislodge if subjected to manual force.

- II. A Foreign Object Debris (FOD) incident was reported involving aircraft VT-YBF operating flight QP-1305 (IXZ–MAA) on 12.11.2025. Upon arrival, paint flakes were observed in the aircraft's wheel well. Immediately after receiving this information, operational jeep carried out a detailed inspection of the aircraft's Runway–Taxiway movement route. No FOD was detected along the inspected route. However, an area between Taxiway P and Taxiway V was identified where the taxiway guideline marking had multiple layers of paint. Although no loose paint material was found at the time of inspection, the condition of the marking was noted. This location lies approximately 0.375 meters to the left of the centerline of Runway 07.

- I. High-pressure water blasting or mechanised rubber removal;
- II. Mechanical grinding or shot-blasting in high-rubber zones;
- III. Restoring runway markings in phases or sections instead of the entire runway at once;
- IV. Periodic full stripping cycles based on cumulative runway marking paint thickness,
- V. Condition-based maintenance triggered by contrast or adhesion performance.
